Mi HOME BUYER SURVEY

# HOME BUYER SURVEY REPORT

The format of this Mi HOME BUYER SURVEY REPORT is consistent with the guidance note requirements for a Survey Level 2 as defined by RICS Surveys of Residential Property 3rd edition May 2016

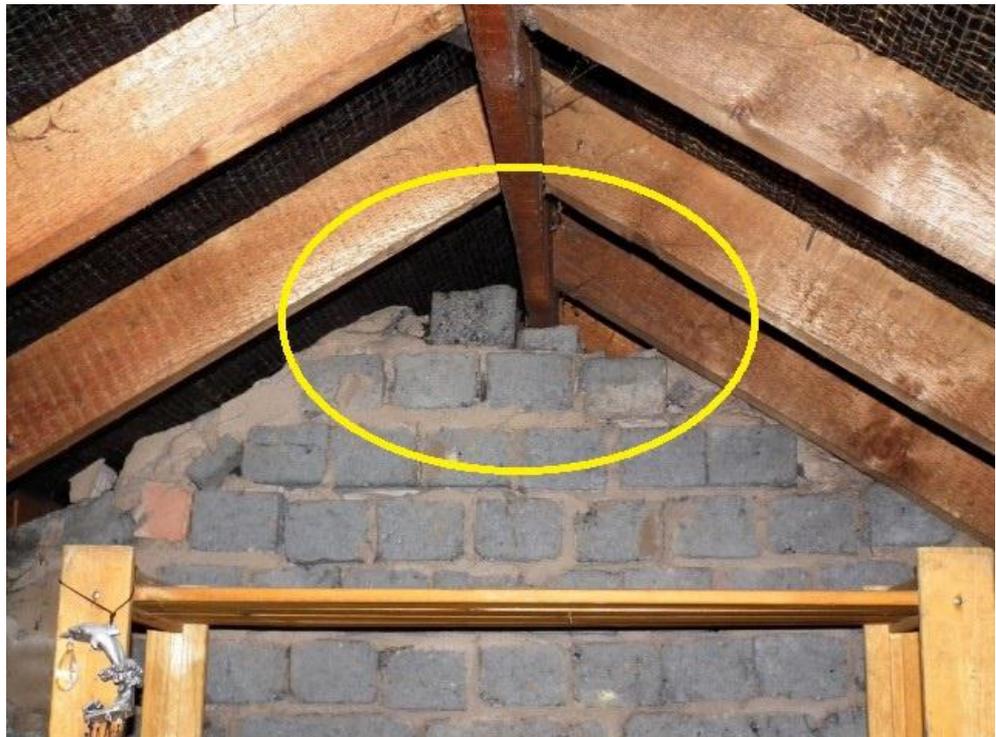
There are gaps in the Party Wall in the loft space that could increase the risk of fire spread should one occur

Holes in Party Wall

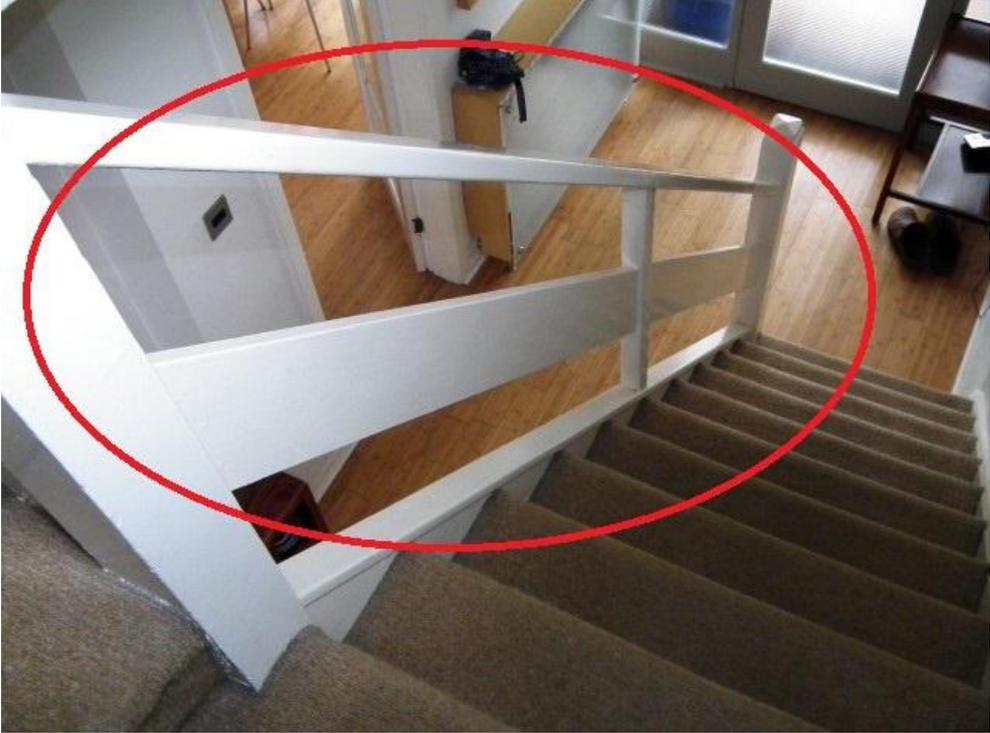
<p>Banister is a risk to children due to large gaps</p>
<p><b>Unsafe Fittings</b></p>	<p>No issue noted by surveyor</p>
<p><b>Insect and Rodent Infestations</b></p>	<p>No issue noted by surveyor</p>
<p><b>Recent testing of services</b></p>	<p>There is no evidence of recent inspection of the electrical or heating systems, but certification may be available. See also 6.1 and 6.2.</p>

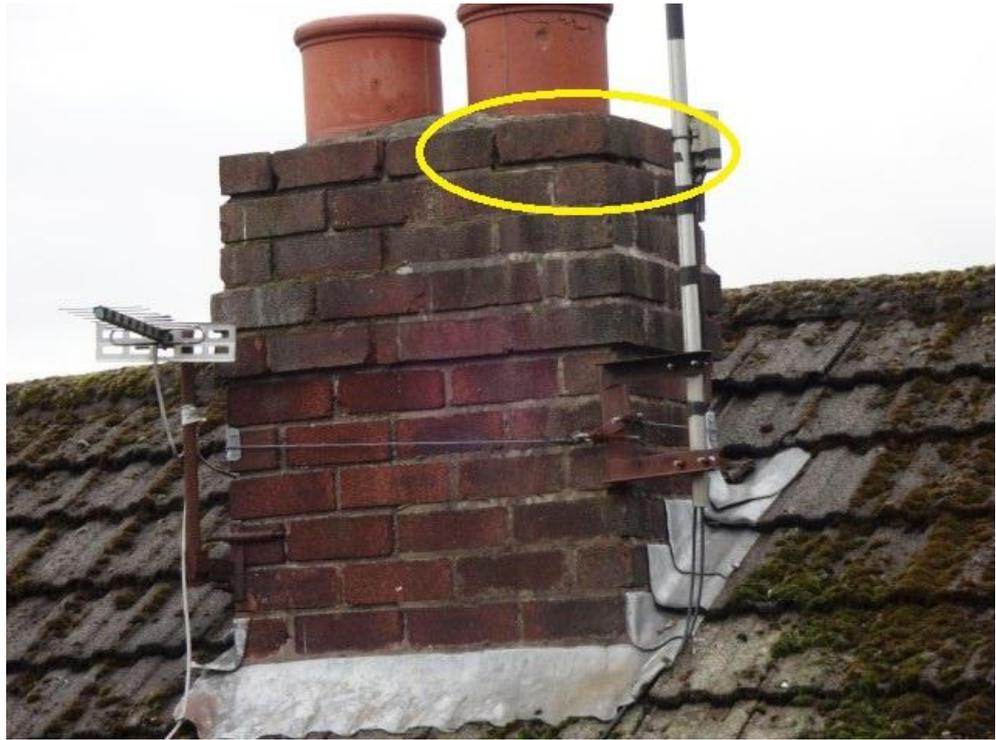
The pointing to the chimney stack is crumbling and missing in places which will be allowing the ingress of water.

Cracked and crumbling pointing on chimney

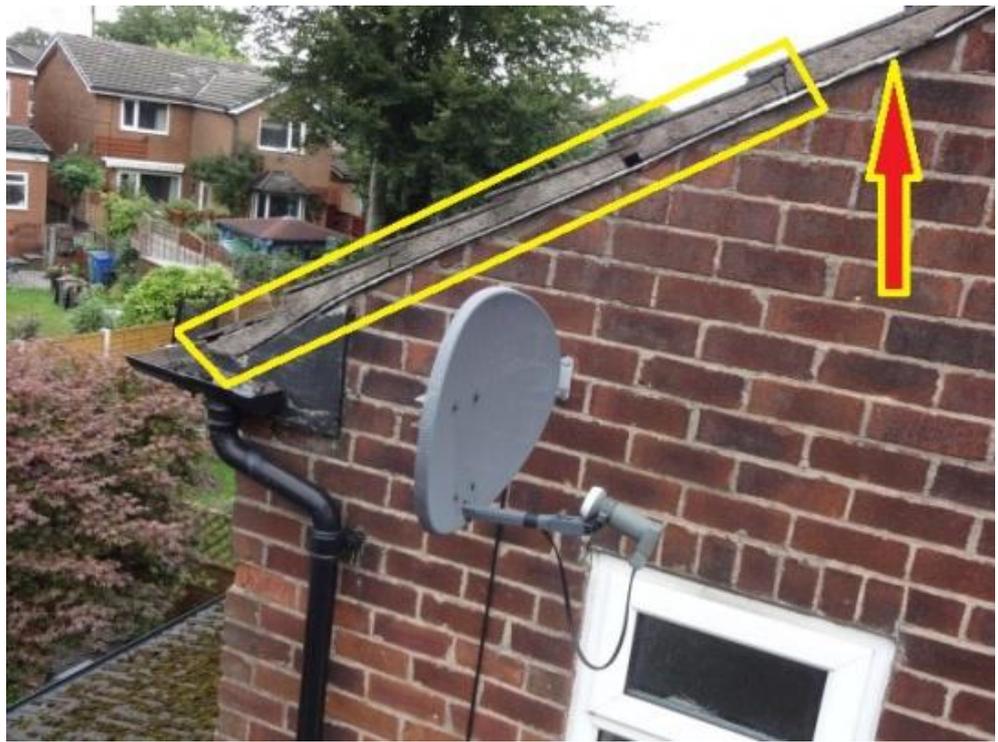
Minor cracks in pointing and possible asbestos

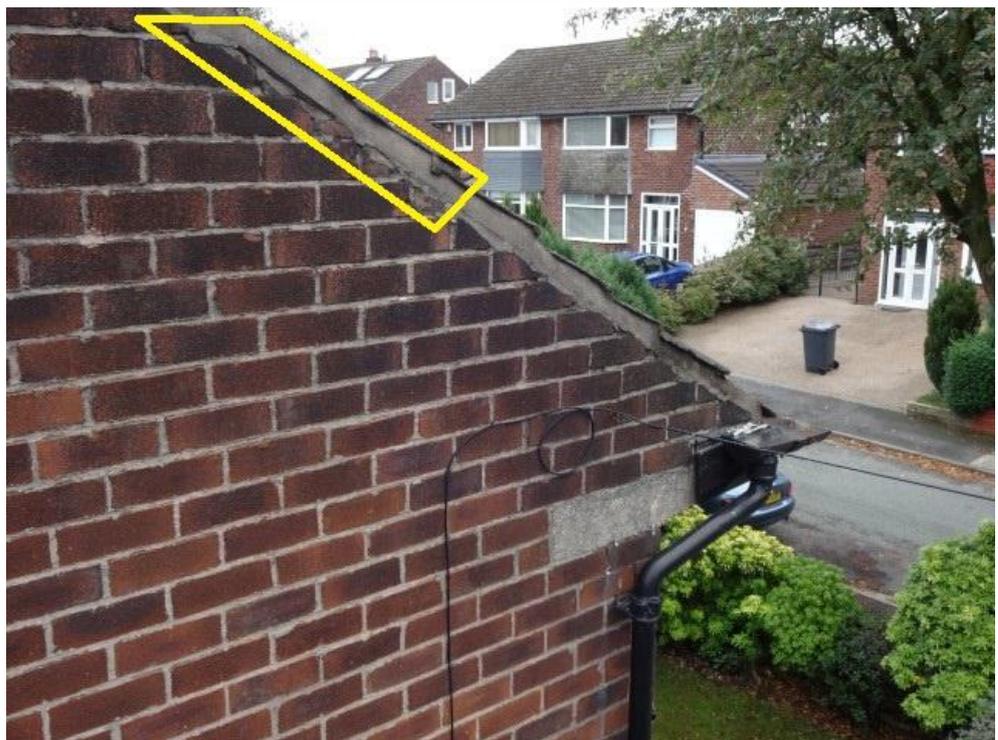
Minor cracks in pointing

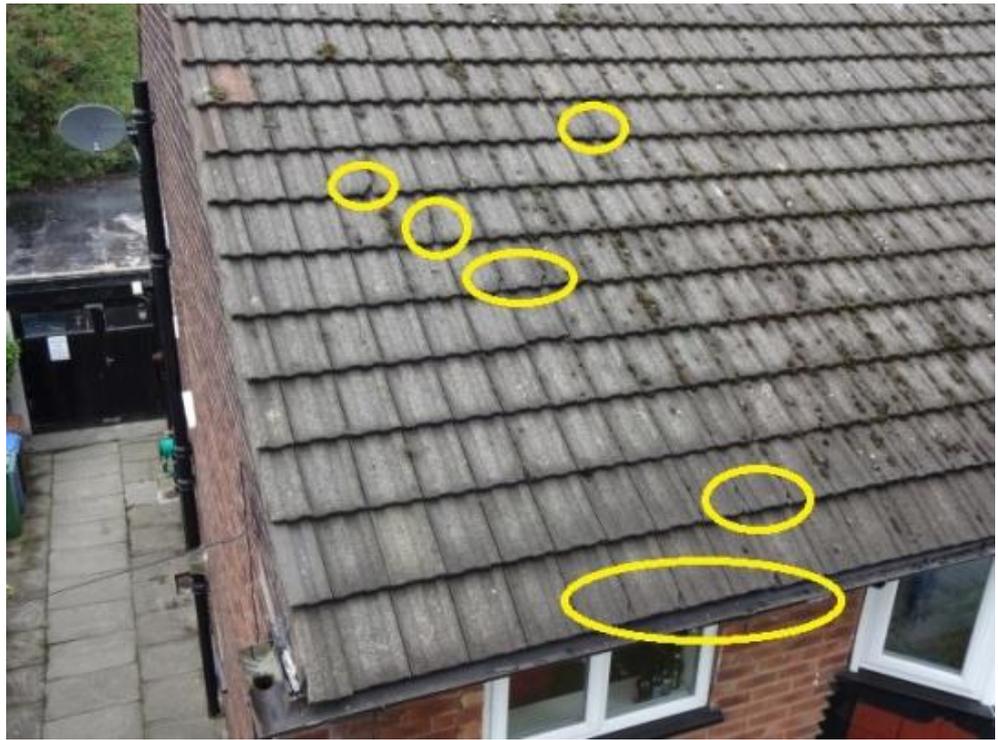
Cracked tiles

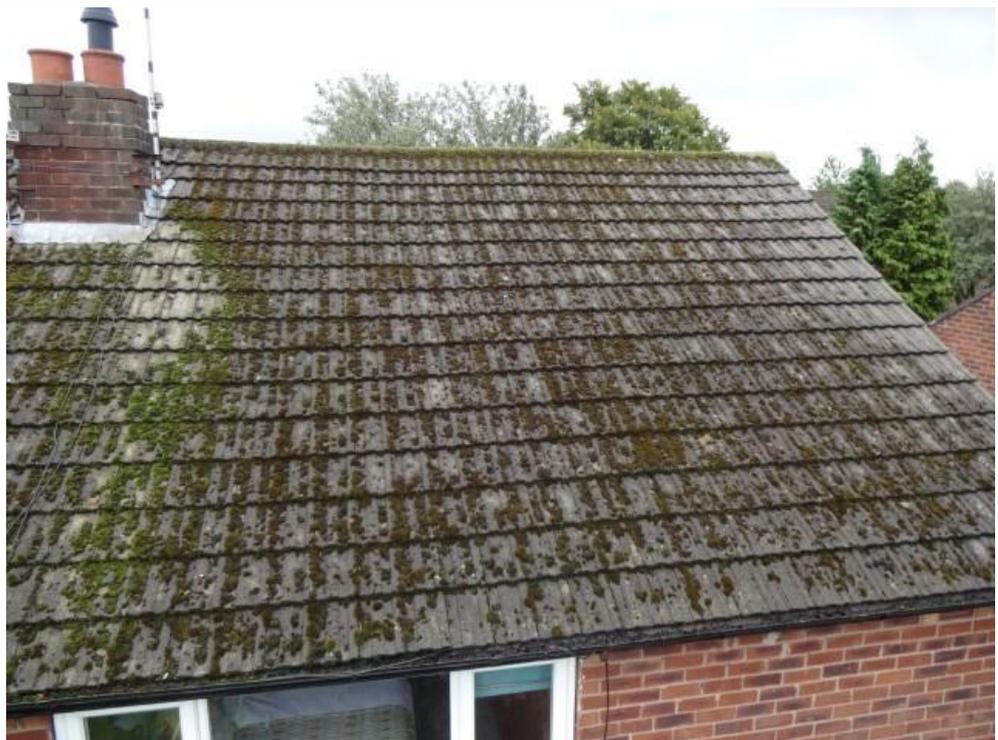
Large amount of moss growth to roof

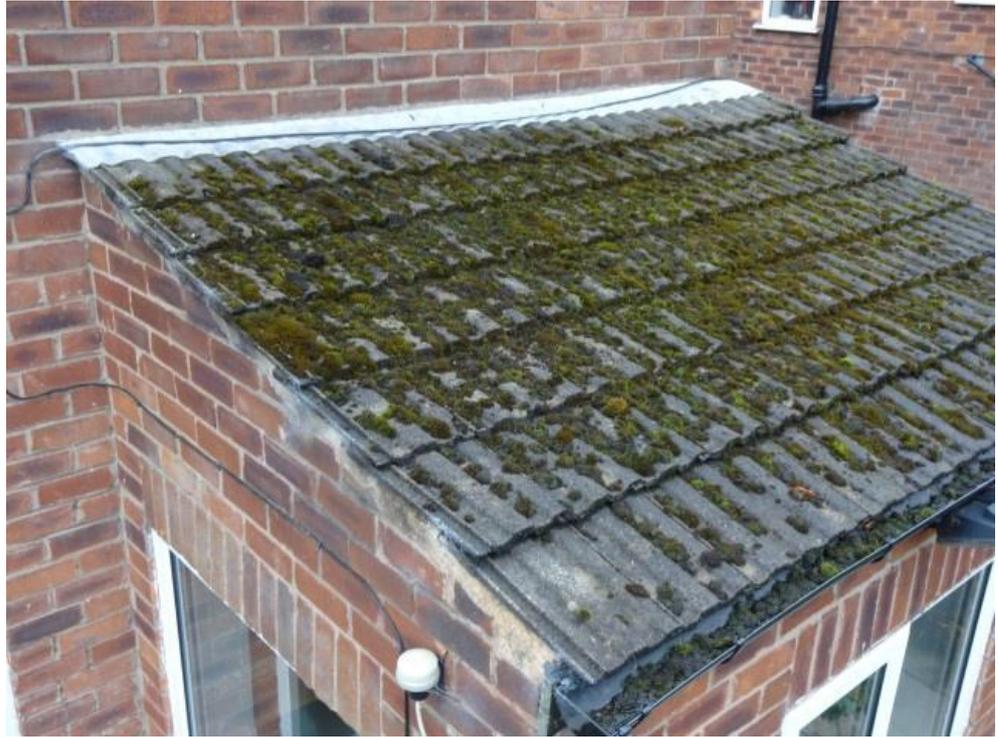
Large amount of moss growth to extension roof

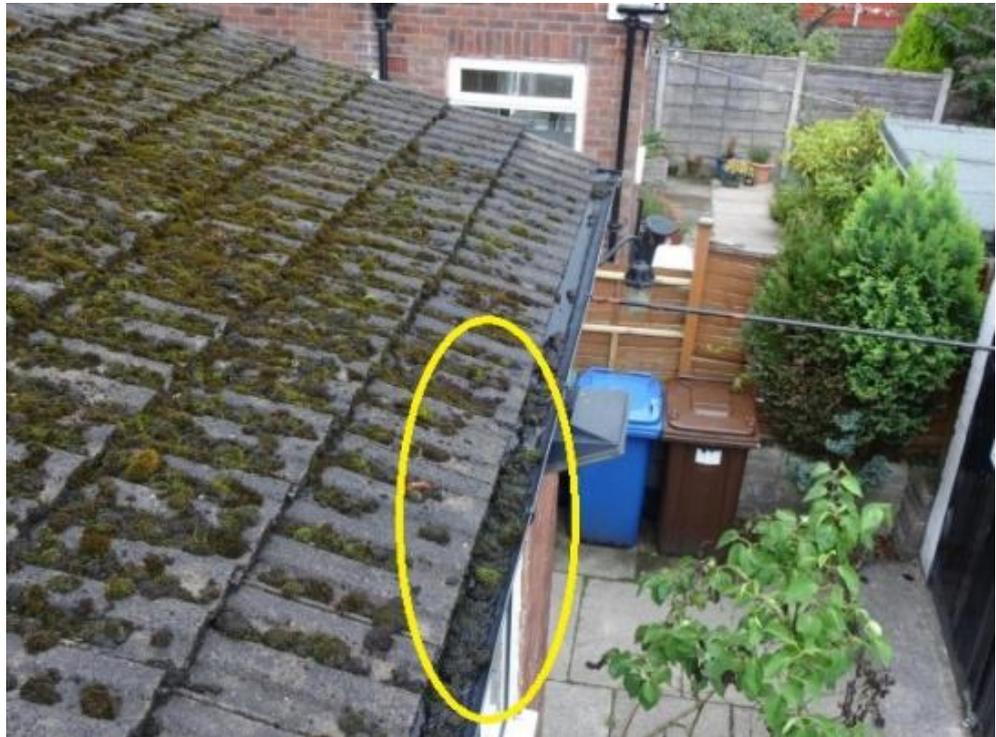
Guttering is blocked to the extension

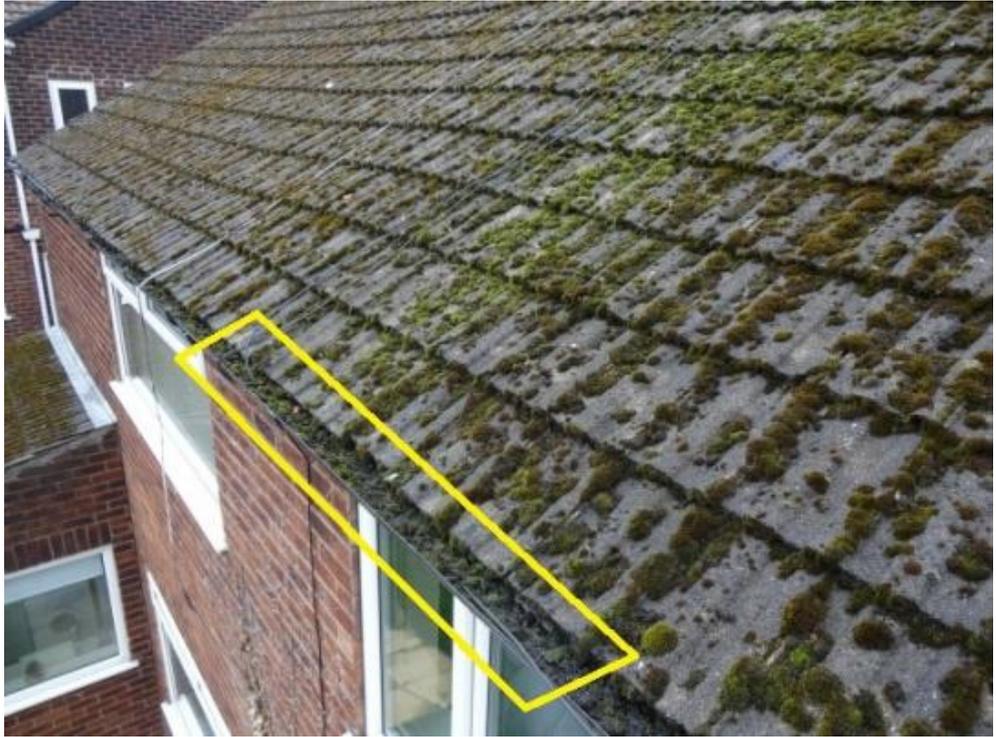
Guttering is blocked to the rear

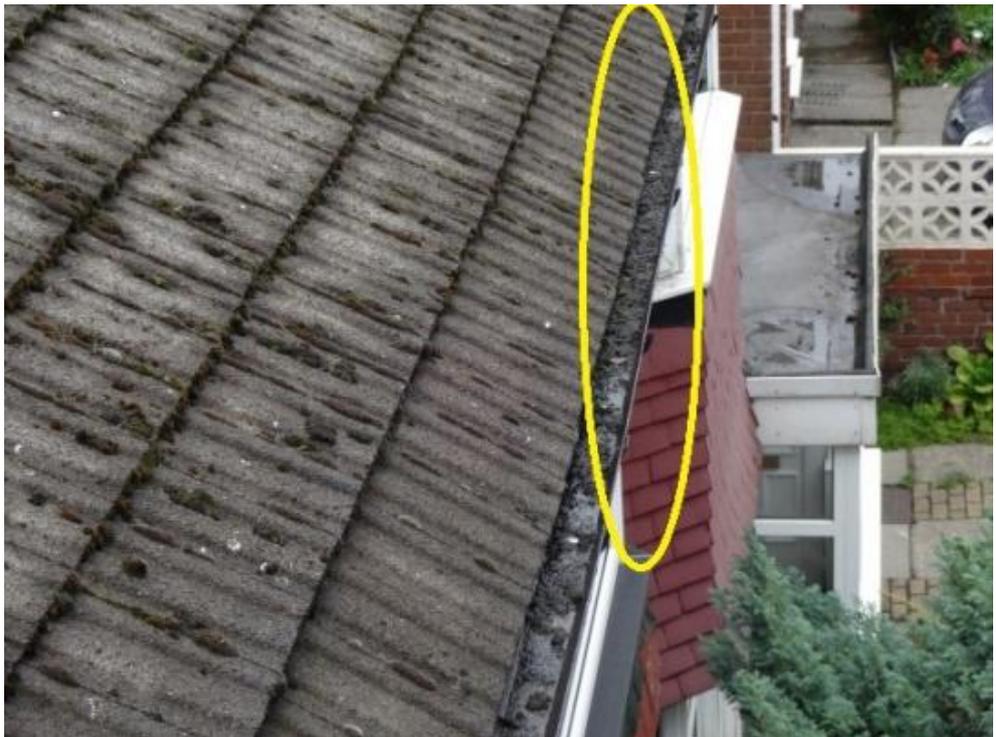
Guttering is partially blocked to front

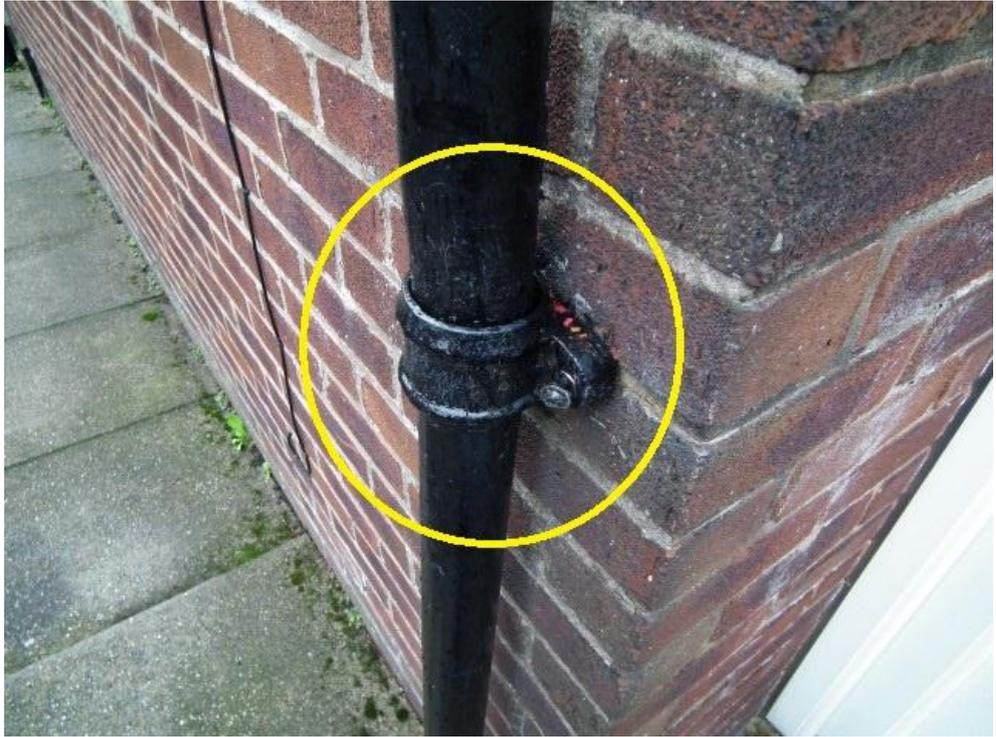
Downpipe is broken and loose

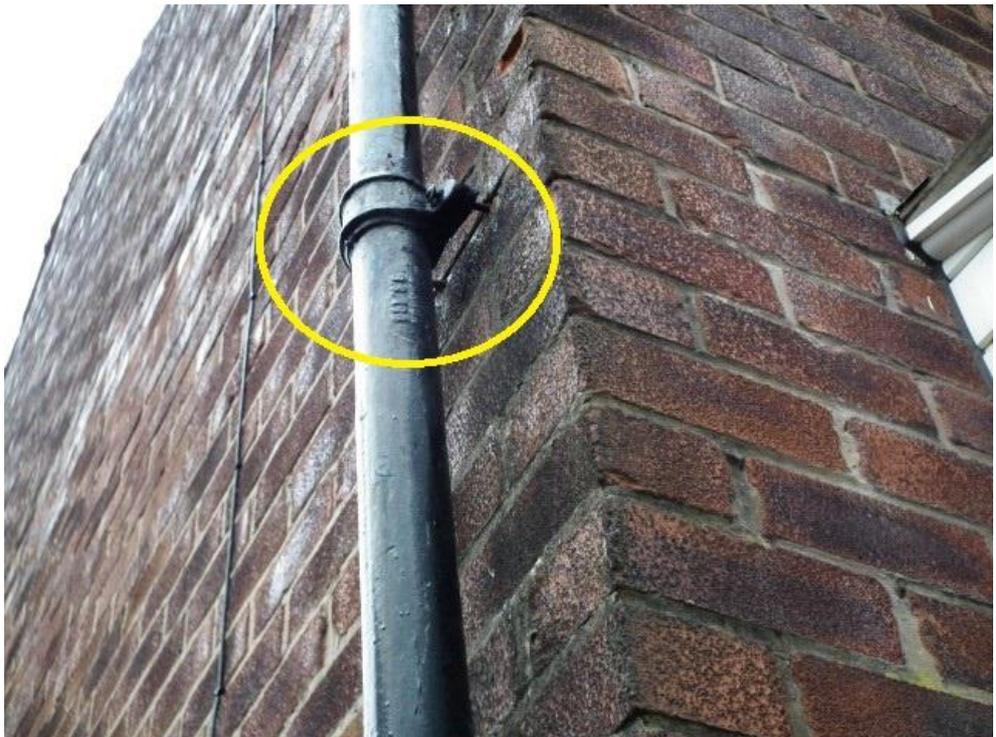
Downpipe is broken and loose at the centre also

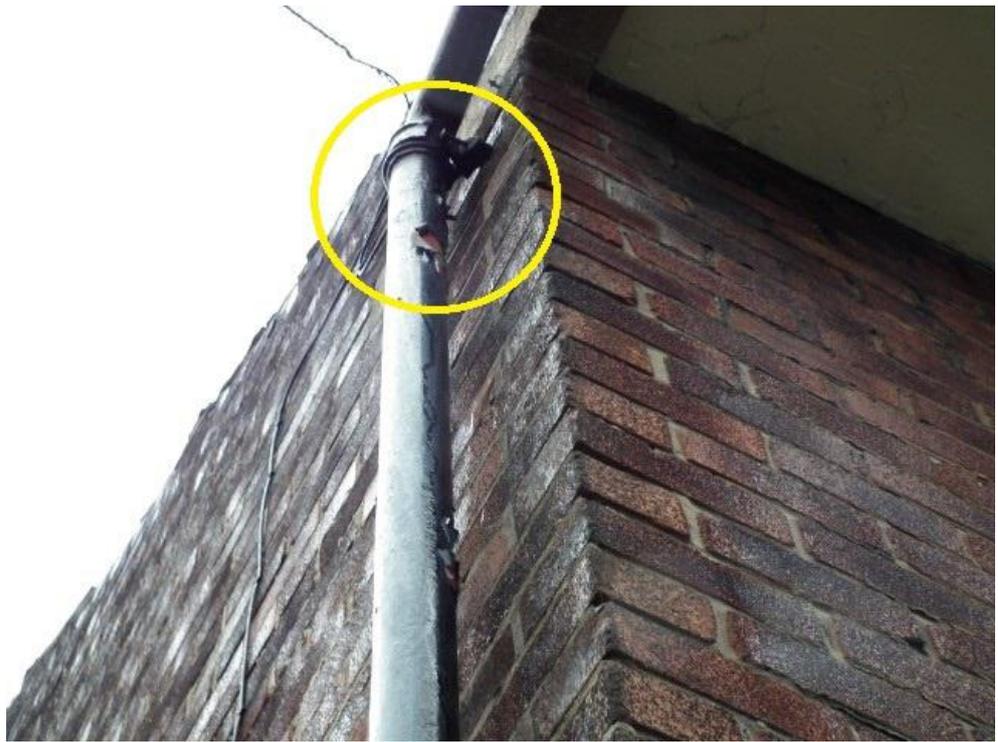
Downpipe is broken and loose at the top as well

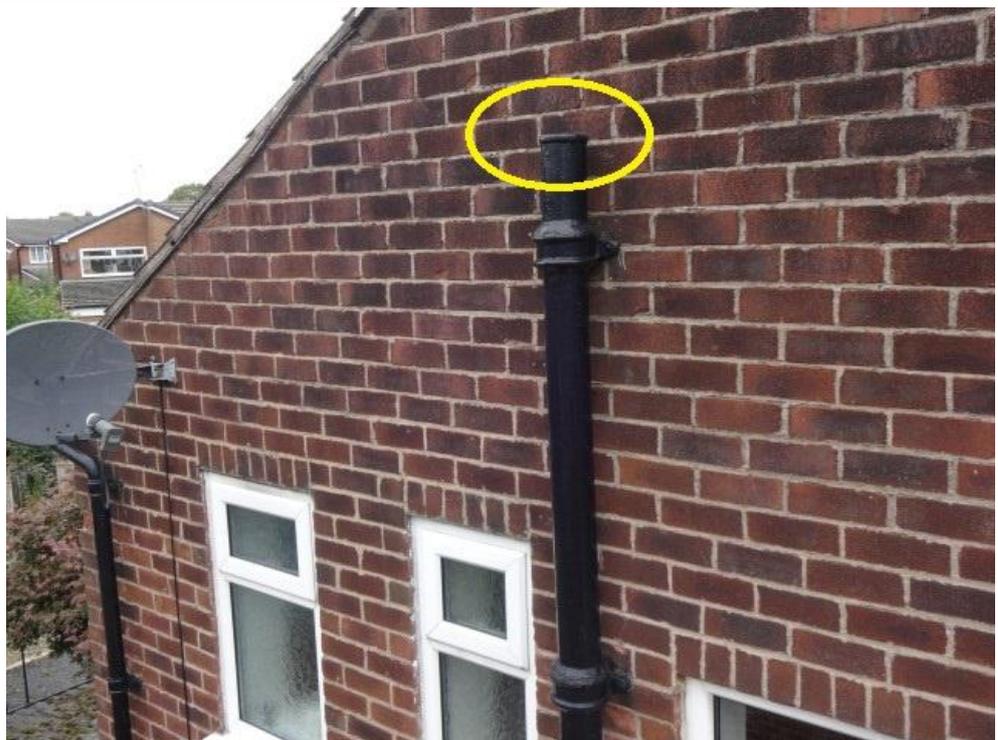
The soil stack and associated plumbing is in a fair condition with no leakages noted, but there is no vented cover to the top of the pipe.

Vented cover in missing

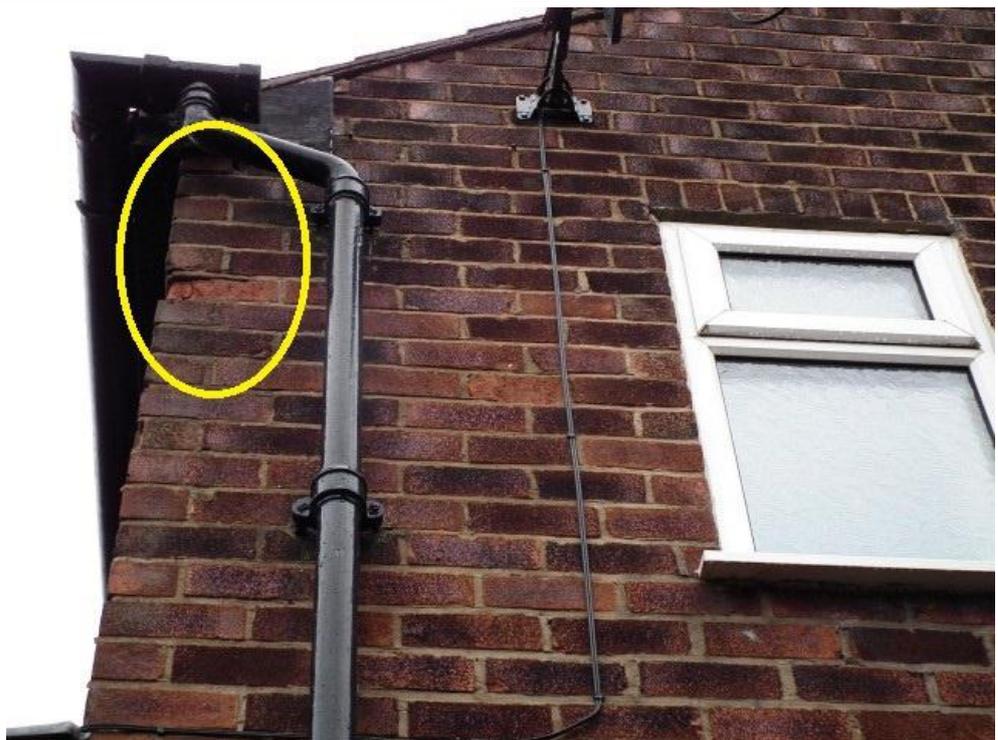
Damaged brickwork and minor crack

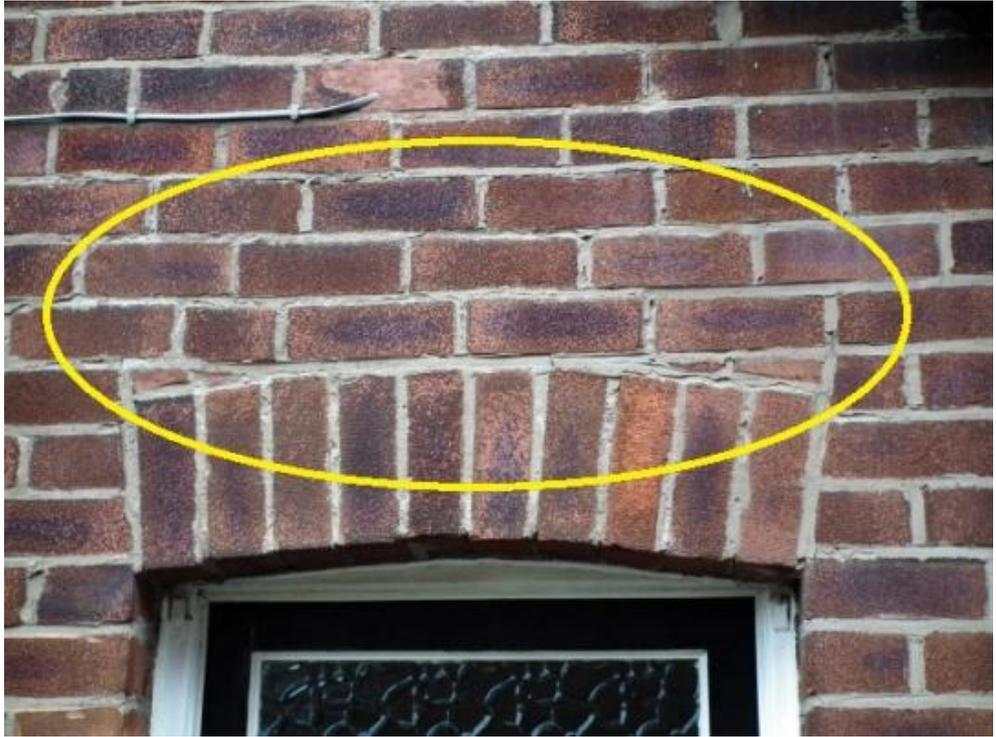
Minor cracks in pointing

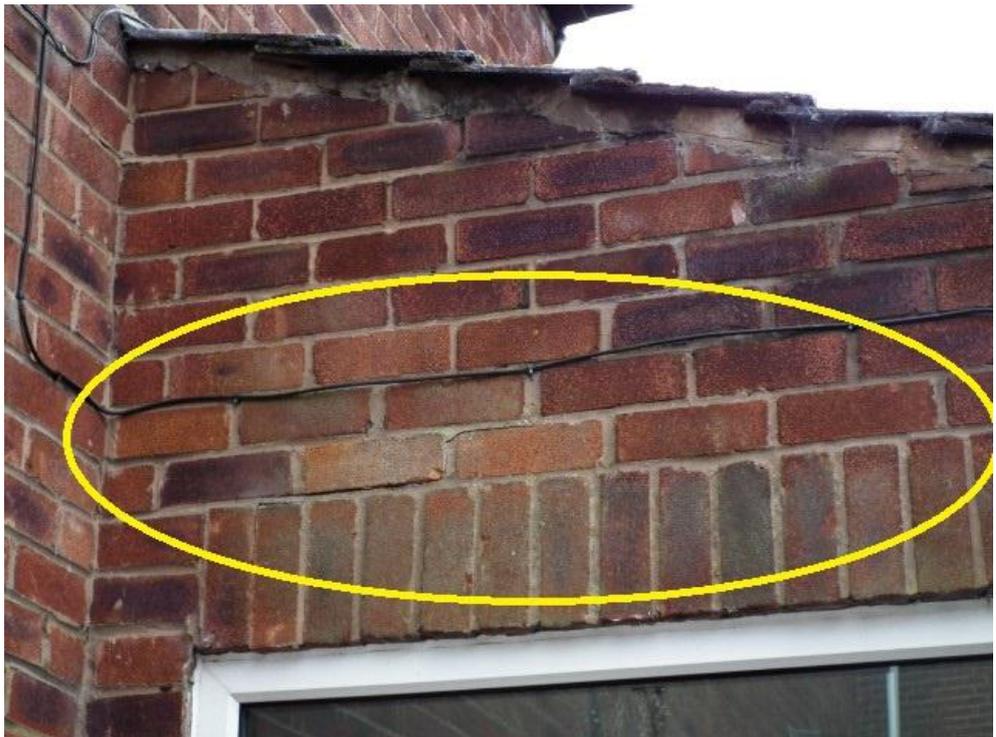
Minor cracks in pointing

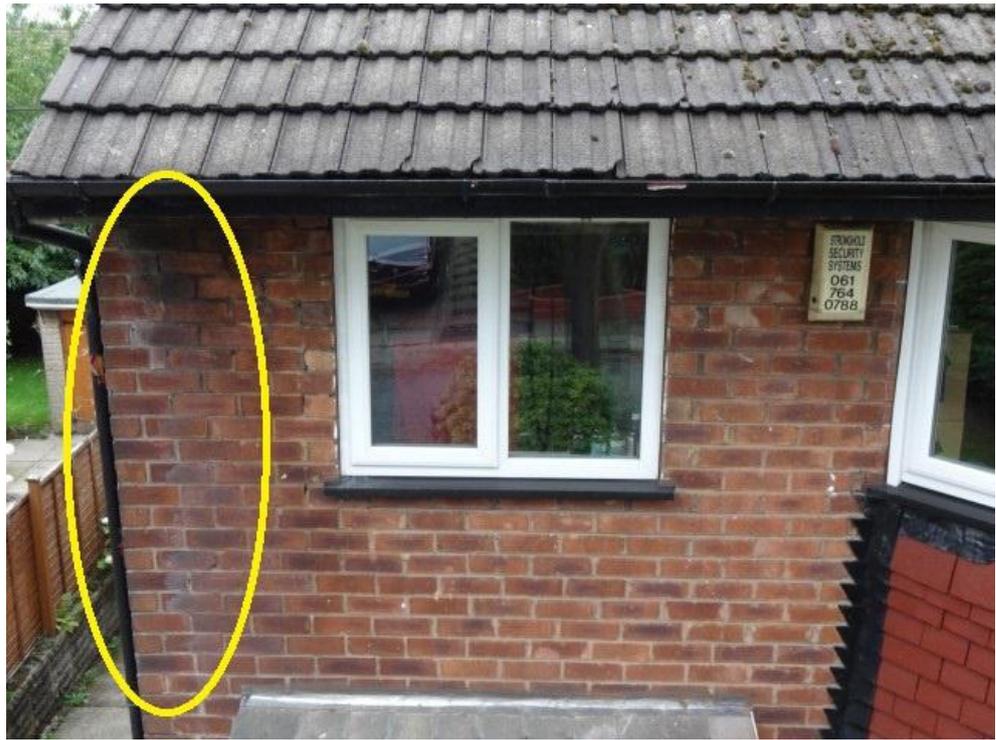
Water stain

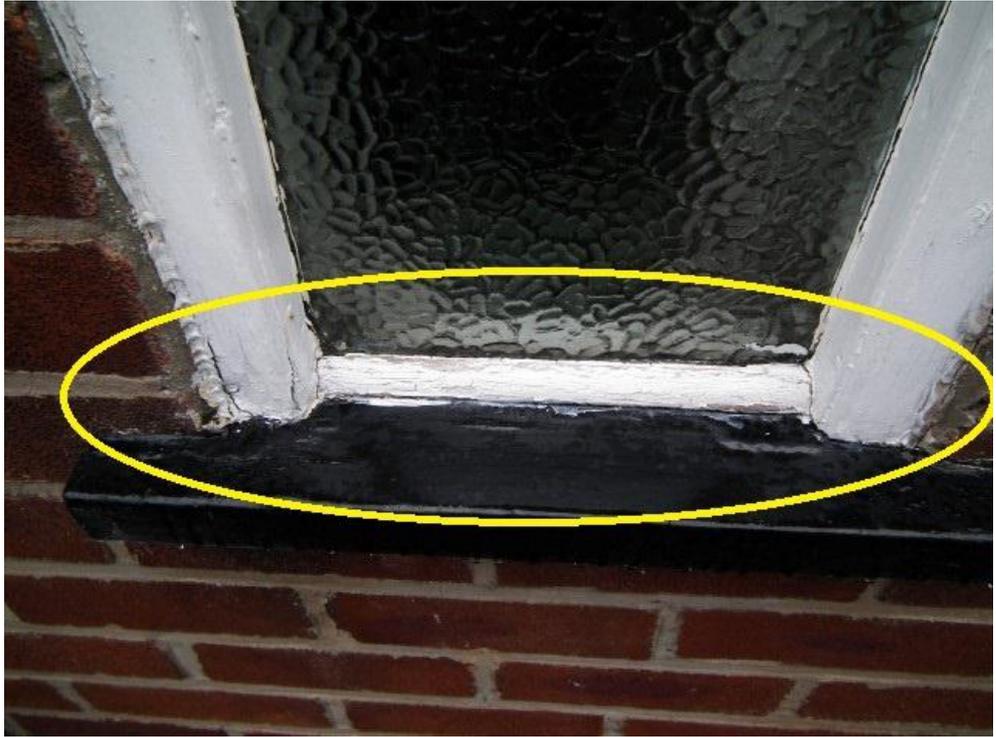
Timber windows showing signs of decay

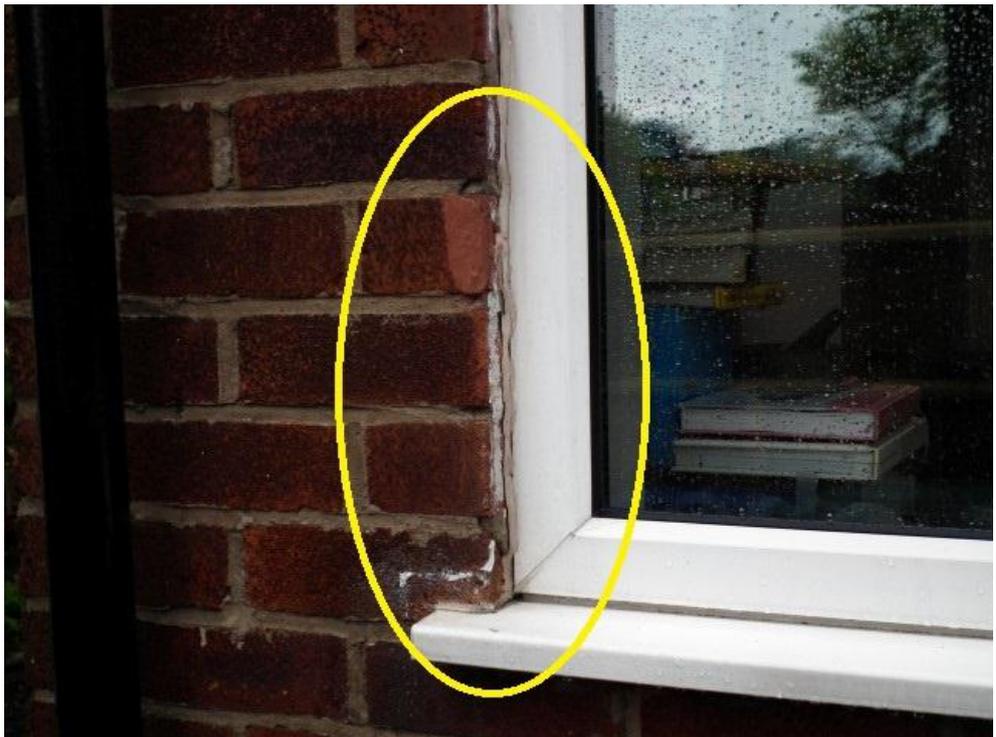
Cracked sealant around frames

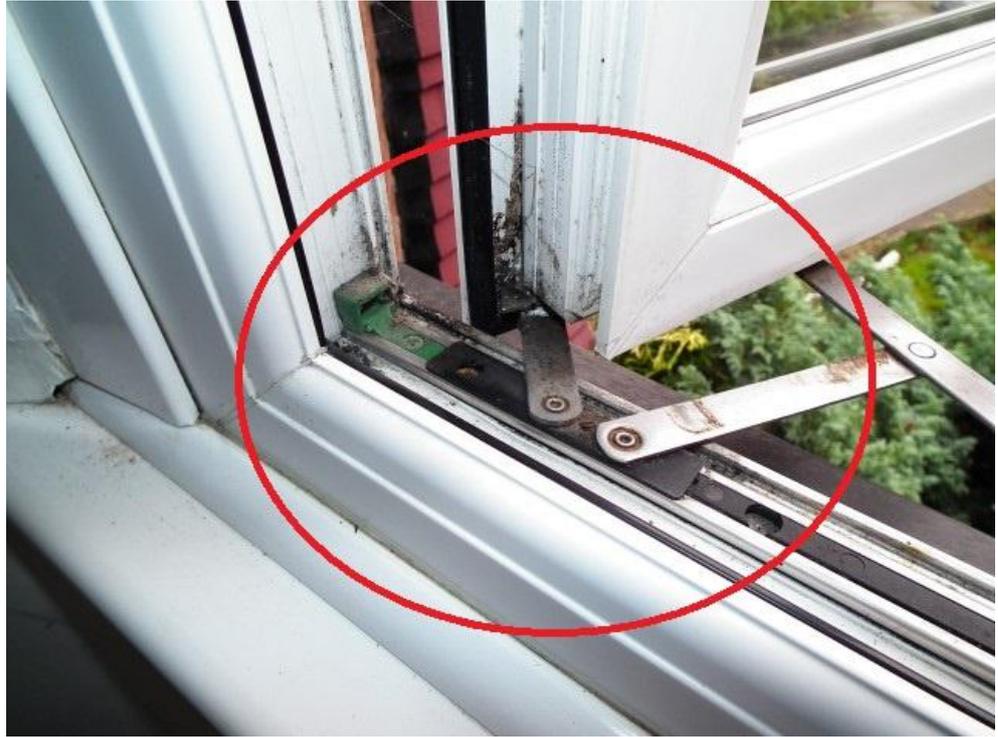
Hinge is broken on front bedroom window

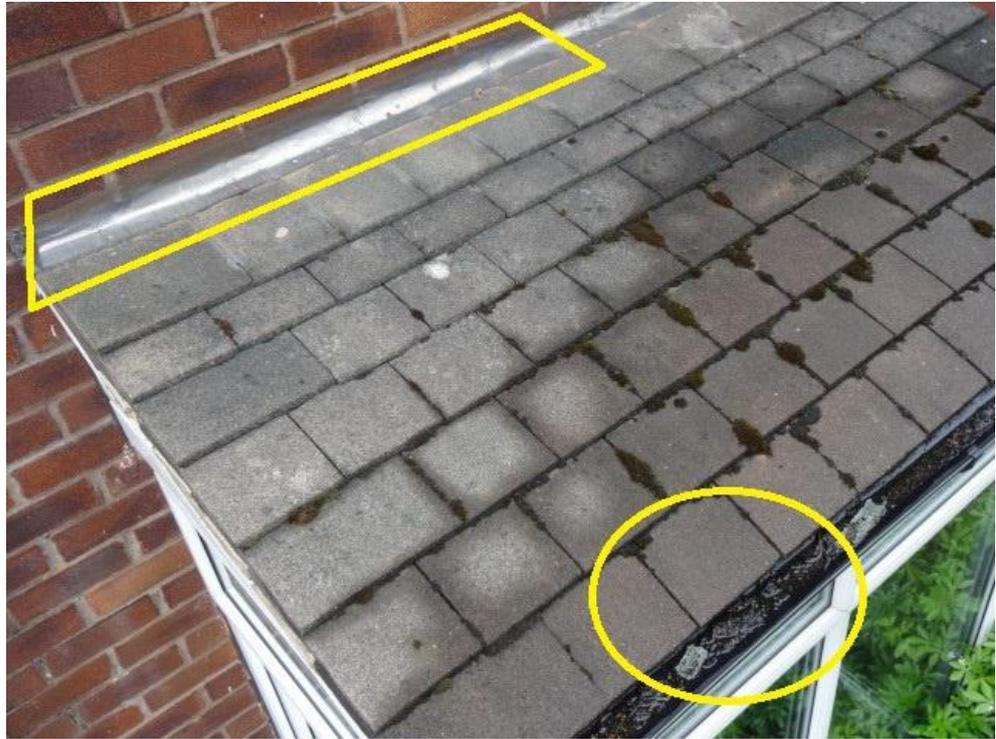
Guttering is partially blocked on porch

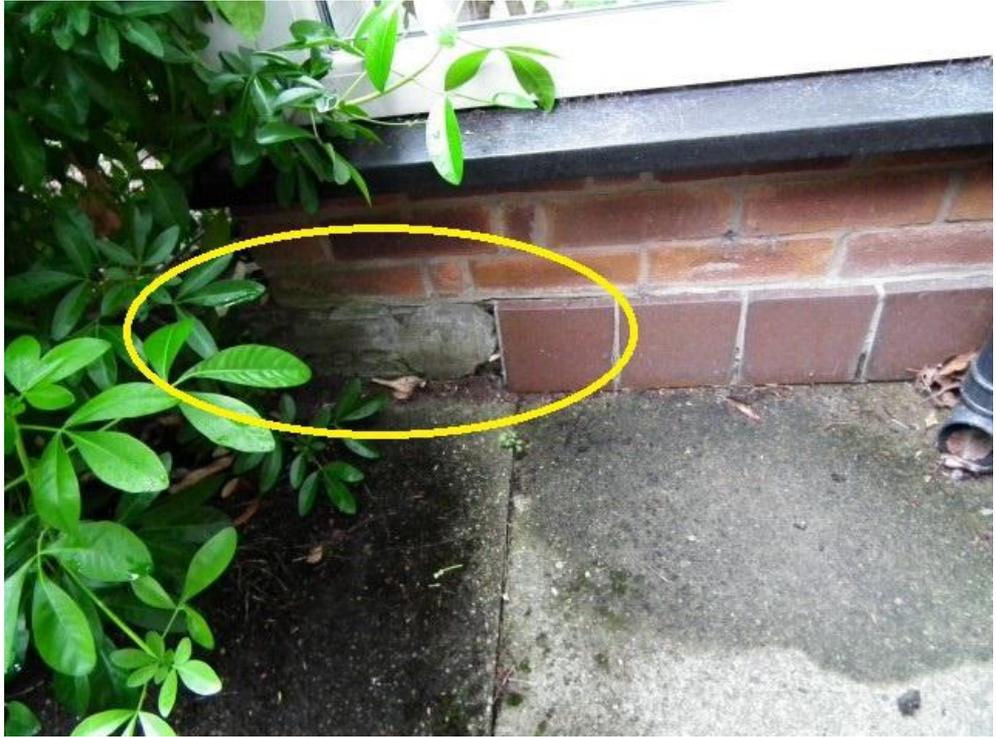
Missing tiles around porch

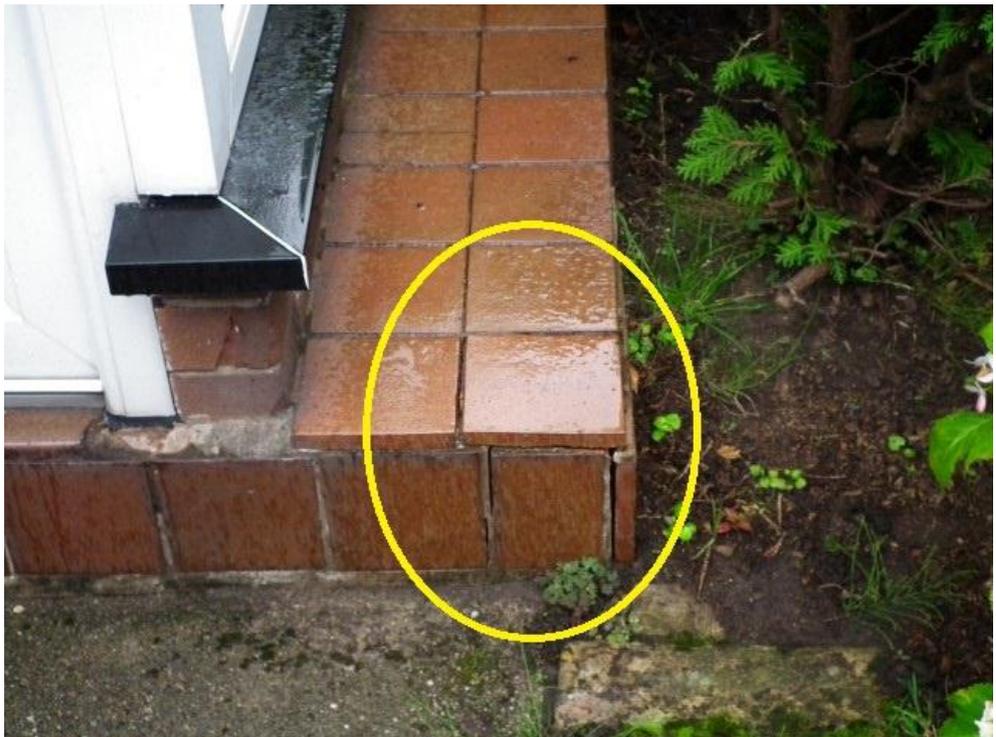
Cracked tiles around porch

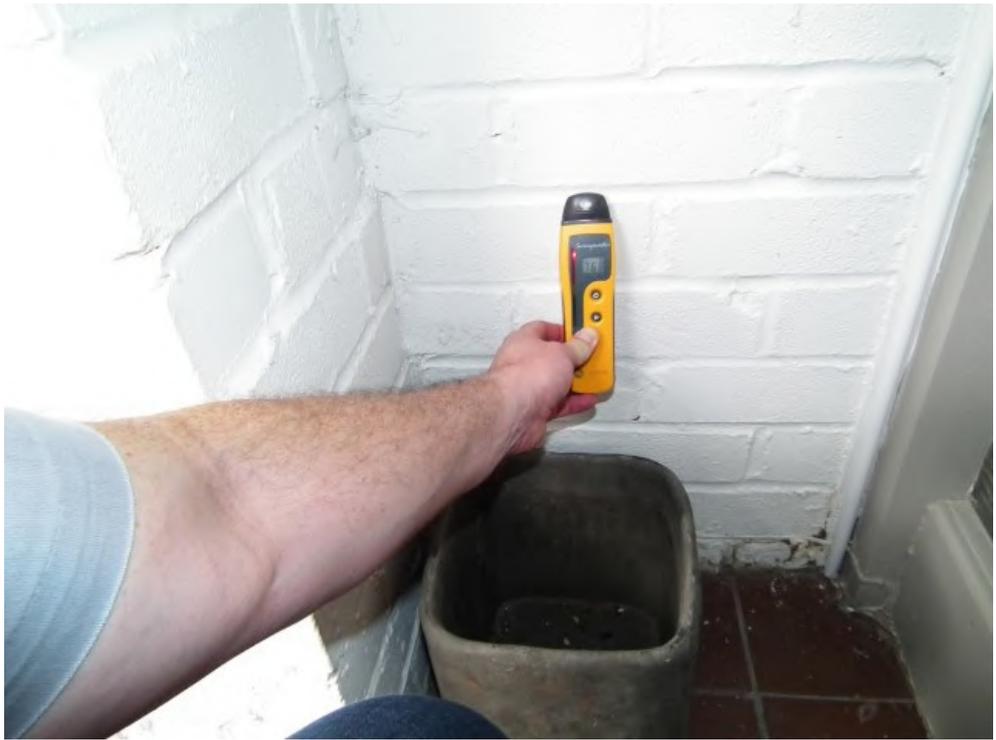
Some high damp readings on internal walls

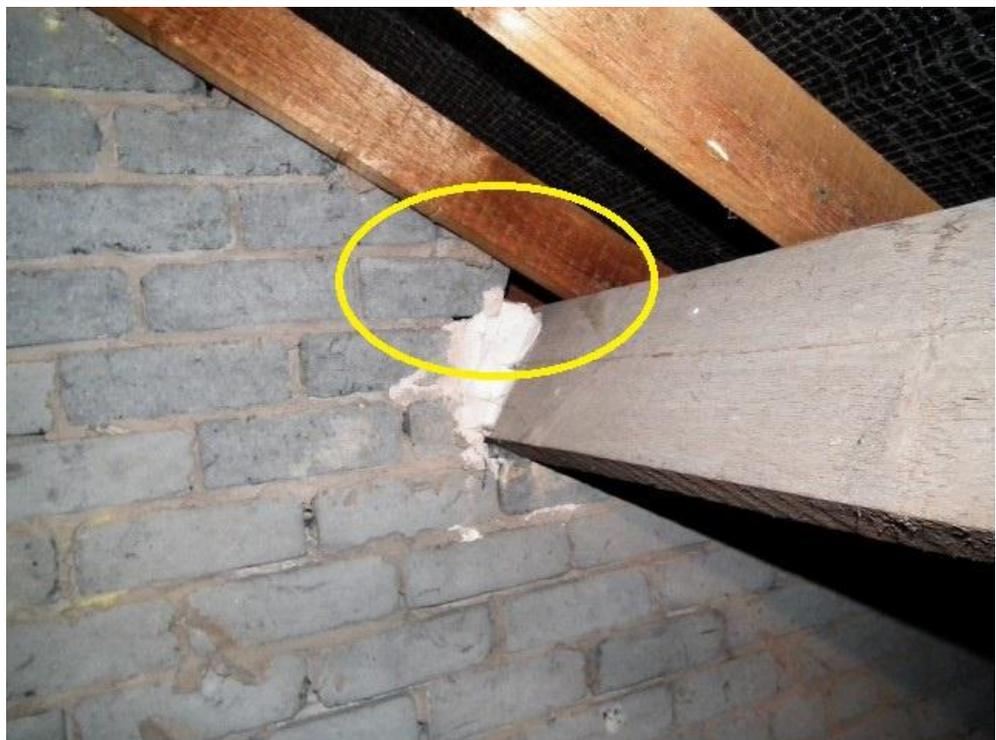
Gaps in Party Wall in loft

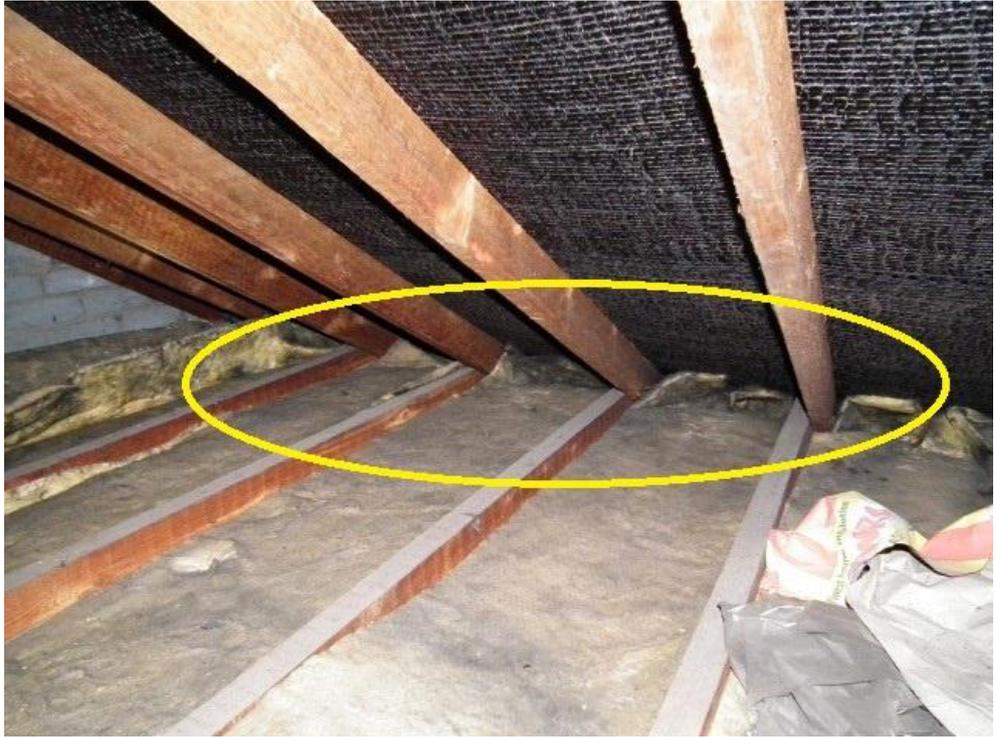
Insulation pushed into eaves

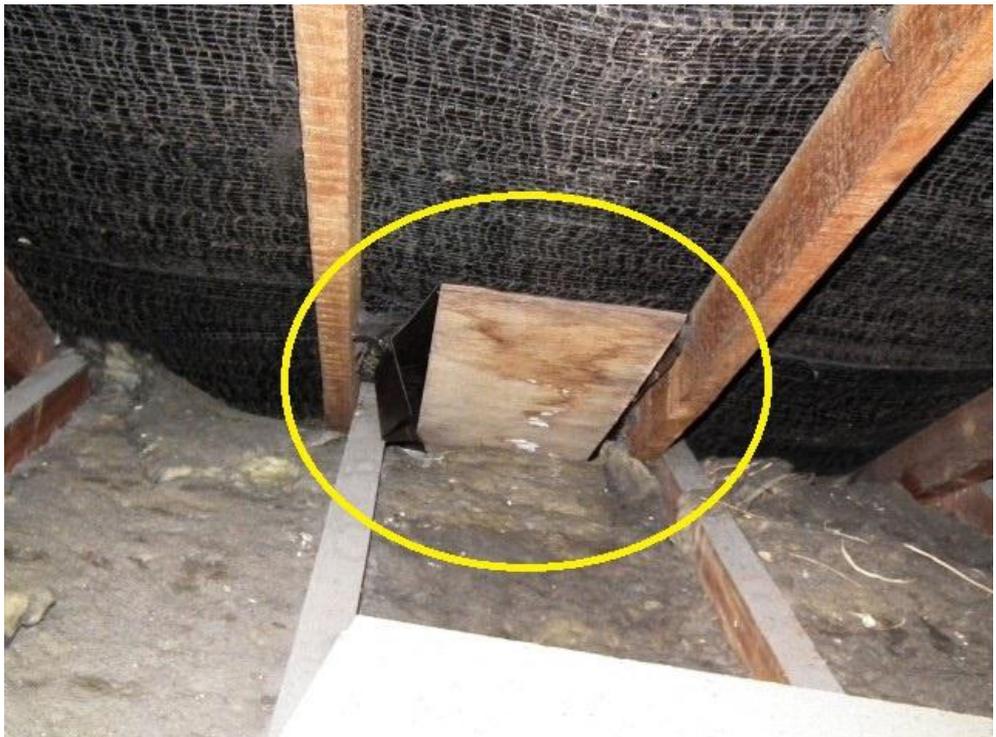
Roof under felt has been patched up

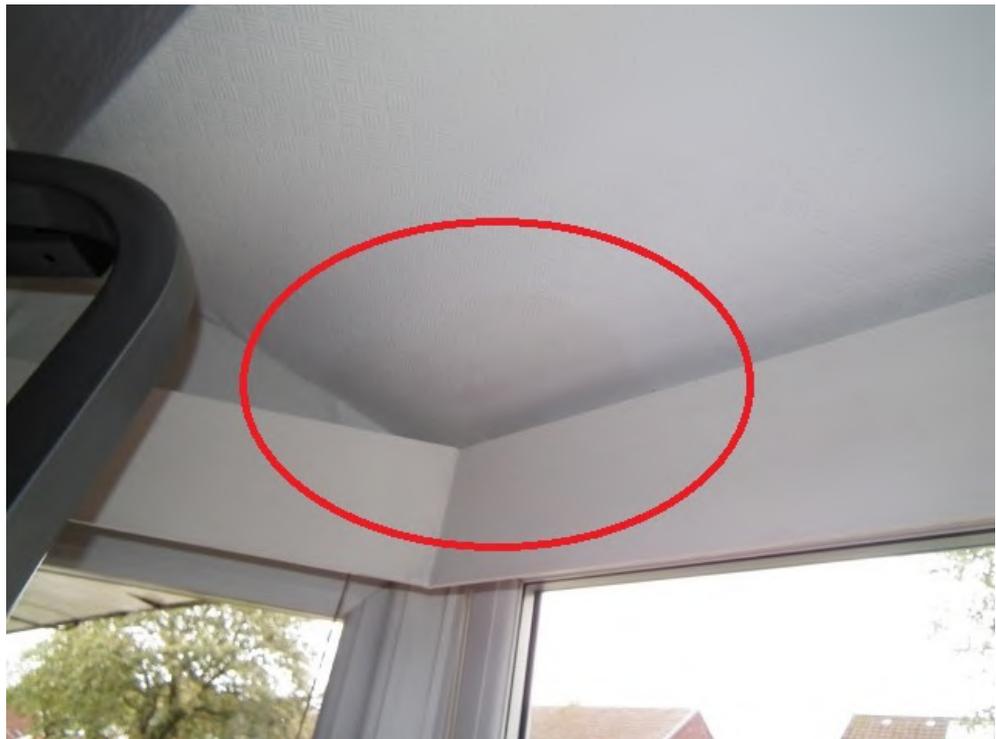
There are visible damp patches on ceiling of bay window

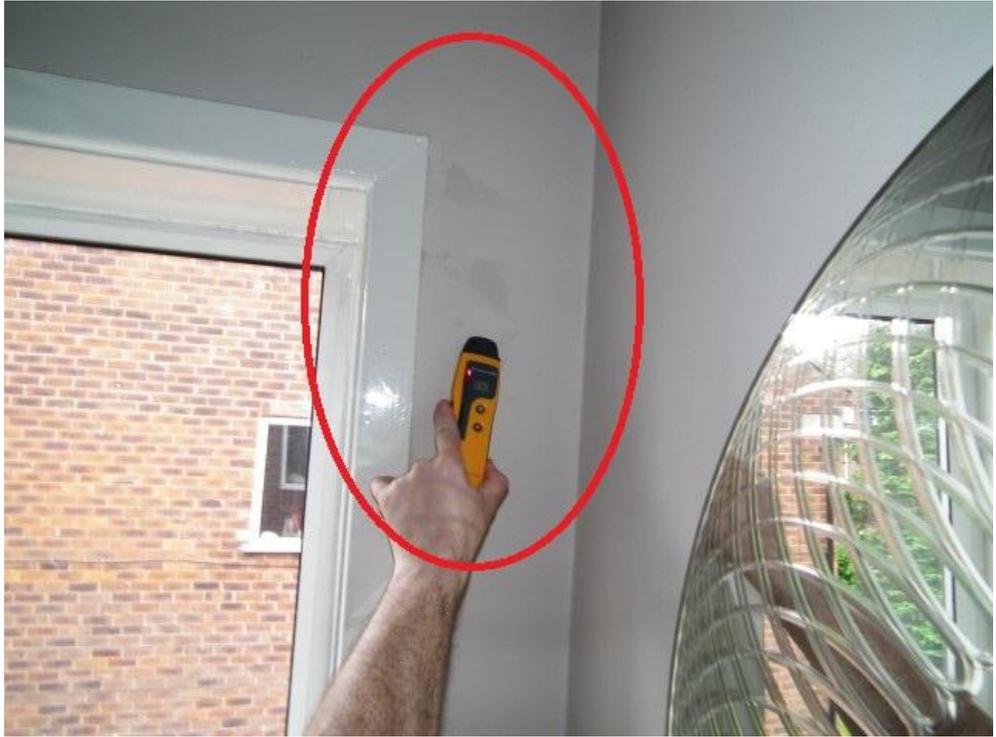
There are visible damp patches on some walls
