Mi HOME BUYER SURVEY

# HOME BUYER SURVEY REPORT

The format of this Mi HOME BUYER SURVEY REPORT is consistent with the guidance note requirements for a Survey Level 2 as defined by RICS Surveys of Residential Property 3rd edition May 2016

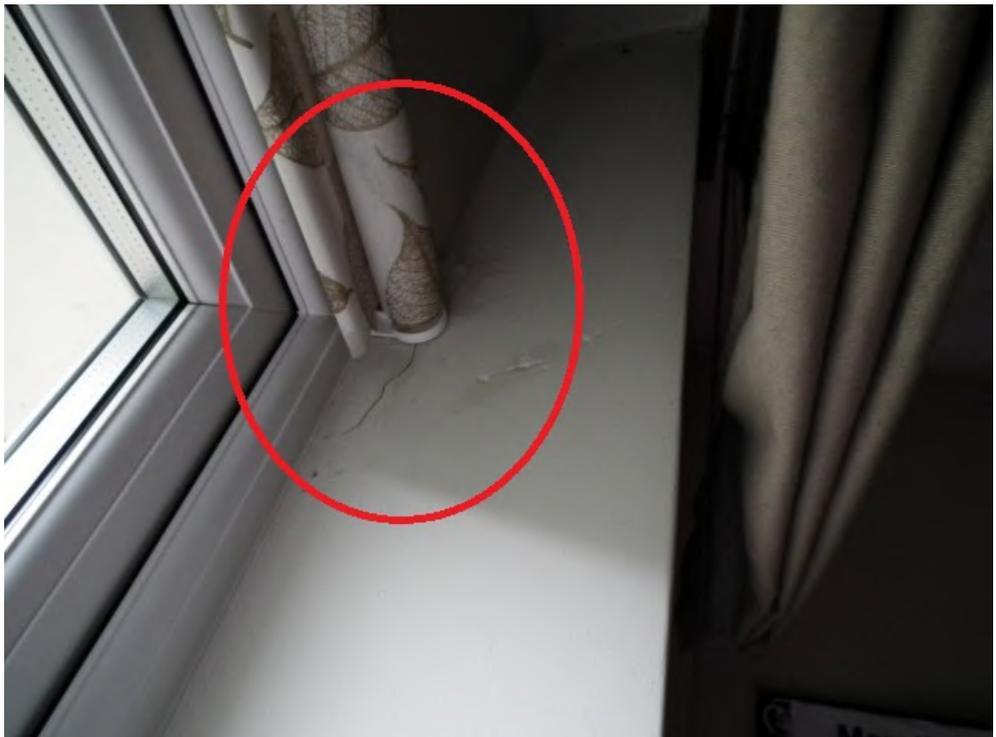
Minor cracks in plaster

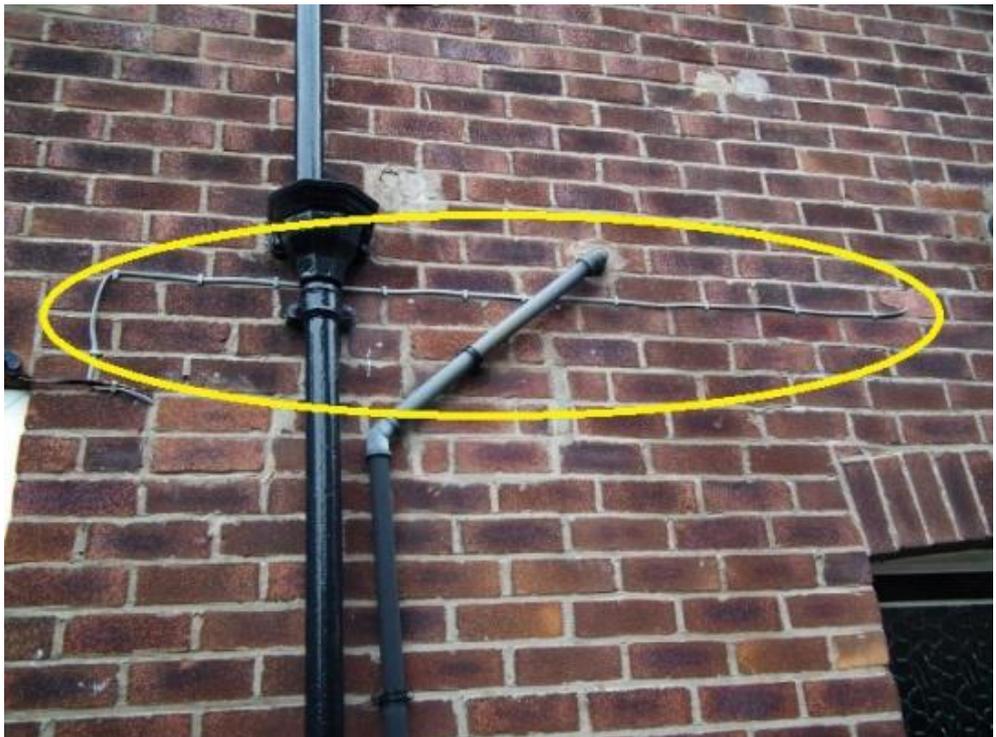
Unprotected cables

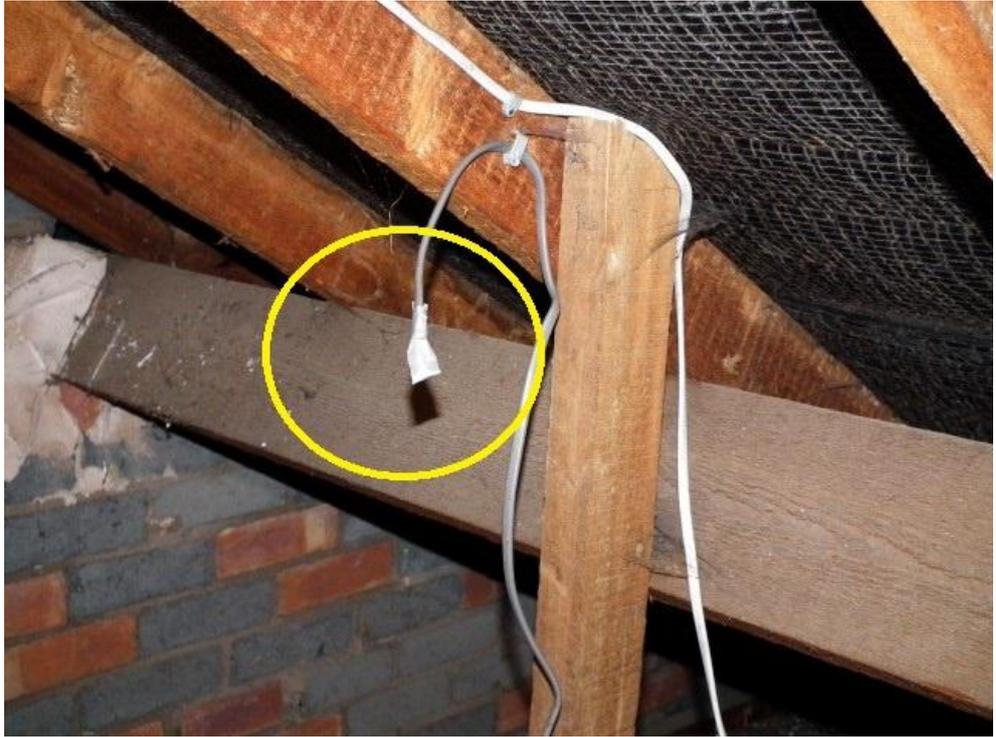
Possible live wiring in loft

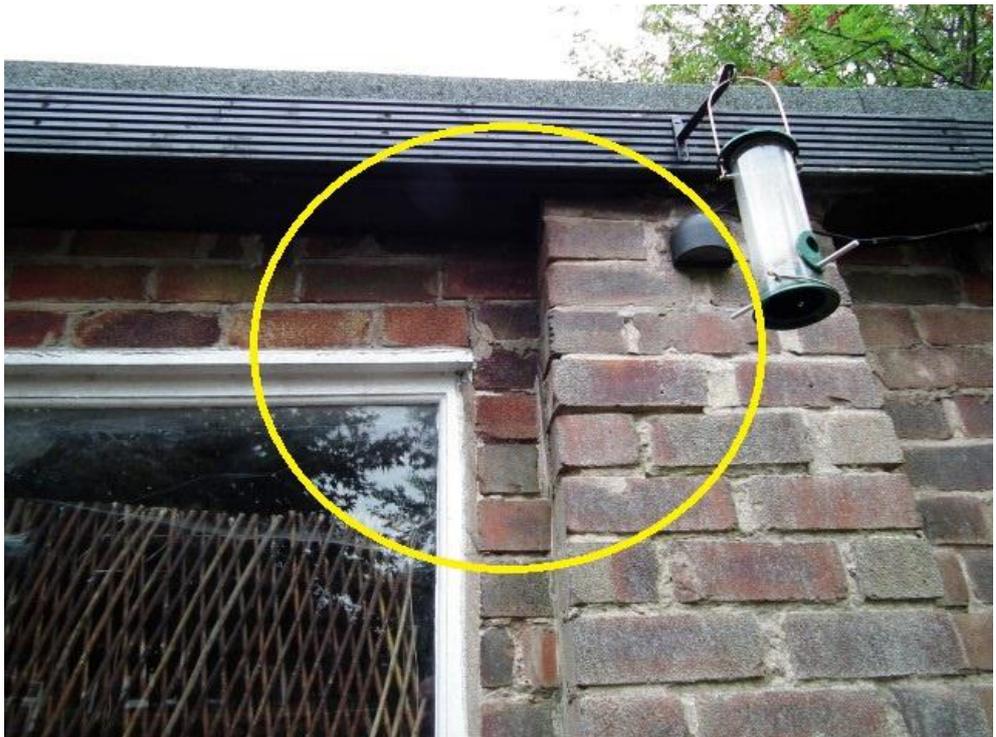
Minor cracks in pointing

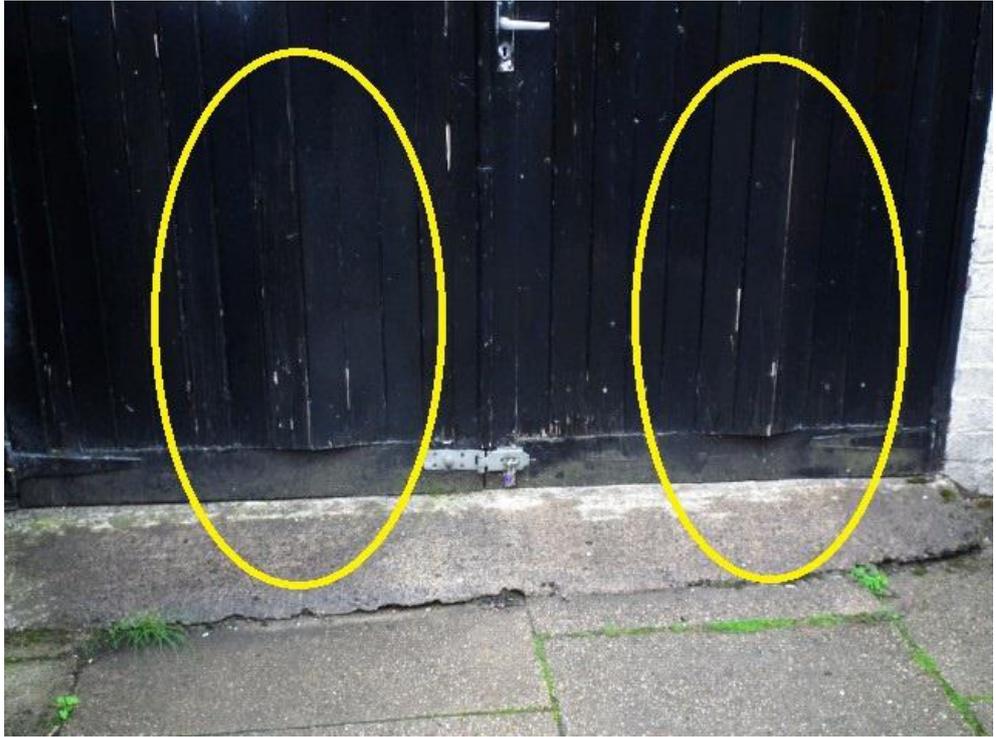
Garage doors are bowing outwards

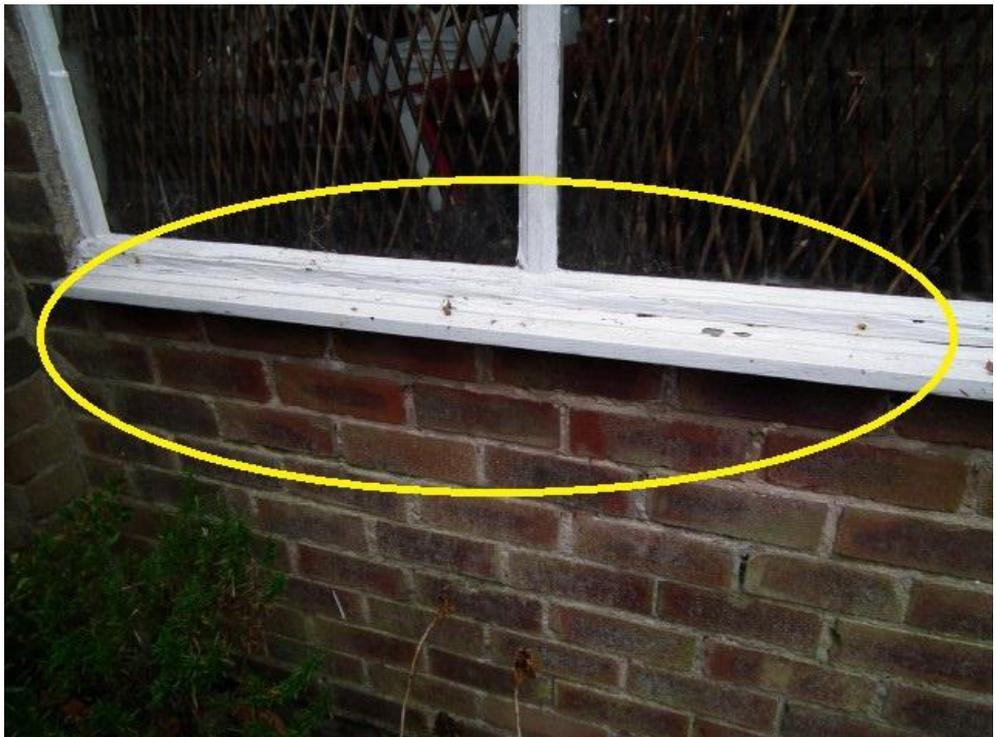
Timber windows showing signs of decay on garage

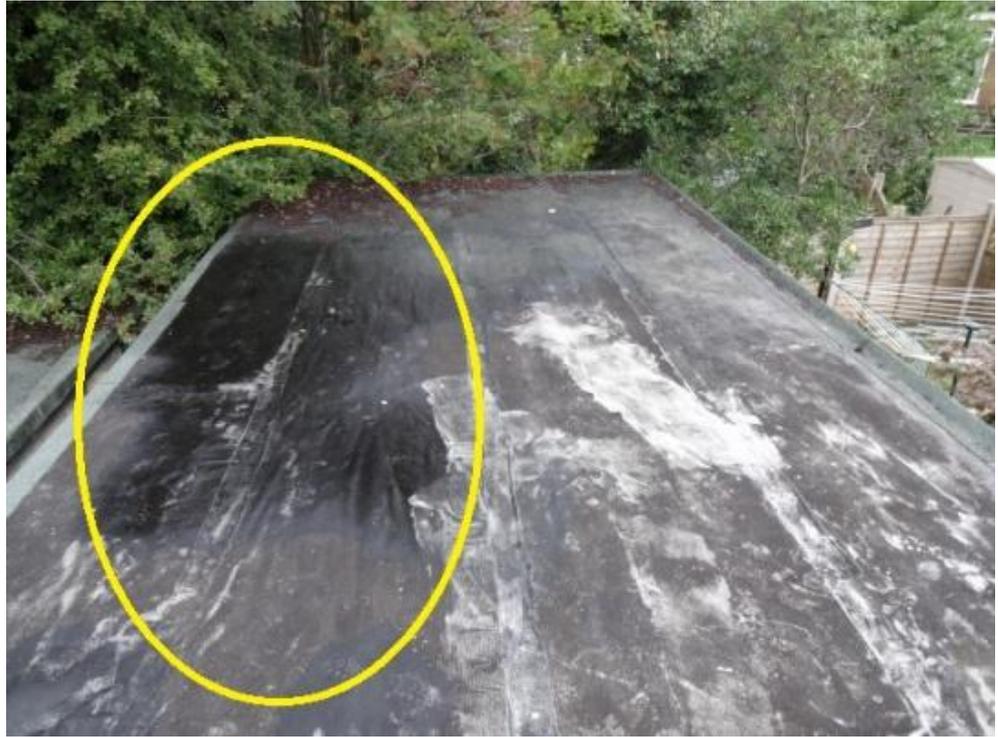
Garage roof is wrinkled and has pooling water

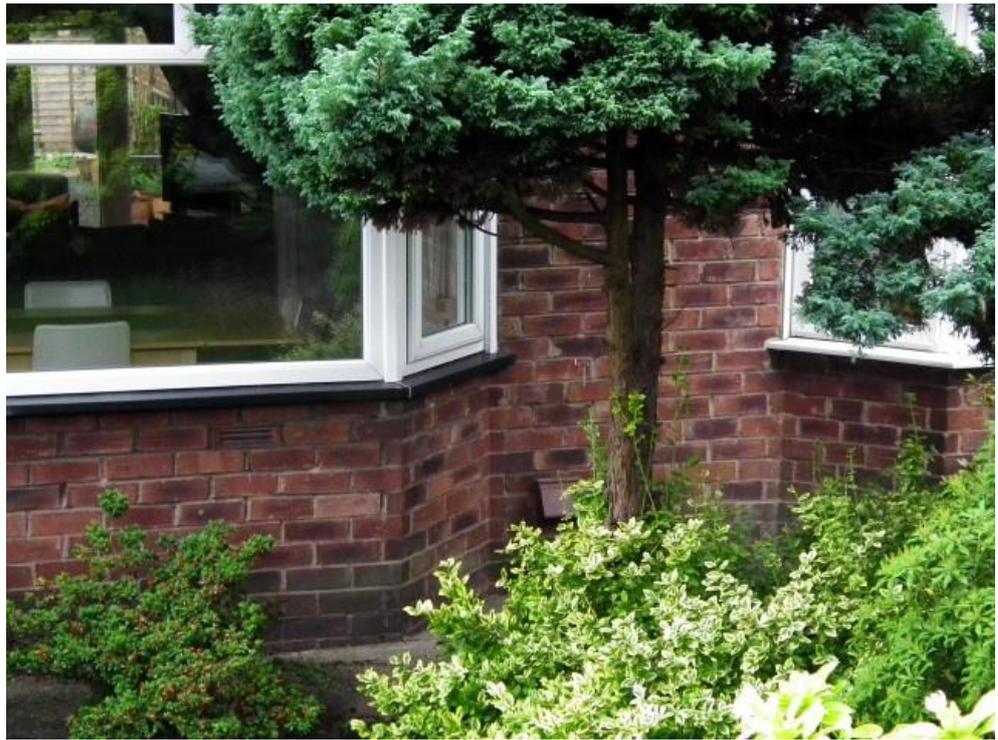
Trees close to property

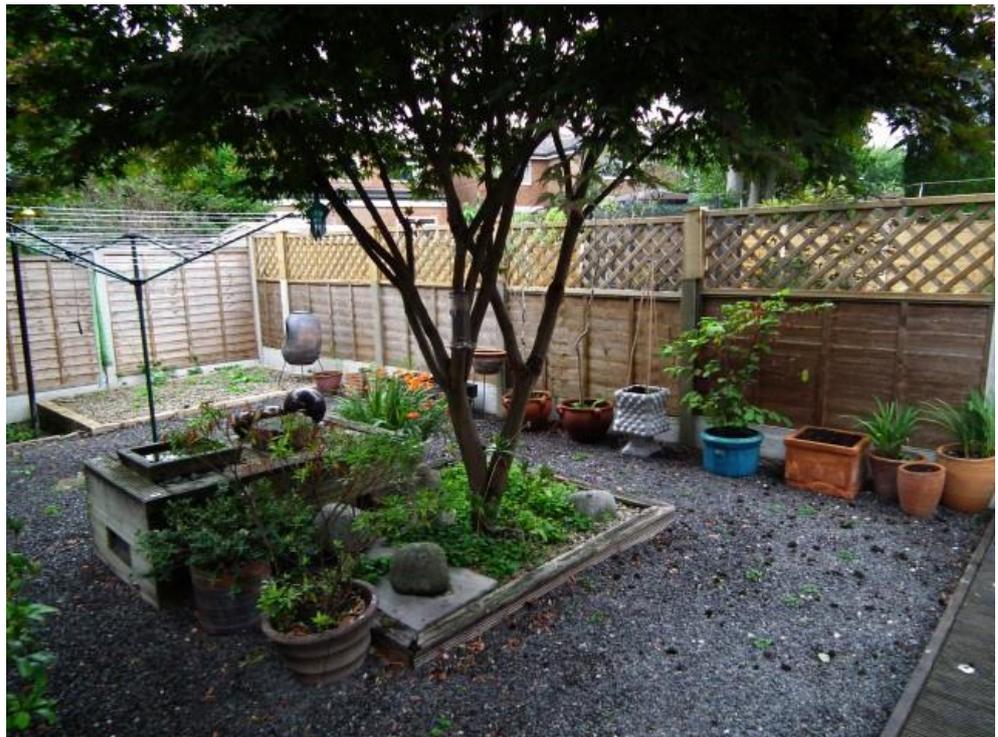
Trees close to property

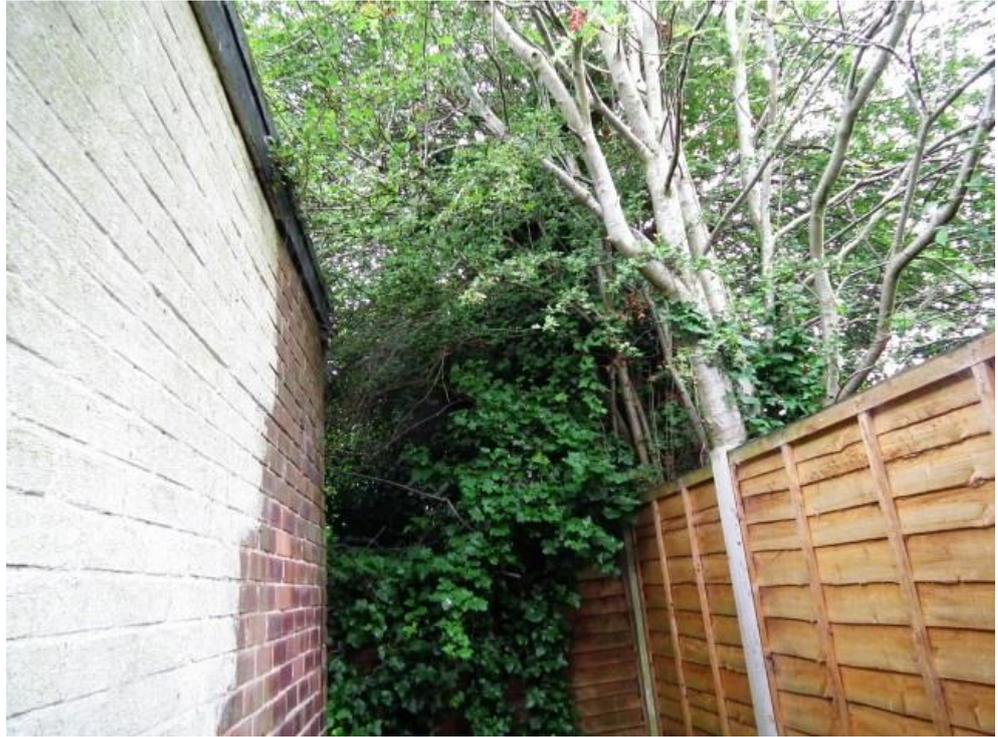
Trees close to garage

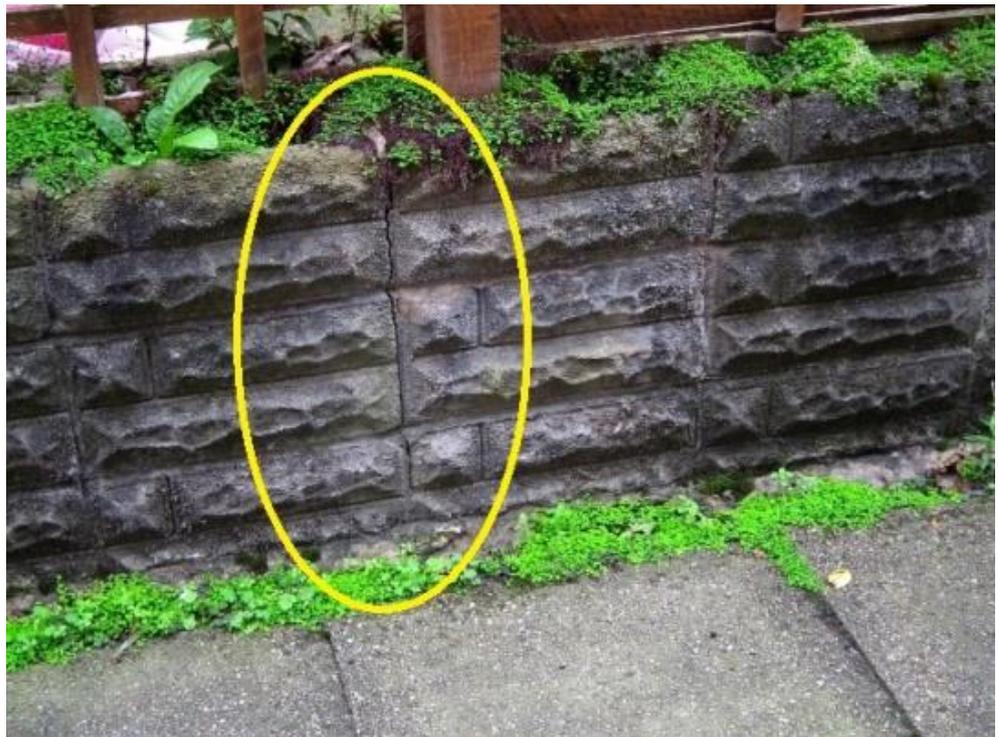
Cracks in garden wall

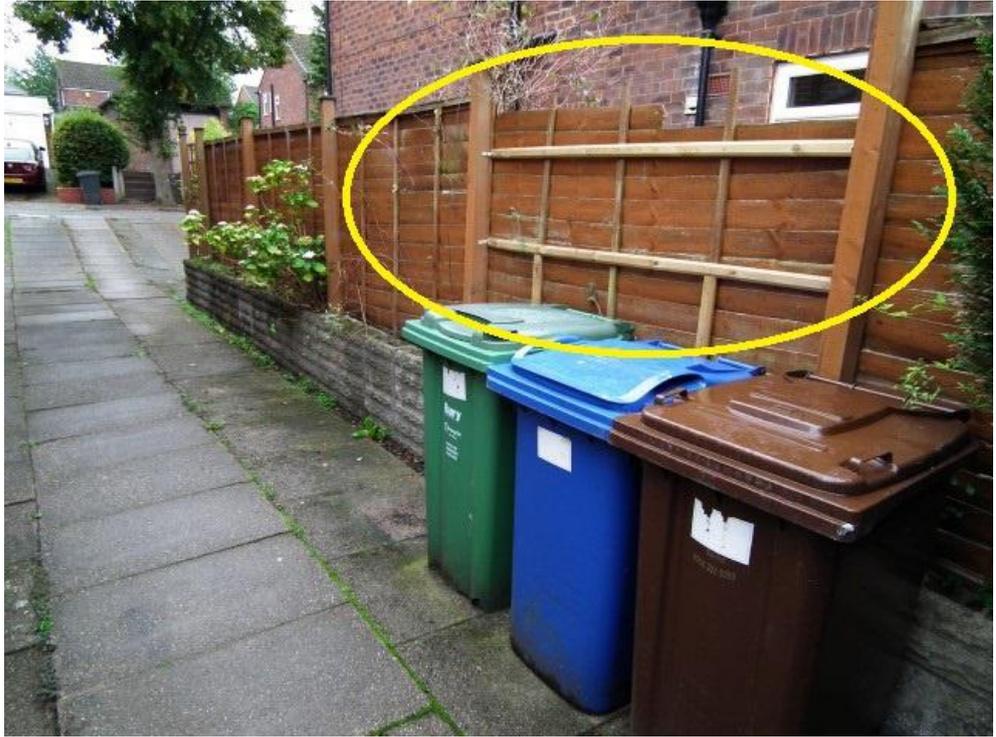
Fence in poor condition

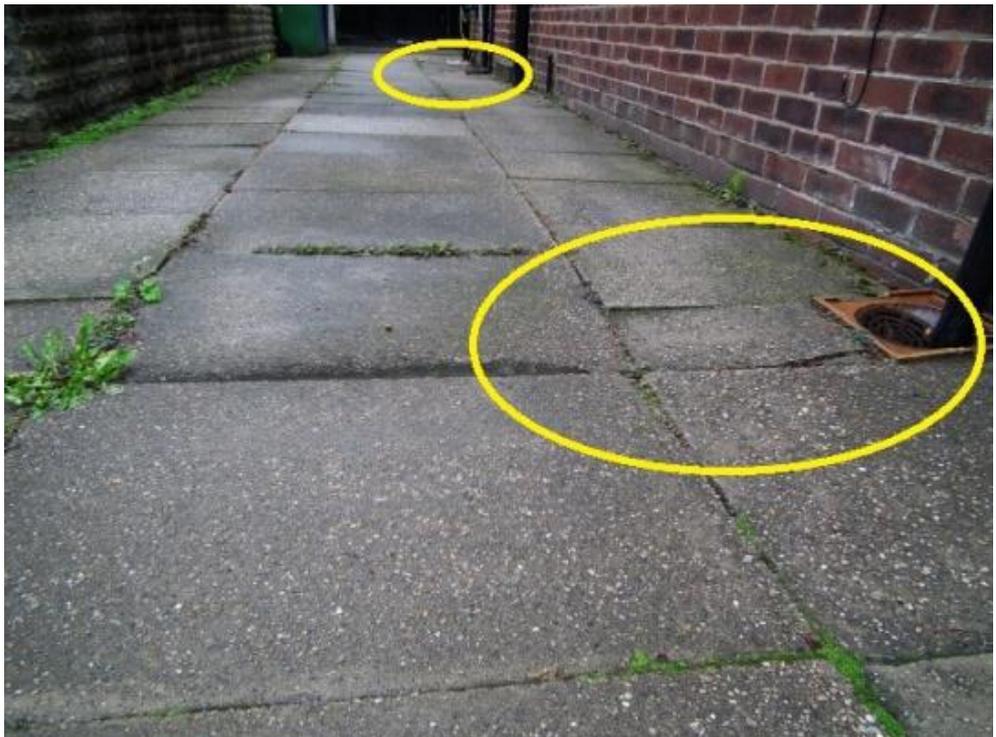
Driveway has sunken areas above the possible drain run
