# BUILDING SURVEY REPORT

CLIENT  
PROPERTY

The format of this MiBuilding Survey Report is consistent with the guidance note requirements for a Survey Level 3 as defined by RICS Surveys of Residential Property 3rd edition May 2016

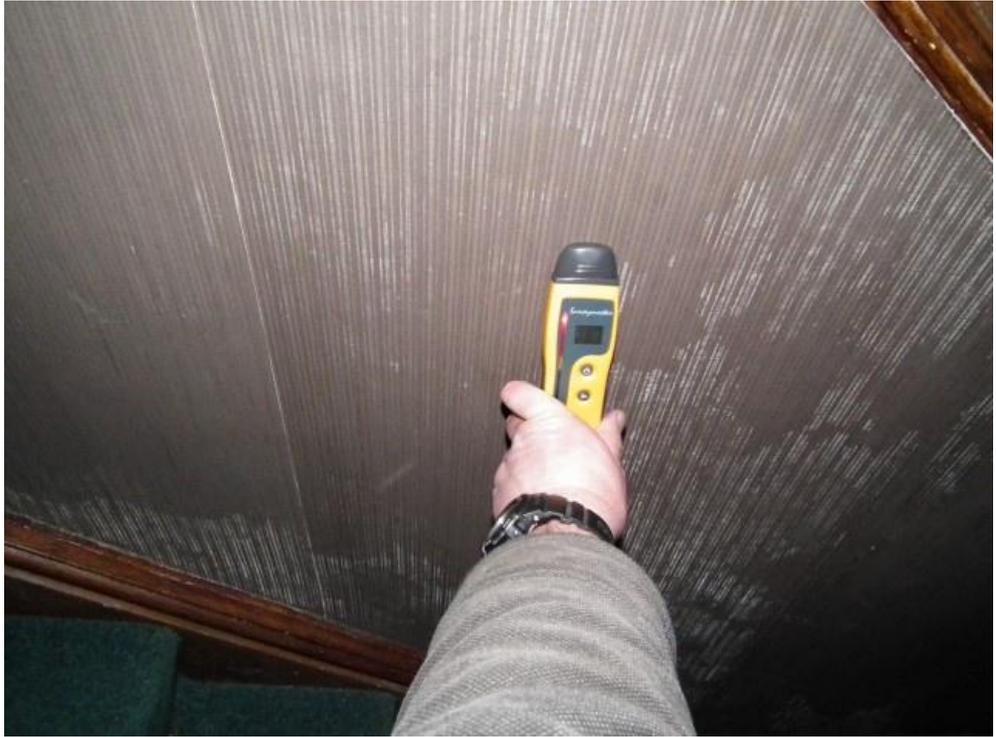
There are high damp readings on the chimney breasts in the loft (refer to 4.1 and 4.2) and also in most of the other chimney breast within the property (refer to 5.5). There are very high damp readings in several of the roof timbers (refer to section 4.2 and 5.1). There are high damp readings at some of the window reveals. There are high damp readings and damaged decor along the entire length of the side elevation (on both floors) and most of the rear elevation. There are high damp readings and visible wet patches on the front wall of the front ground floor room and around the bay window. Refer to sections 4.1, 4.2, 4.3 and 4.4 for associated defects.

High damp readings along the majority of the side elevation

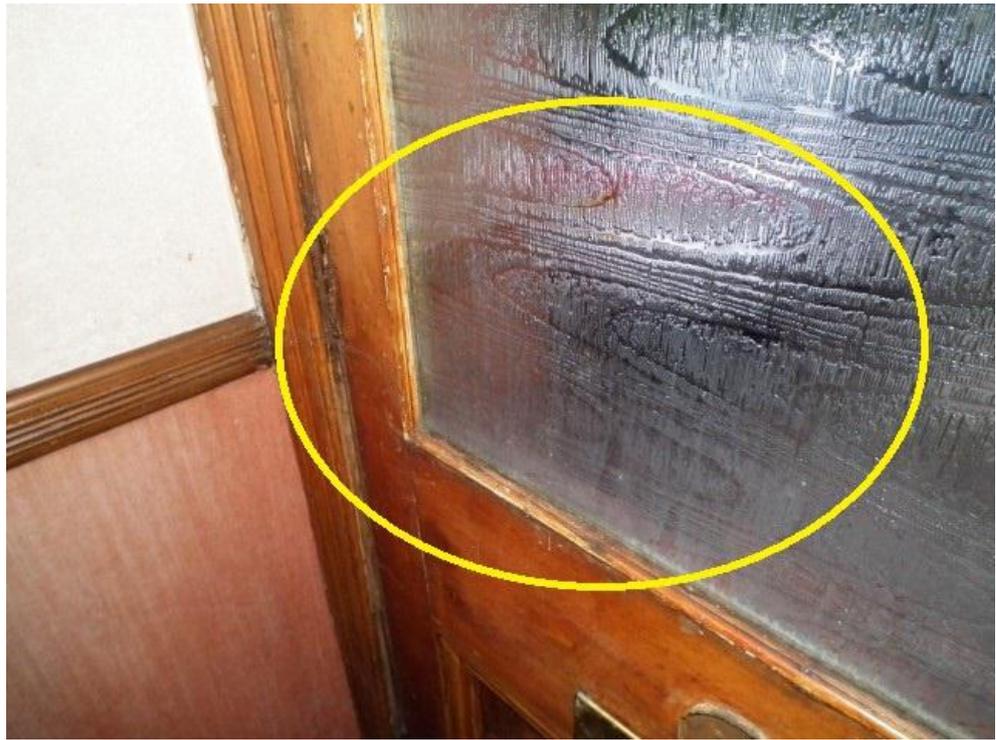
The glass in the front door may not be Safety Glass.

May not be safety glass

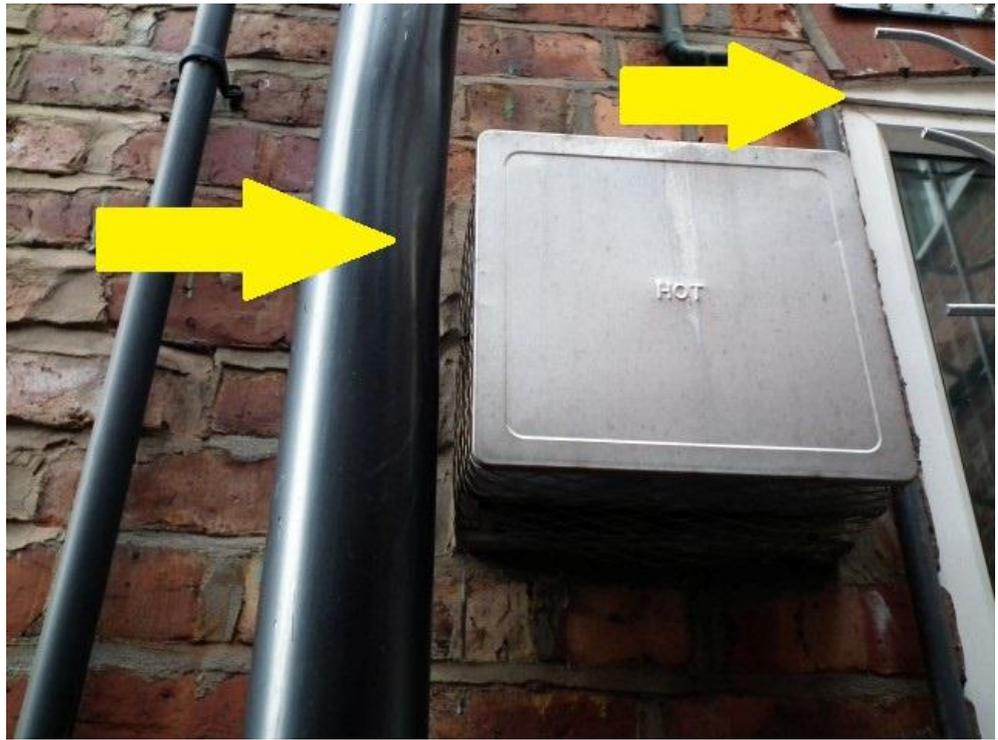
<p><b>Misc</b></p>	<p>The position of both boilers means that the flues do not comply with current building regulations and could be a Carbon Monoxide risk . The one near the side door is too close to the door opening and therefore the fumes could enter the property through the doorway. The one in the downstairs bathroom is right next to the bathroom window and the same risk is therefore present. This flue is also next to the plastic soil pipe, which is being deformed by the heat.</p>

Boiler flue is too close to the window and is also melting the soil pipe

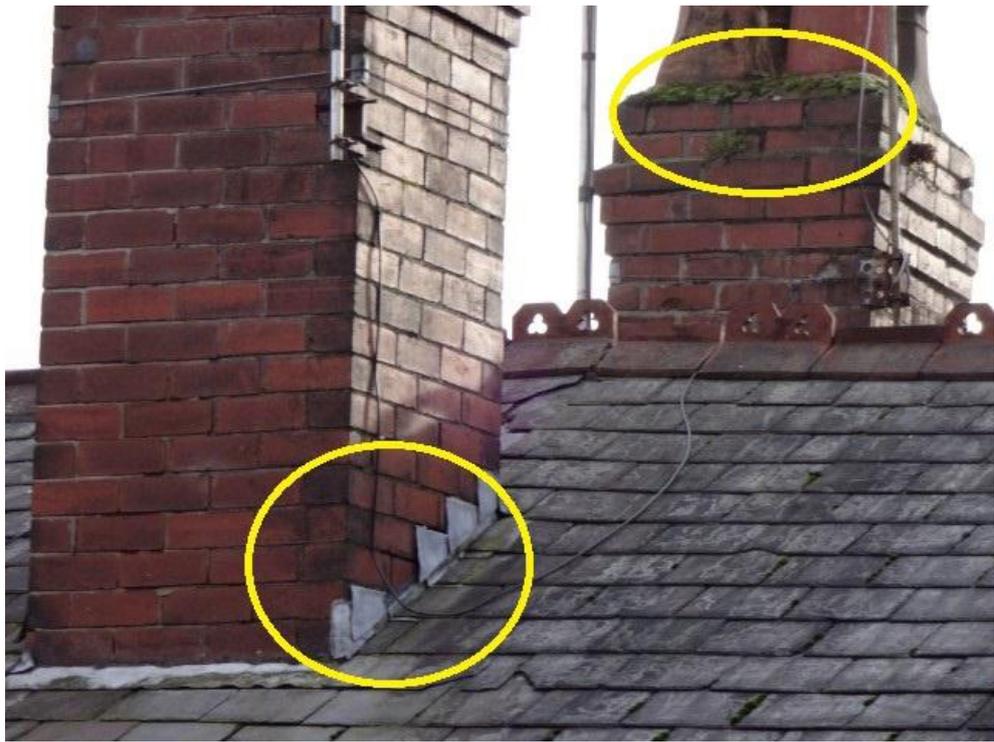
<b>Construction &amp; Type</b>	The chimney stacks are brick built. The flashing at the base of the stacks at the junction with the roof slopes is of lead. The pots are secured with cement mortar
<b>Nature of inspection and Limitations</b>	<p>The chimneys were examined from ground level with the aid of a high zoom camera and also a pole camera, for possible defects including undue movement, distortion, chemical or weather related damage, brickwork, render and pointing damage and other evidence of failure.</p> <p>Due to limited viewing angles it is not possible to see all faces of the chimney stacks from ground level, and it is assumed that the condition of those faces not visible is similar to that of the visible faces.</p>
<b>Condition</b>	<p>The pots are uncapped and open to the elements. If any pots are left uncapped then rain can penetrate the flues and damp can appear inside the property on the breasts. Providing fireplaces are regularly used then any penetrating moisture will dry out, however if fireplaces are used infrequently then it would be prudent to provide rain cowls to allow flue gases to escape but prevent moisture ingress to the flue.</p> <p>The lead flashing is damaged in places which will be allowing the ingress of water (refer to Dampness section and 5.1). There is also some plant growth and moss build up at the top of the stacks.</p> <p>The pointing to the chimney stacks is crumbling and missing in places which will be allowing the ingress of water.</p>

Missing lead flashings and plant growth within chimney

<b>Action Required</b>	<p>Plant roots can cause damage to the mortar in chimney stacks which will lead to loose brickwork or pots. The plants should be removed and any damaged mortar renewed.</p> <p>Capping of the pots is required to prevent water penetration to the flues and any crumbling or cracked pointing should be renewed.</p> <p>The chimney stack should be regularly monitored for any indications of damage, instability or other defects. Missing, loose or defective mortar should be re-pointed as necessary.</p>

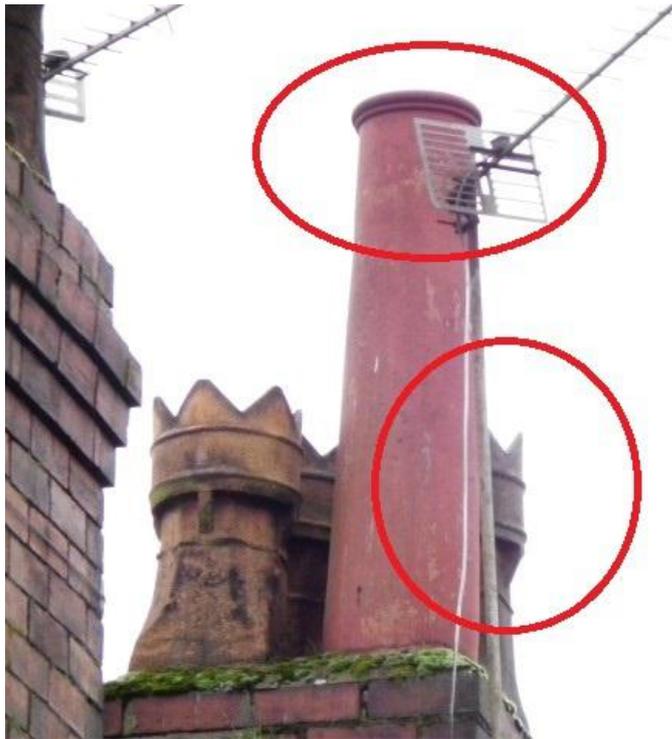
No cowl on chimney pots

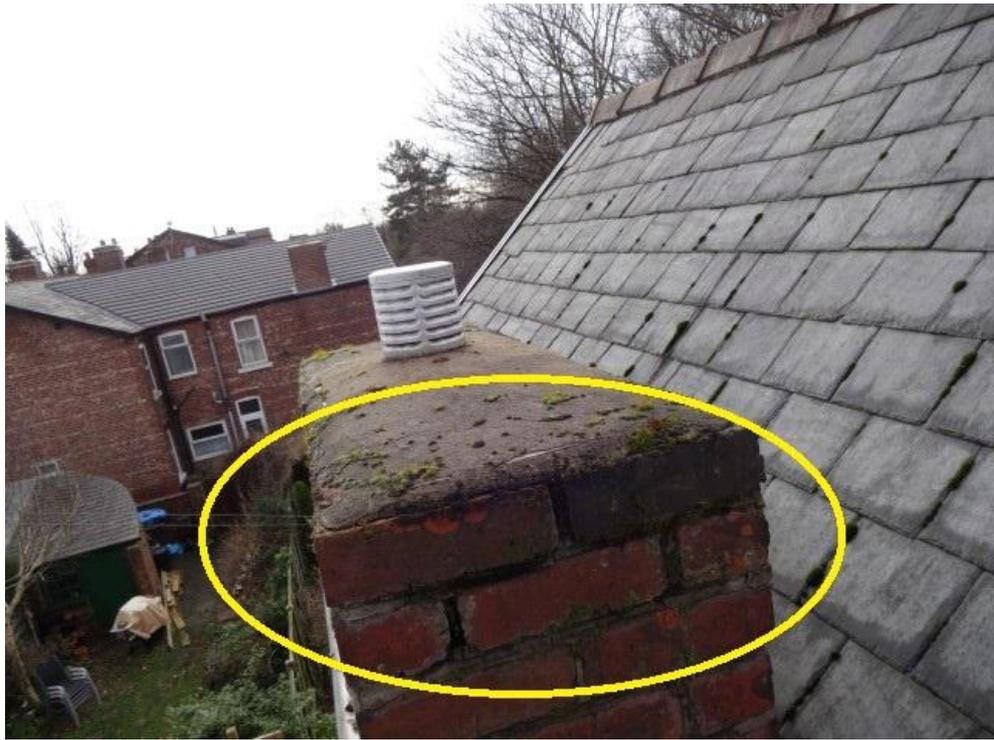
Cracked and crumbling pointing on chimney

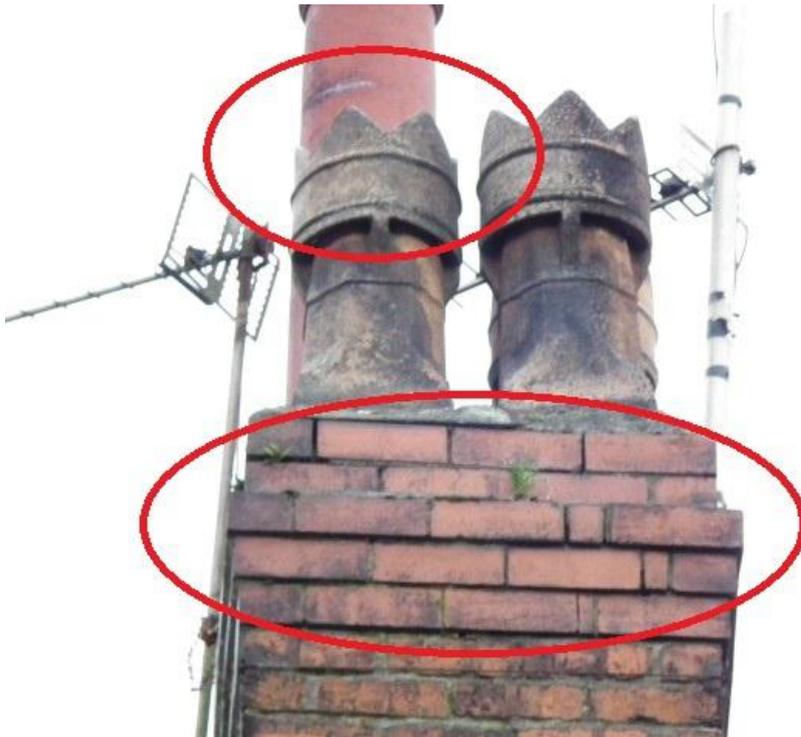
Cracked and crumbling pointing on chimney and no cowls fitted

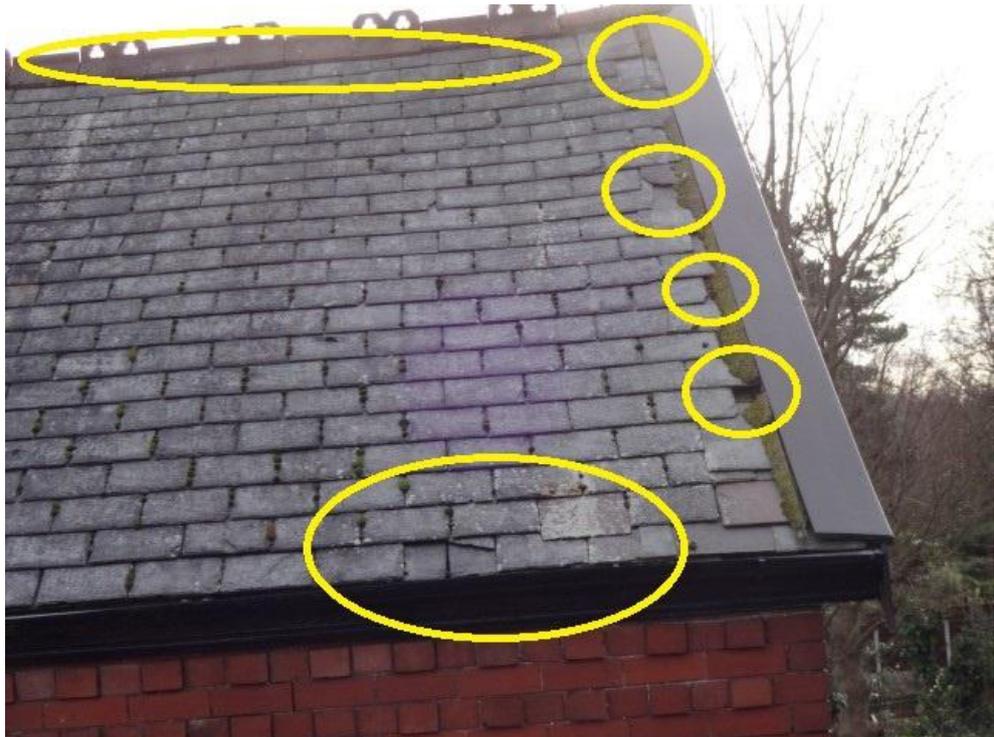
Cracked or missing pointing on ridge tiles and holes in roof

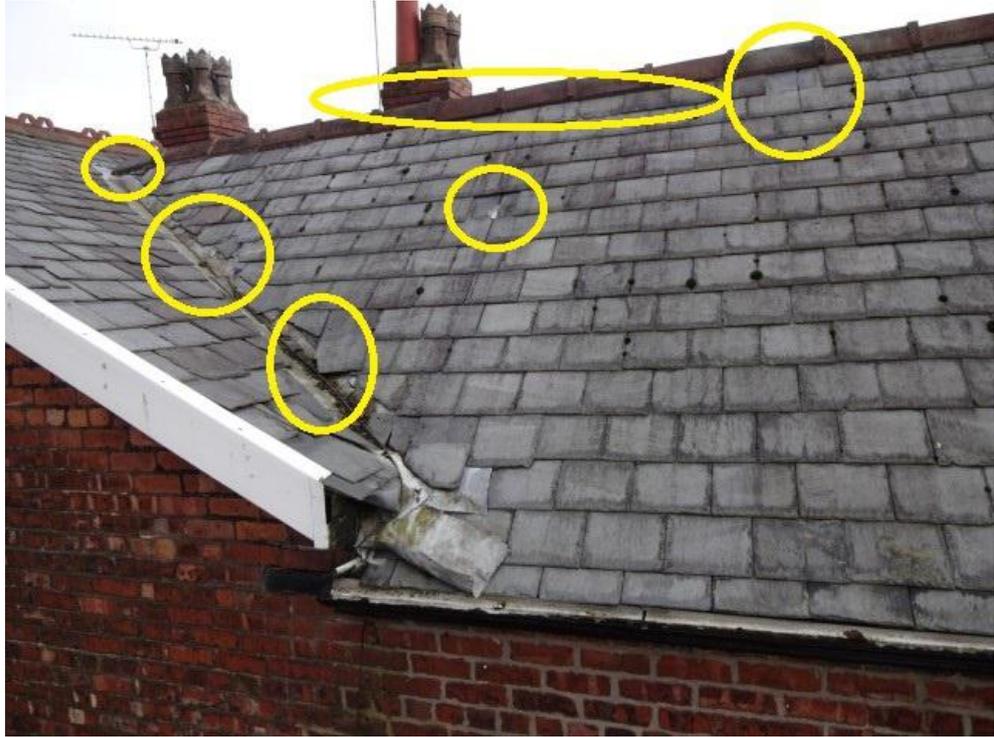
Cracked, broken and displaced slates and missing ridge tile pointing

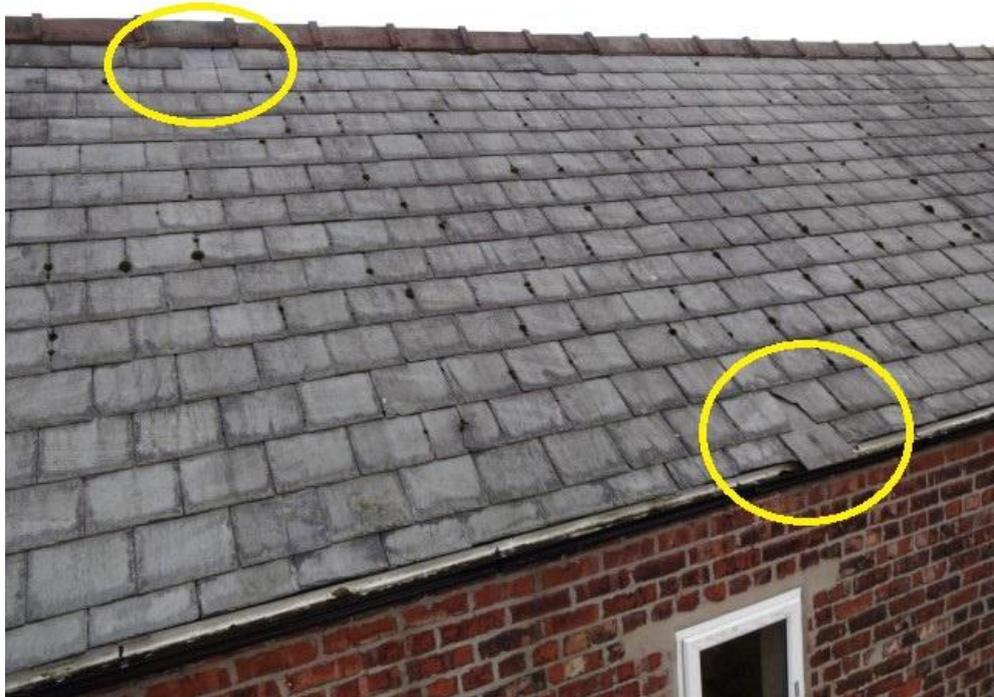
Broken and displaced slates

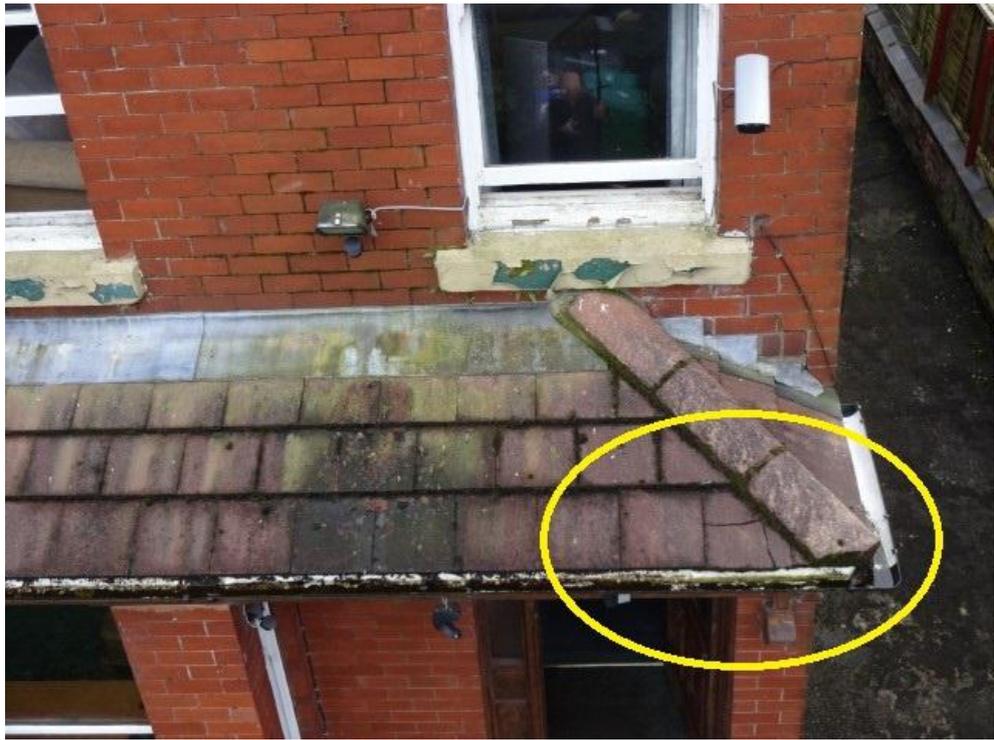
Cracked, broken and displaced tiles

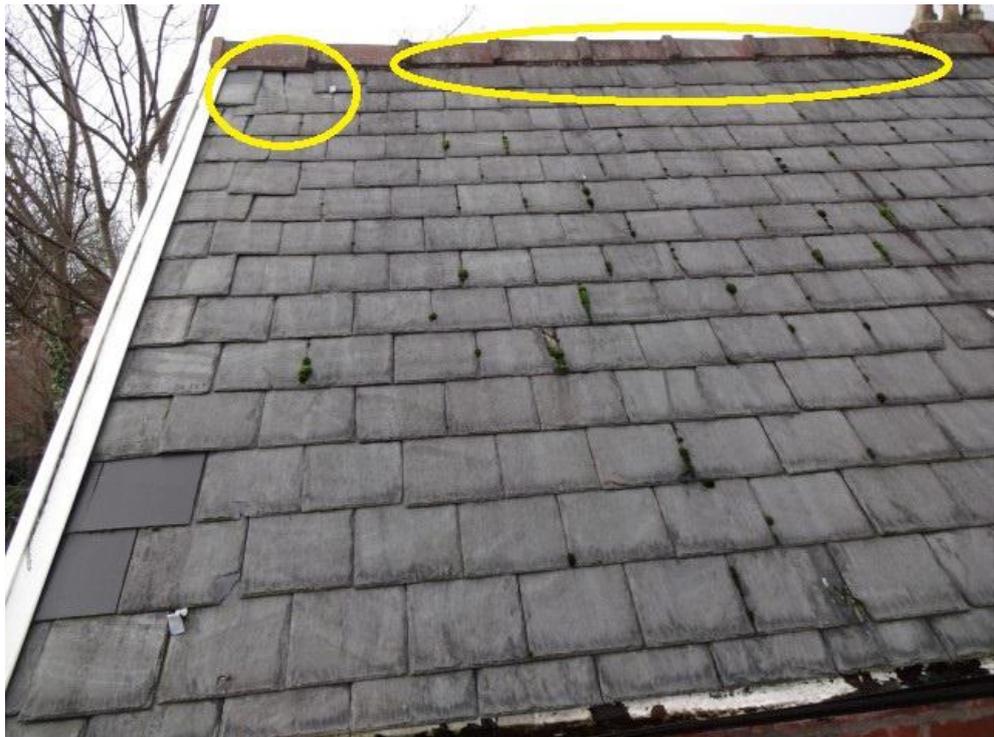
Cracked, broken and displaced slates and missing ridge tile pointing

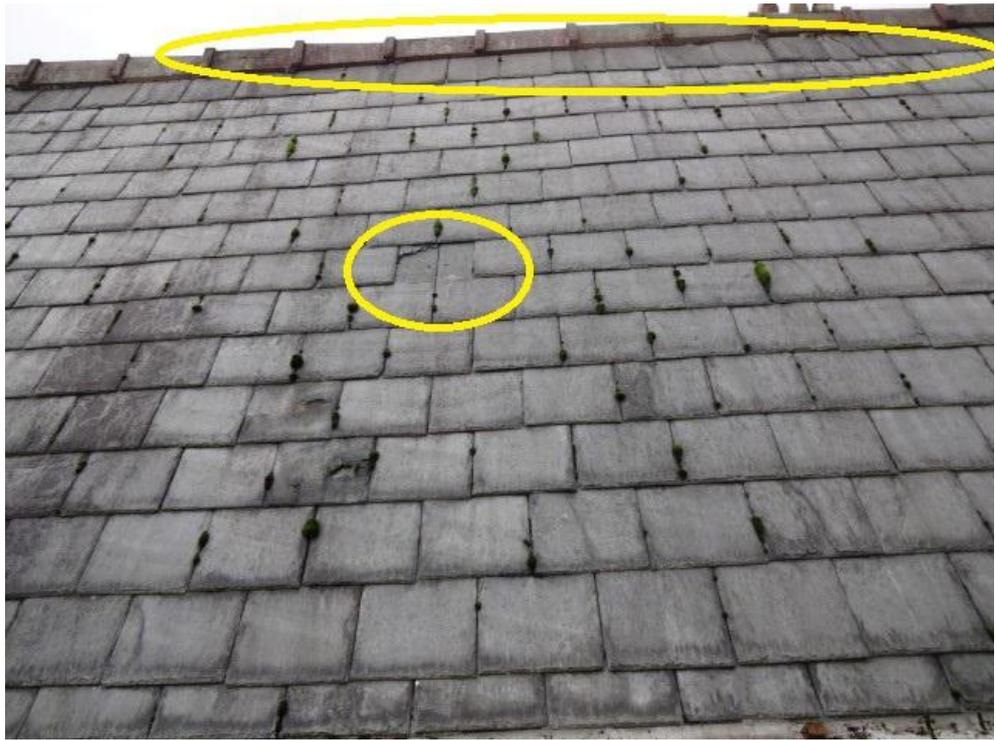
Cracked, broken and displaced slates and missing ridge tile pointing

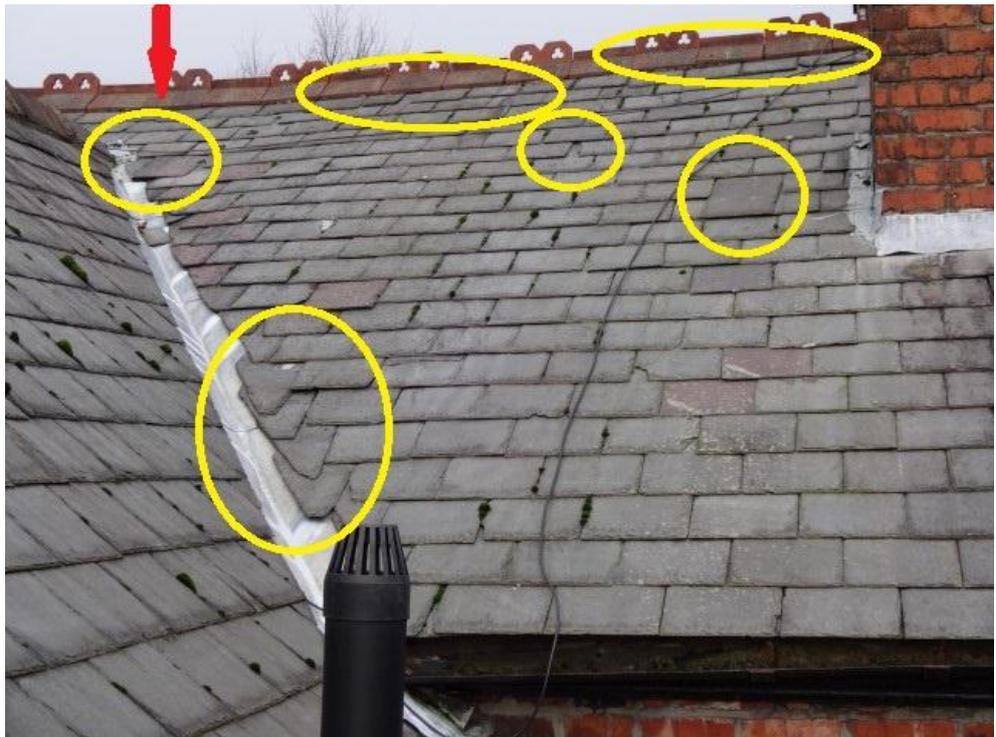
Cracked, broken and displaced slates and missing ridge tile pointing Arrow shows sagging ridge

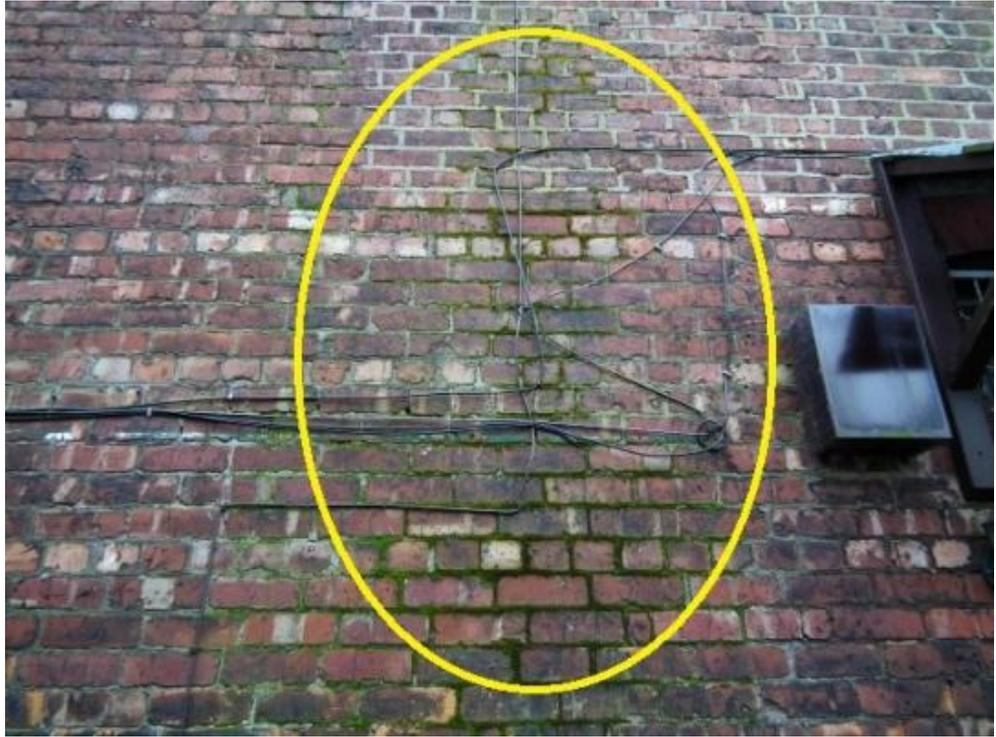
Evidence of leaking guttering

<b>Action Required</b>	<p>Leaking gutters or downpipe joints must be fixed as soon as possible to prevent water penetration to the property and damage to the foundations.</p> <p>Gutters and downpipes should be cleaned and inspected regularly to ensure that they are free from blockages and leaks.</p>

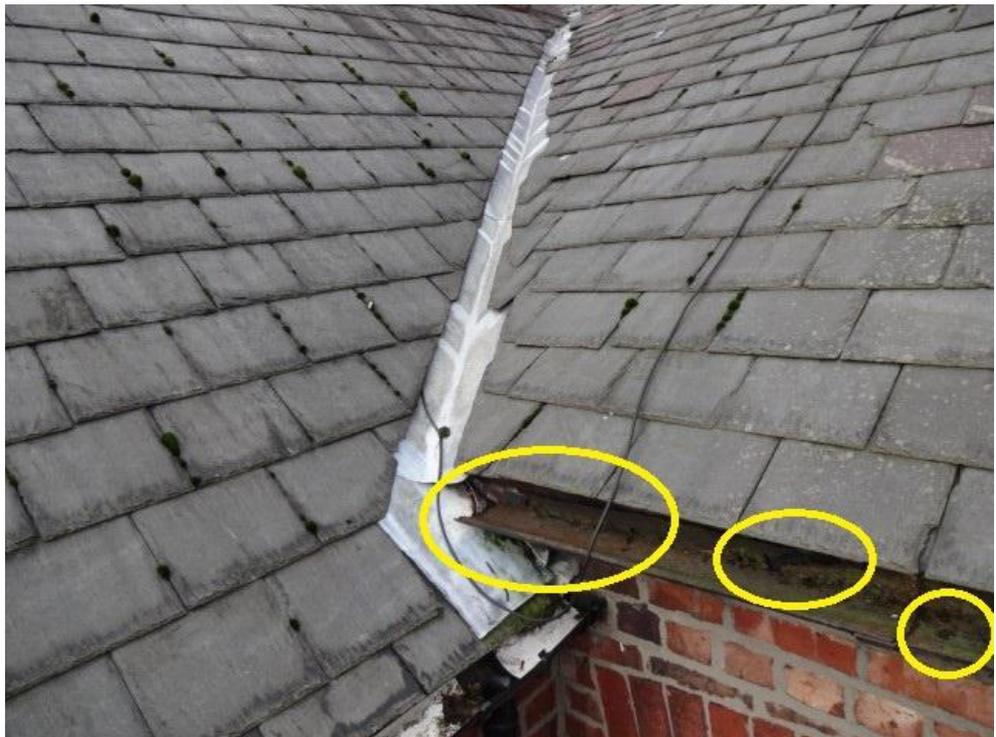
Rusty and unsecured cast iron guttering with large holes in several places

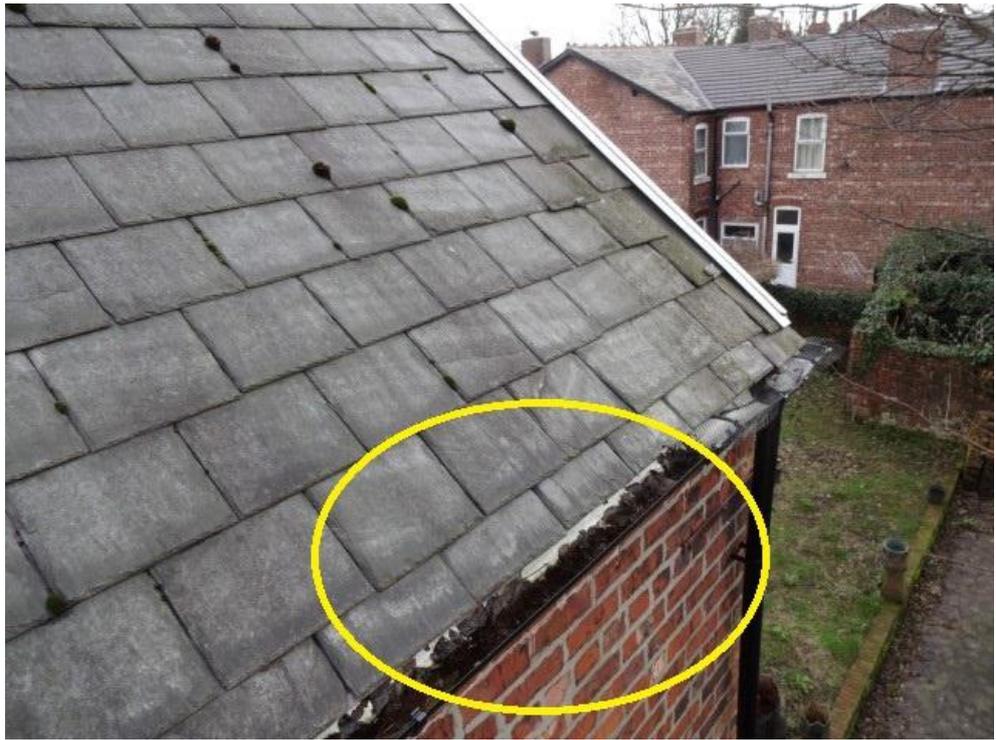
Guttering is partially blocked on side elevation

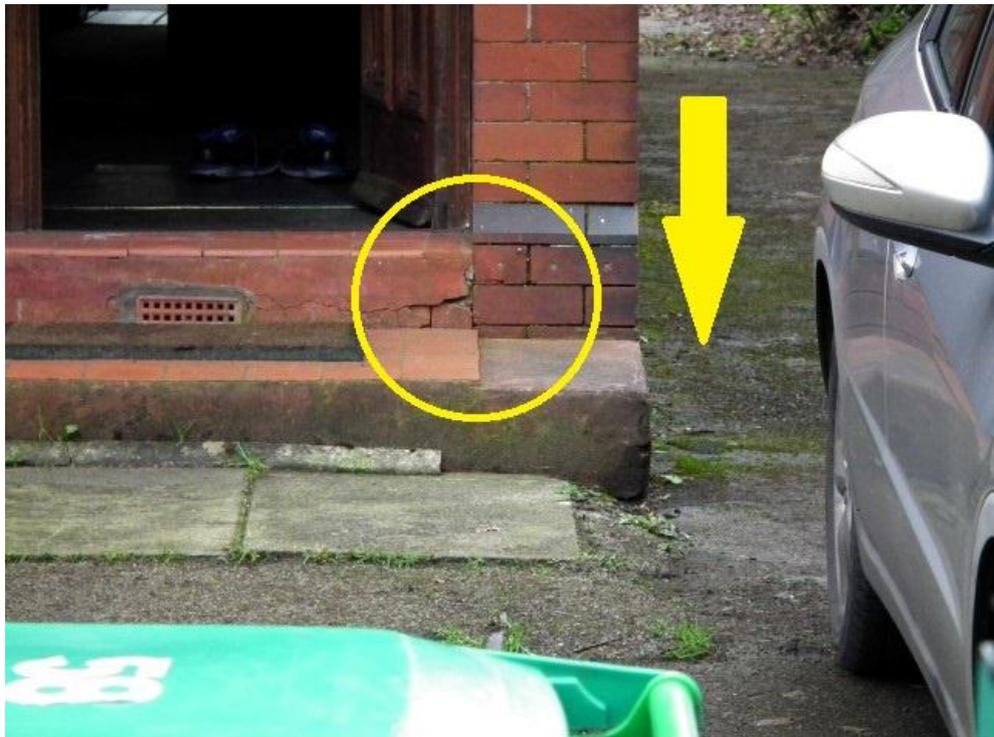
Crack in wall and the wall has settled along the side elevation

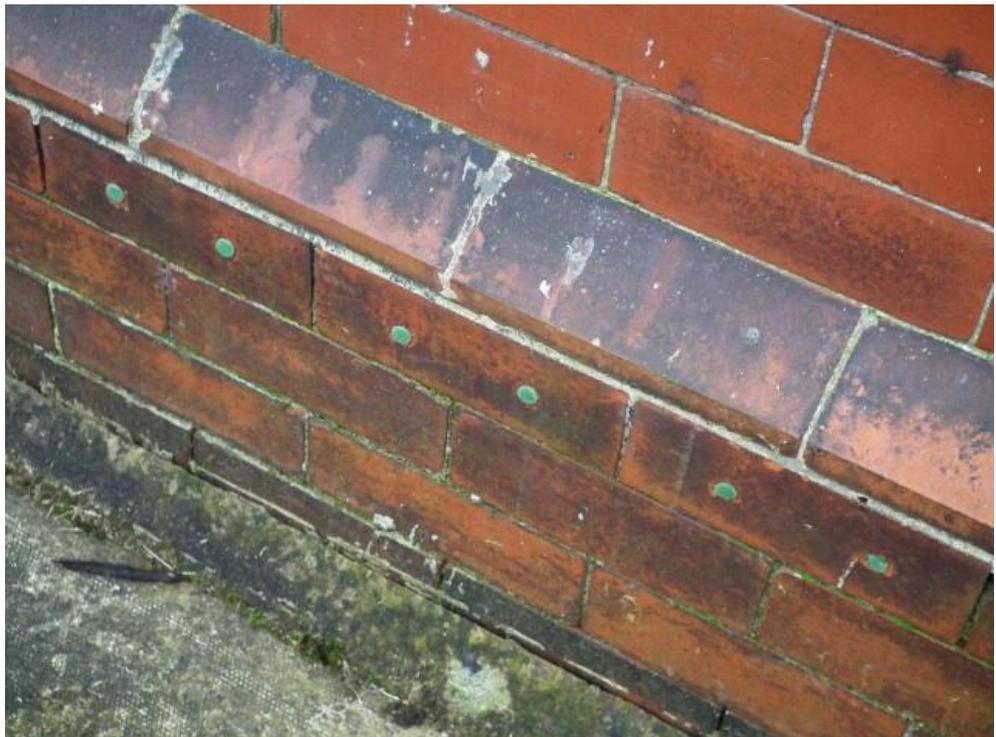
Evidence of injected damp proof course

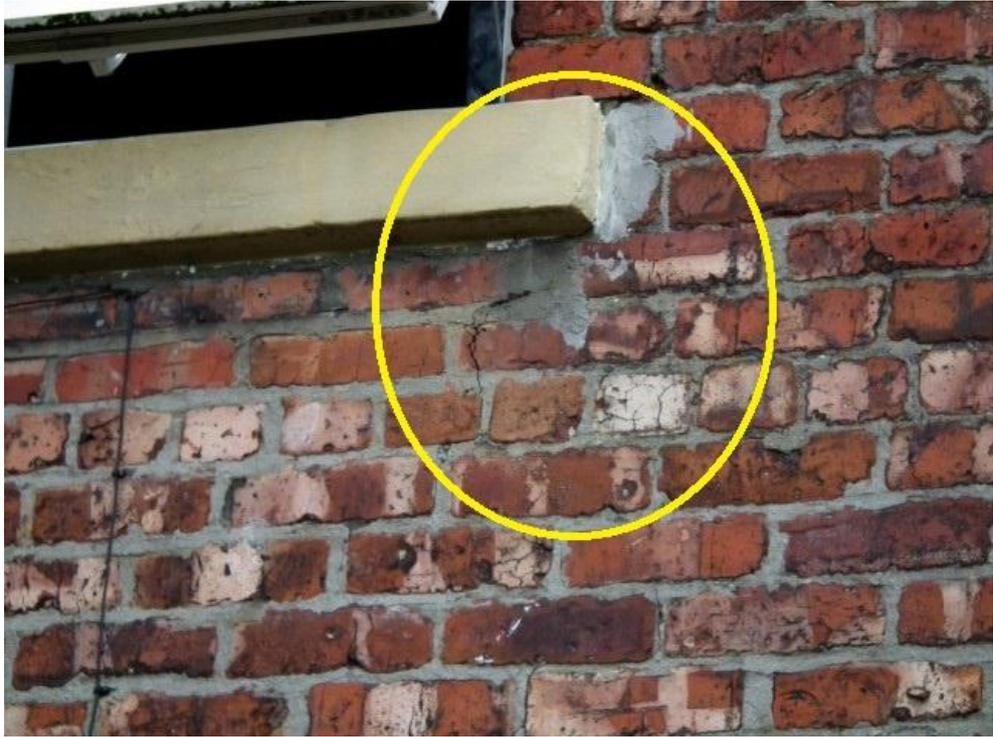
Minor cracks in pointing

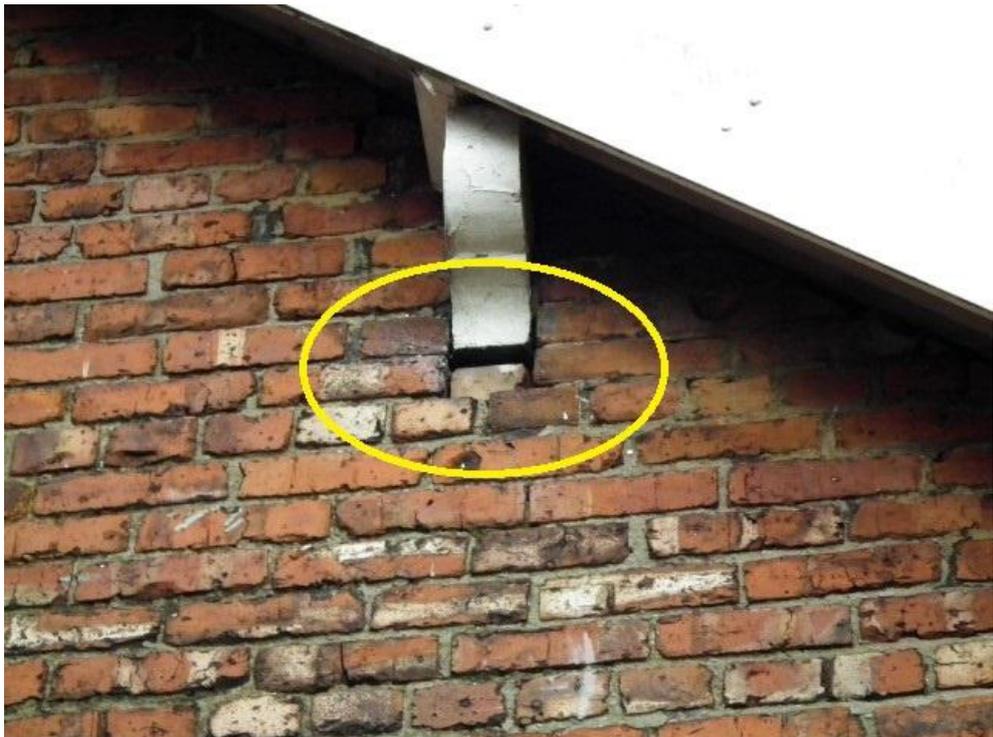
Loose brick on rear elevation

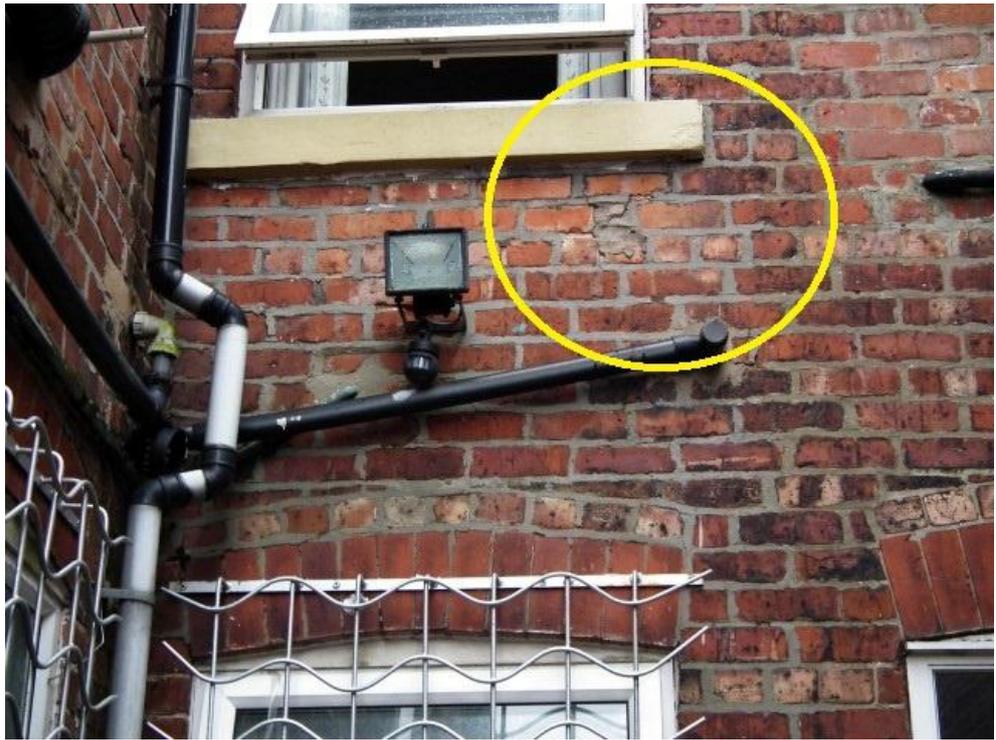
Minor cracks in pointing

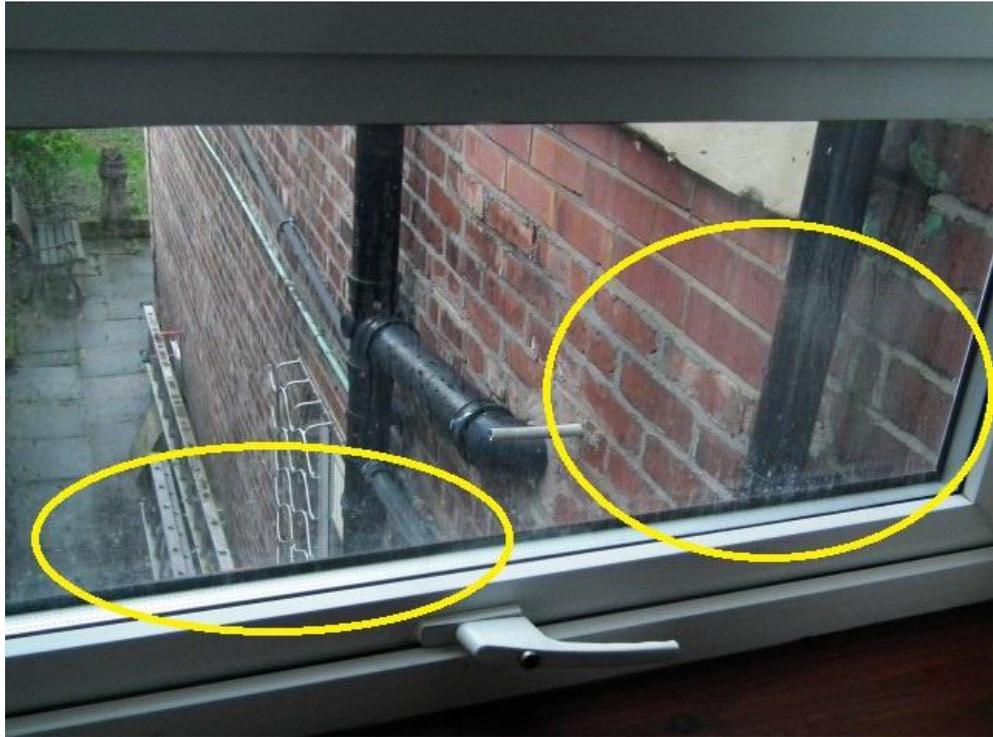
Condensation inside double glazing

<b>Action Required</b>	<p>Any future blown double glazing units require replacement. It should also be considered that, where some sealed units within a window have failed, others may also fail in due course.</p> <p>Normal maintenance of frames, hinges and locks is required.</p> <p>Be aware that previous owners may have distributed multiple sets of keys for the windows and doors to individuals not known to you. When purchasing a property, you should consider the cost of replacing all of the door and window locks as soon as possible after you take up occupation. When doing this you should consult your insurers to ensure that you meet their requirements for security, and obtain any discounts that may be available by improving the security of the property.</p>
------------------------	--

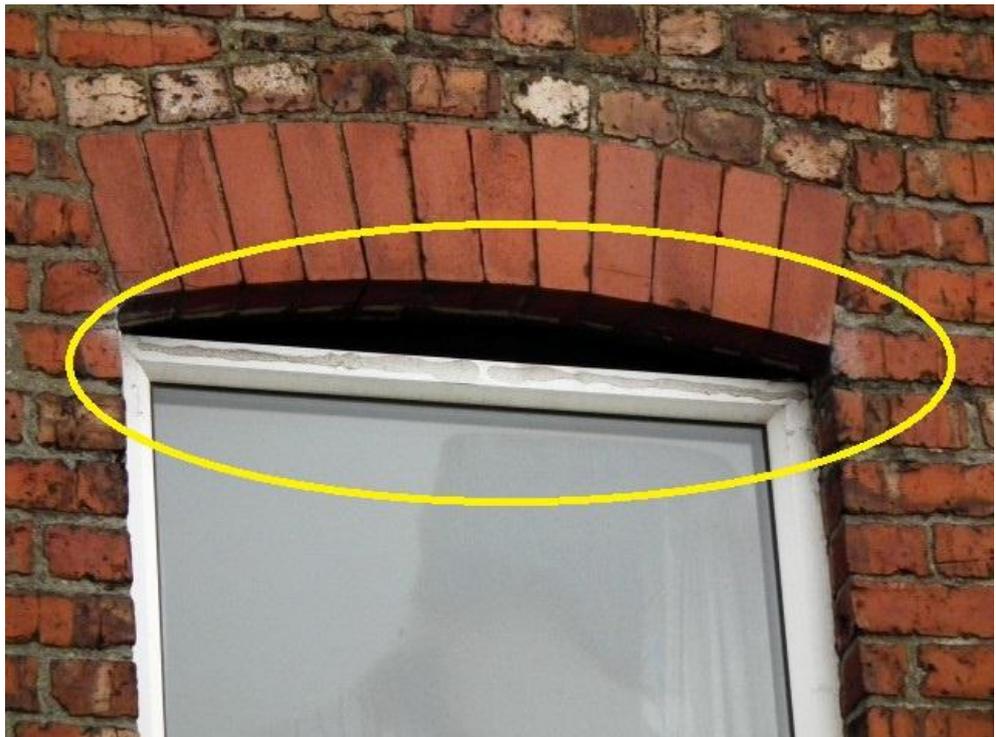
A piece may be missing from above the rear window

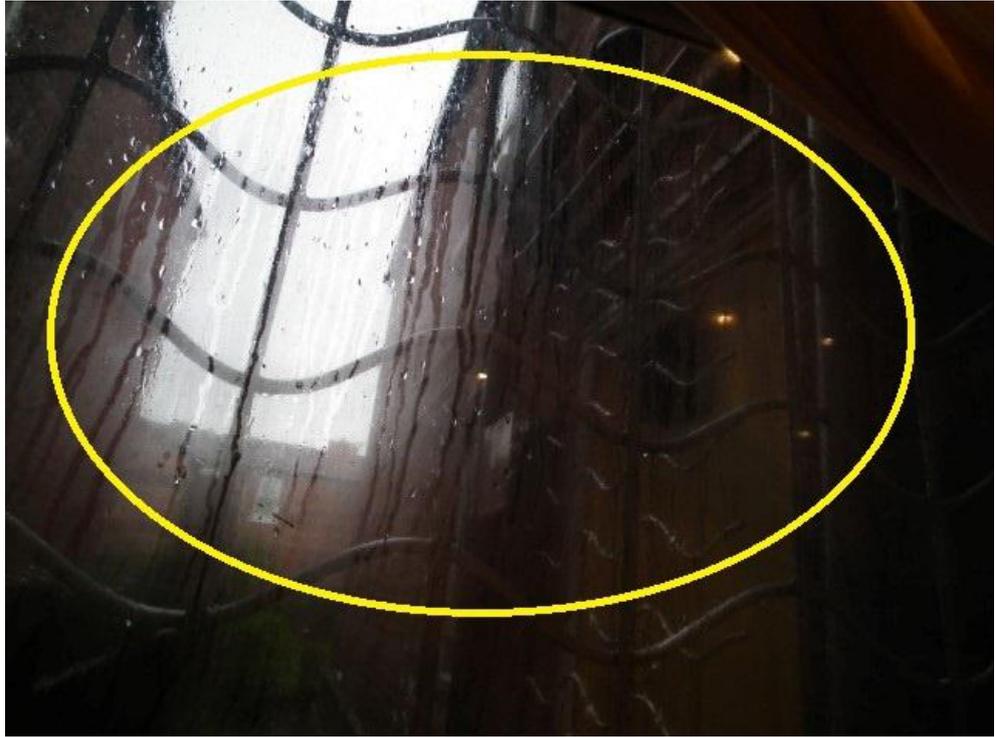
Condensation inside double glazing

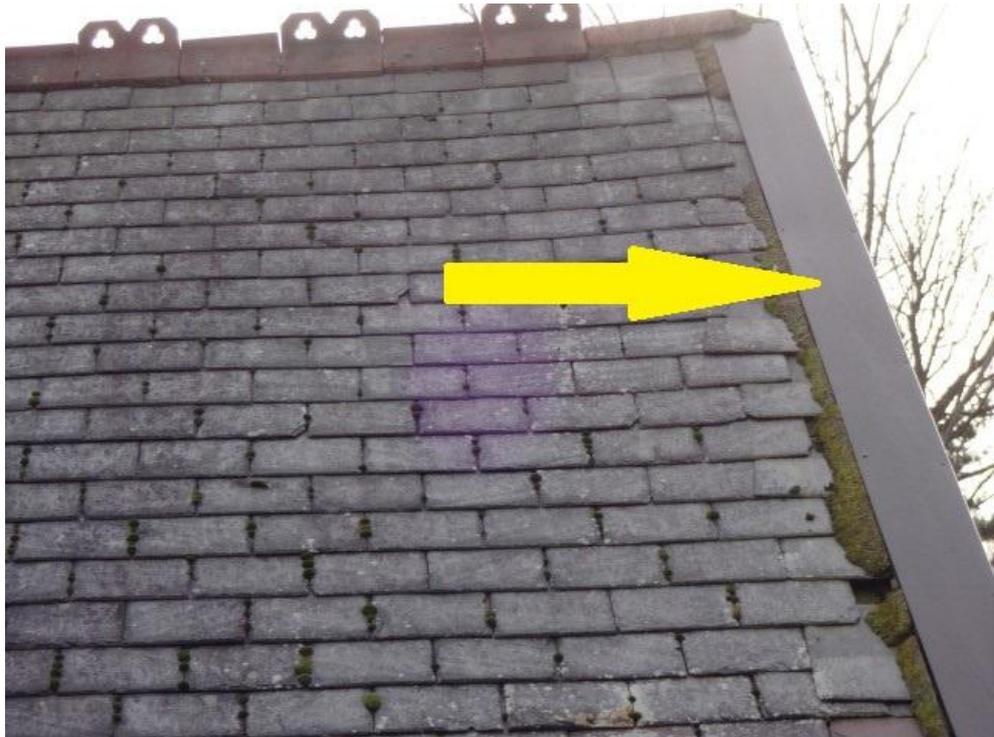
This upvc board is different from the rest and is not the best way to repair a verge

<b>Action Required</b>	<p>Ideally the Barge boards should be replaced using the correct materials and methods (E.g Dry Verge Caps) when the roof is recovered. This will ensure a proper, water tight repair.</p> <p>Any flaking paint on the fascia boards and window sills will need scraping off and new paint applying.</p> <p>Regular maintenance will be required especially to the side elevation which faces south-west. This section of the property will receive most of any inclement weather and the heat of the sun.</p>

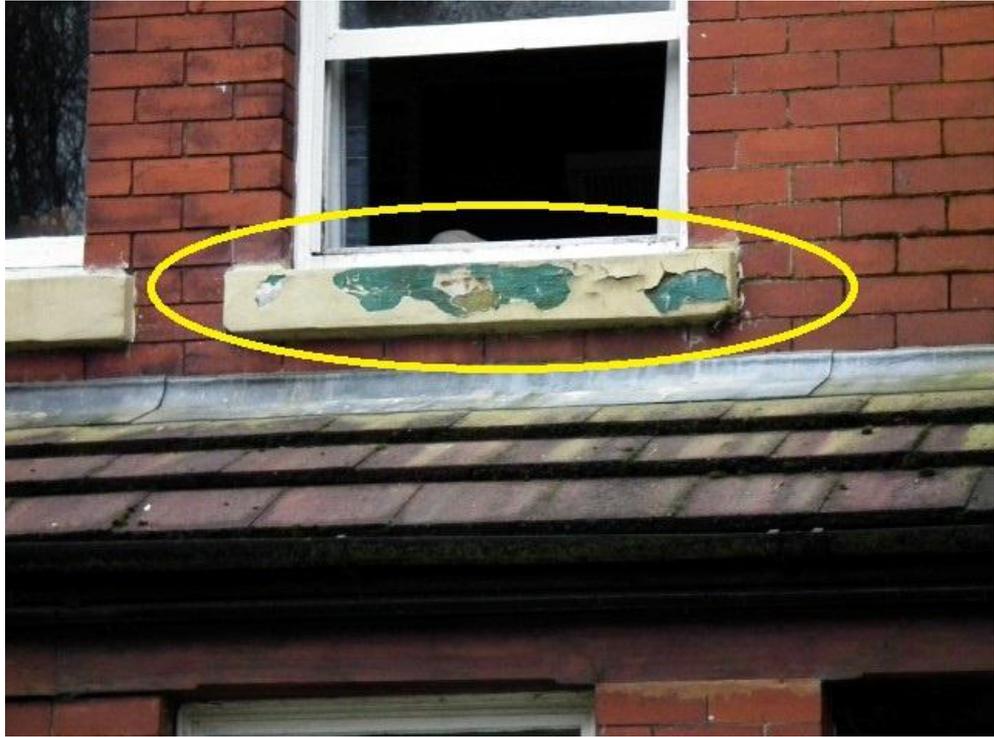
Flaking and worn paintwork

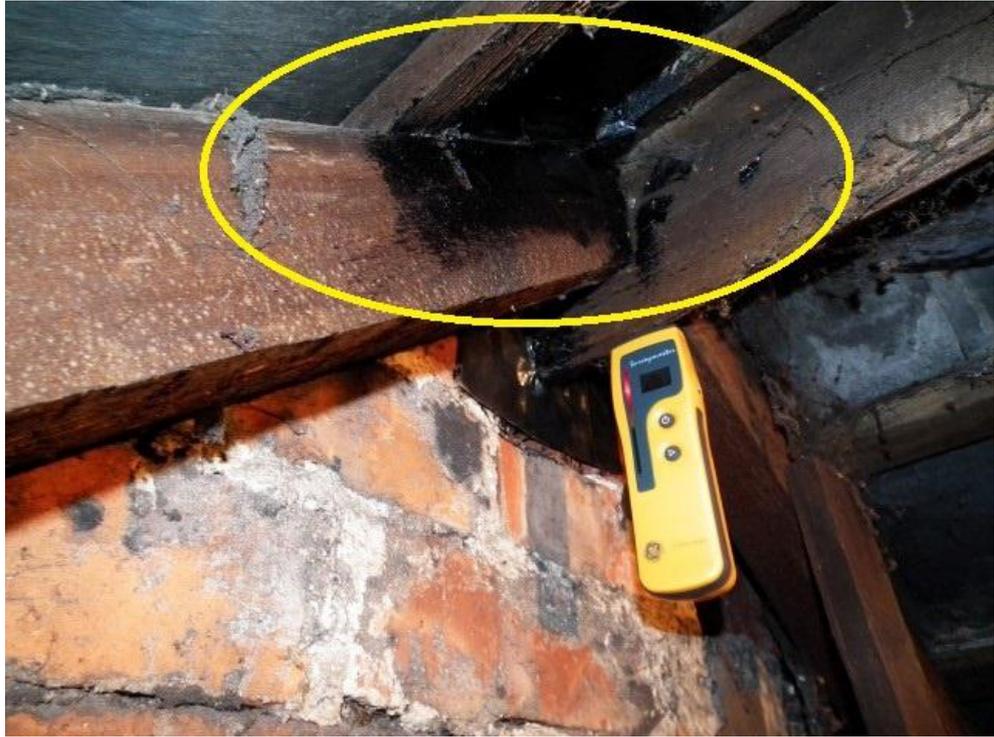
Evidence of roof repairs but timber is still damp

<p><b>Action Required</b></p>	<p>Ventilation must be installed to allow the moisture to evaporate and prevent rot in the timbers. Vents can be installed in the gable walls, the roof slopes or at the roof ridge, but it is recommended to provide a selection of all three to maximise the cross ventilation in the roof space. The areas where white mold is forming will need treating with an appropriate fungicide and the support for the additional brick column should be checked to ensure it is resting on a load bearing wall.</p> <p>It is recommended to have the gaps in the Party Wall filled to reduce the chance of fire spread should one occur. This can be done with cement mortar or fire retardant expanding foam. (Normal expanding foam is not suitable for this purpose, it must be fire retardant)</p> <p>Regularly monitor timbers for evidence of wood boring insects and other such infestations.</p> <p>Care should be taken when moving around, or storing heavy objects, in the roof space. The spaces between the floor joists will not support a persons weight, or that of large boxes etc. Where heavy items are to be stored it is important to distribute the weight evenly using fixed boards. Additional structural support may be required if you plan to store large quantities of heavy items in the roof space.</p>
