# BUILDING SURVEY REPORT

CLIENT  
PROPERTY

The format of this MiBuilding Survey Report is consistent with the guidance note requirements for a Survey Level 3 as defined by RICS Surveys of Residential Property 3rd edition May 2016

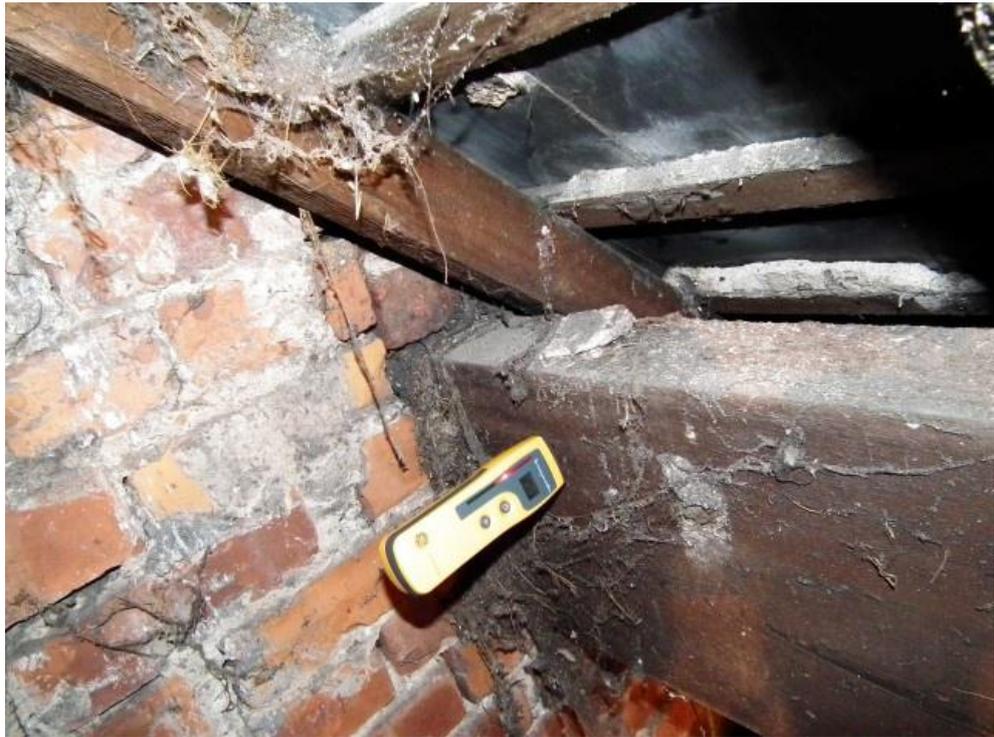
High damp readings in roof timbers

<p><b>Action Required</b></p>	<p>Ventilation must be installed to allow the moisture to evaporate and prevent rot in the timbers. Vents can be installed in the gable walls, the roof slopes or at the roof ridge, but it is recommended to provide a selection of all three to maximise the cross ventilation in the roof space. The areas where white mold is forming will need treating with an appropriate fungicide and the support for the additional brick column should be checked to ensure it is resting on a load bearing wall.</p> <p>It is recommended to have the gaps in the Party Wall filled to reduce the chance of fire spread should one occur. This can be done with cement mortar or fire retardant expanding foam. (Normal expanding foam is not suitable for this purpose, it must be fire retardant)</p> <p>Regularly monitor timbers for evidence of wood boring insects and other such infestations.</p> <p>Care should be taken when moving around, or storing heavy objects, in the roof space. The spaces between the floor joists will not support a persons weight, or that of large boxes etc. Where heavy items are to be stored it is important to distribute the weight evenly using fixed boards. Additional structural support may be required if you plan to store large quantities of heavy items in the roof space.</p>

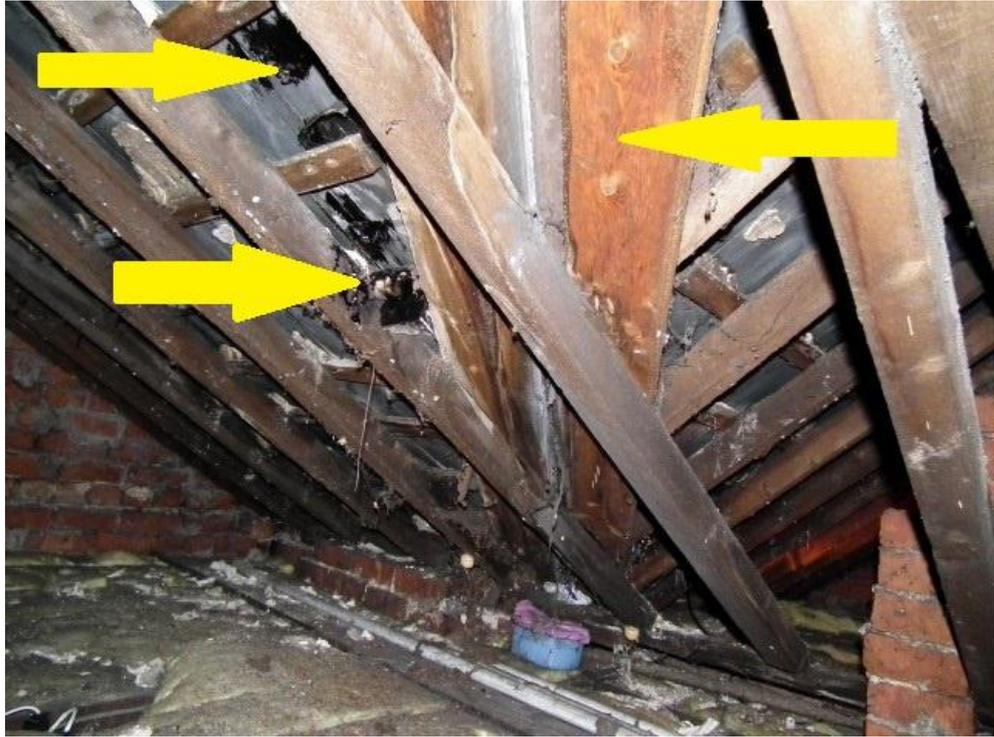
New timber and evidence of repairs

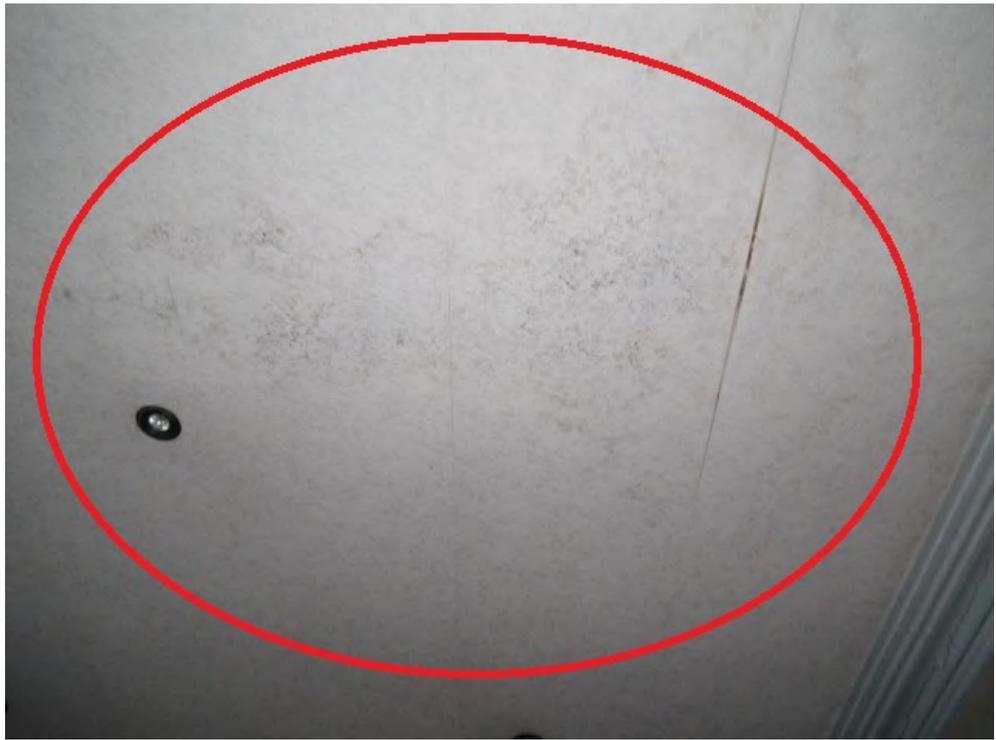
water stain on ceiling of front bedroom

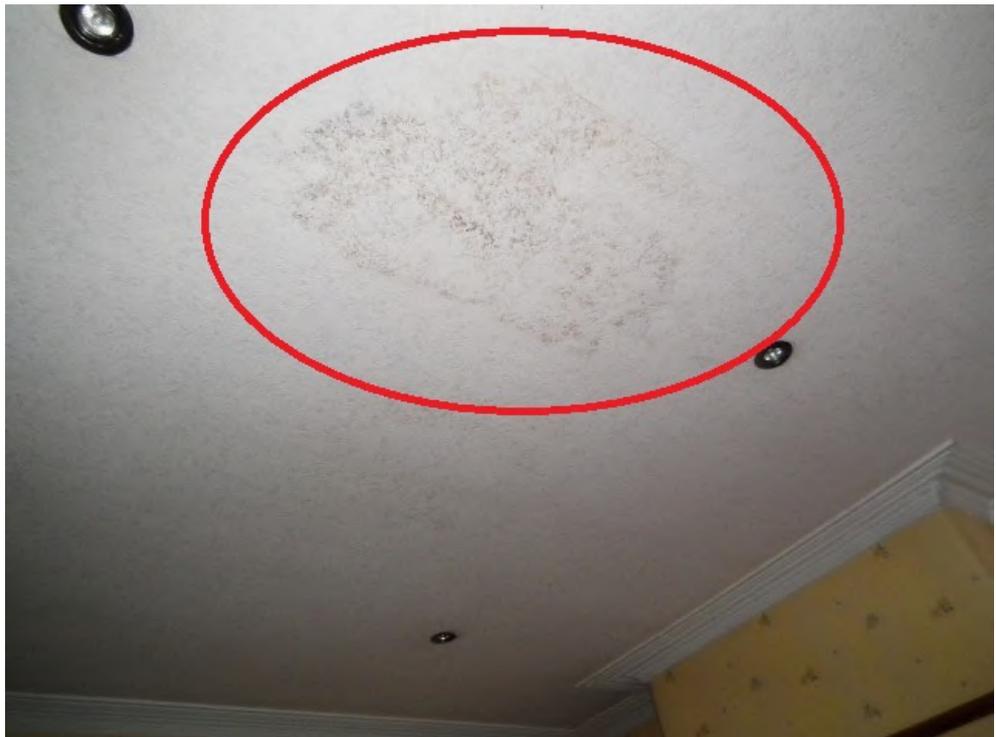
Water stain on ceiling of bedroom 2

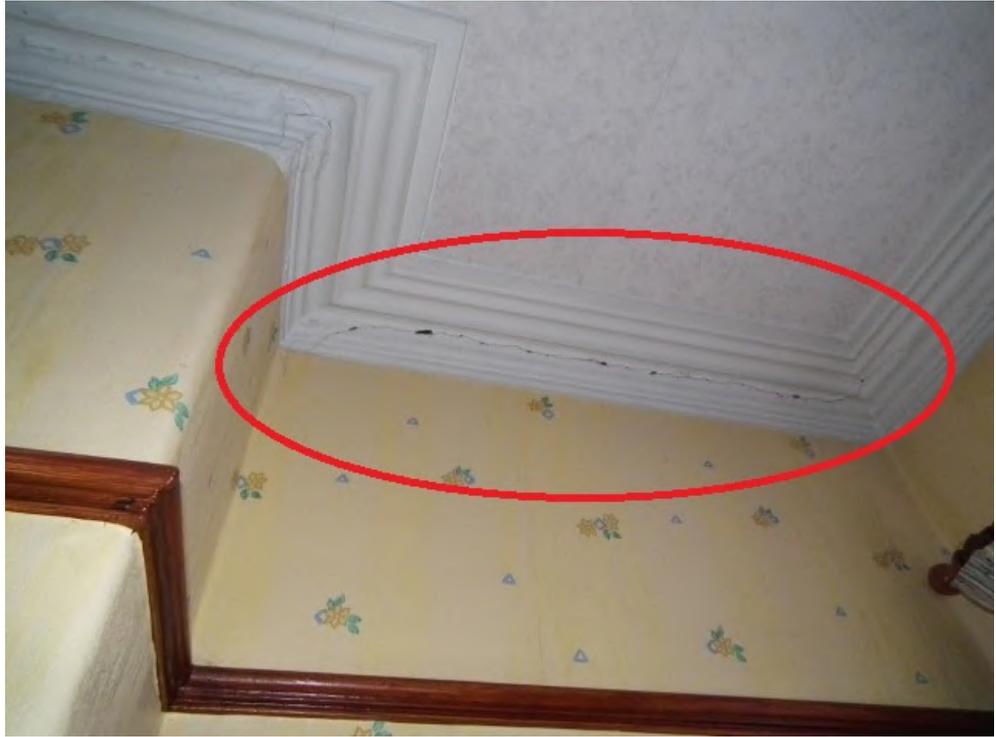
Cracks in plaster in bedroom 2

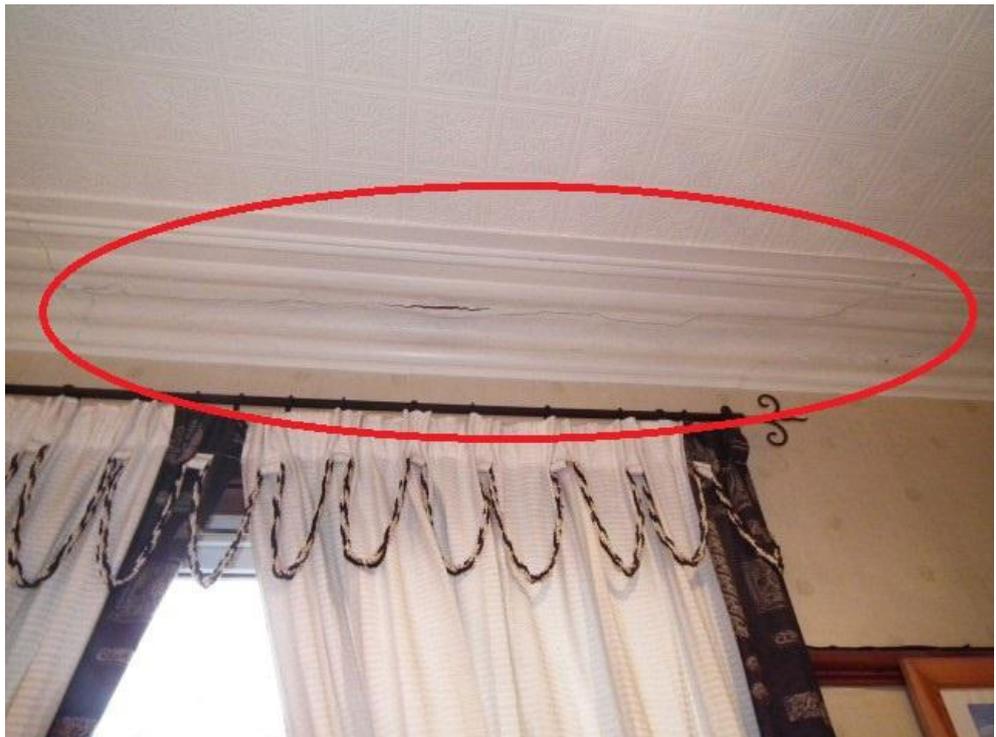
Crack in plaster on rear elevation

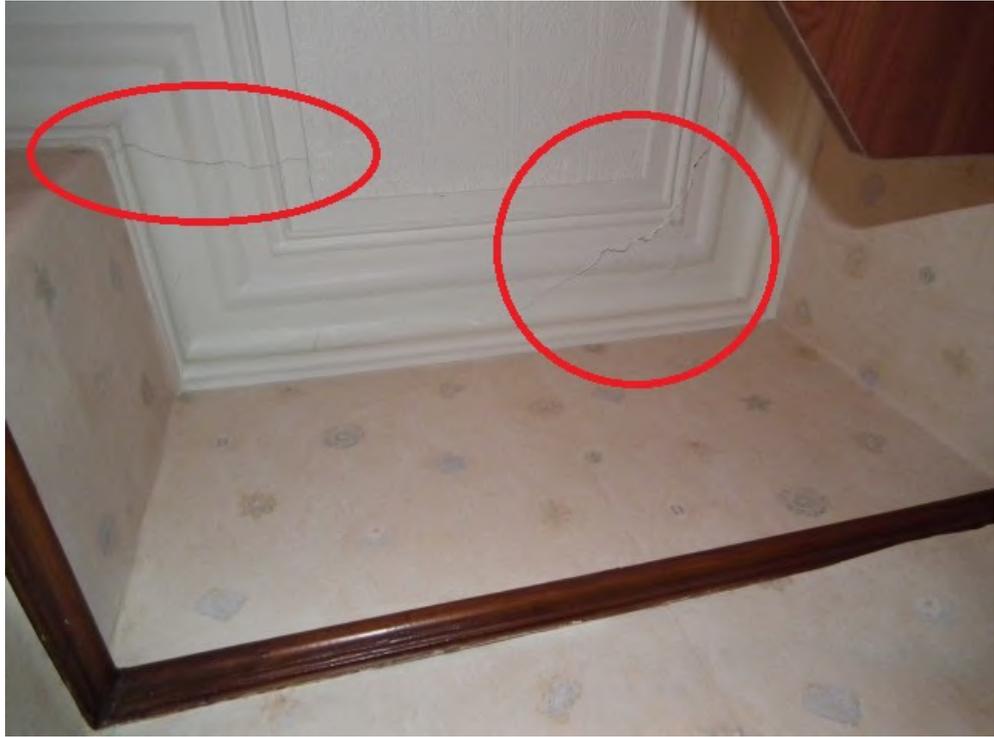
Cracks in ceiling of ground floor front room

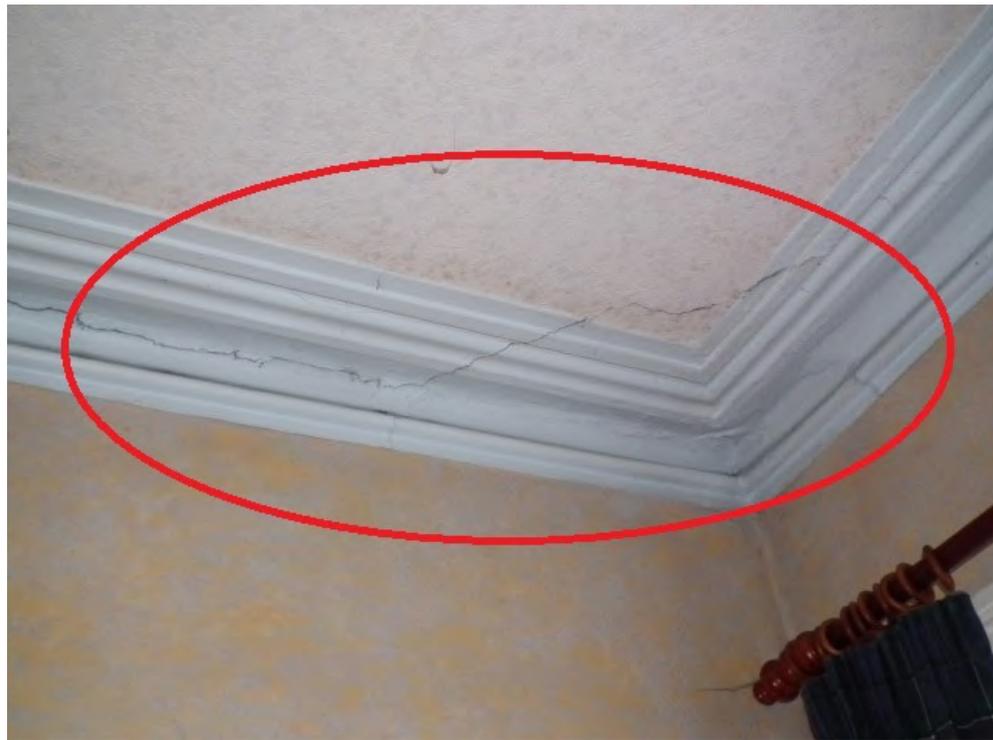
Cracks in plaster of front bedroom

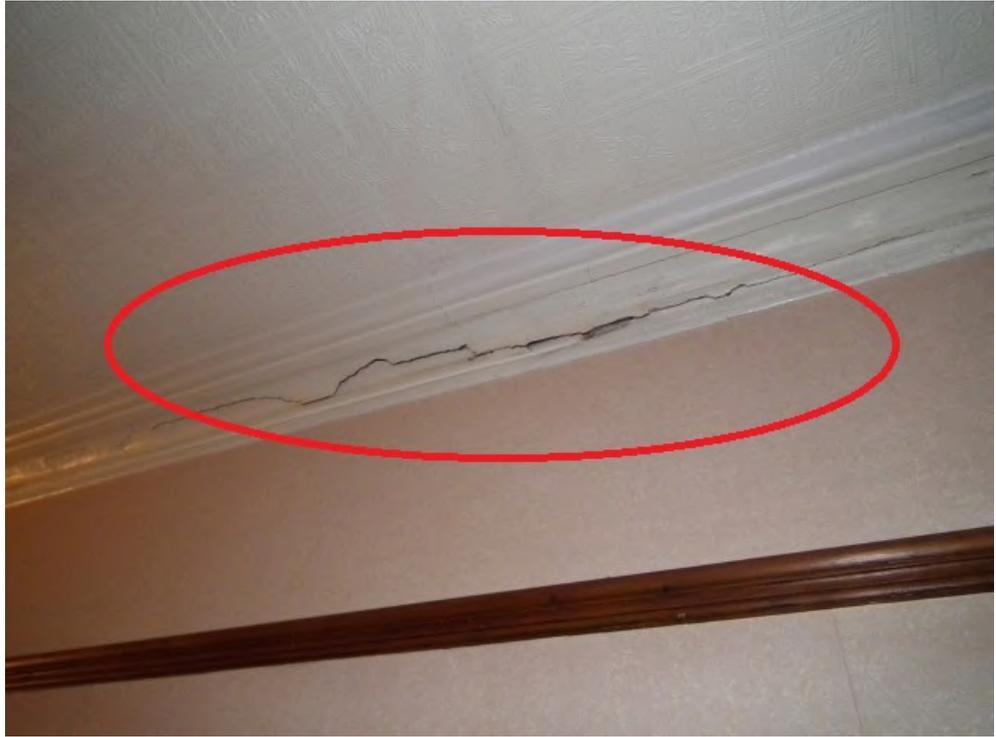
Cracks in side elevation in hallway

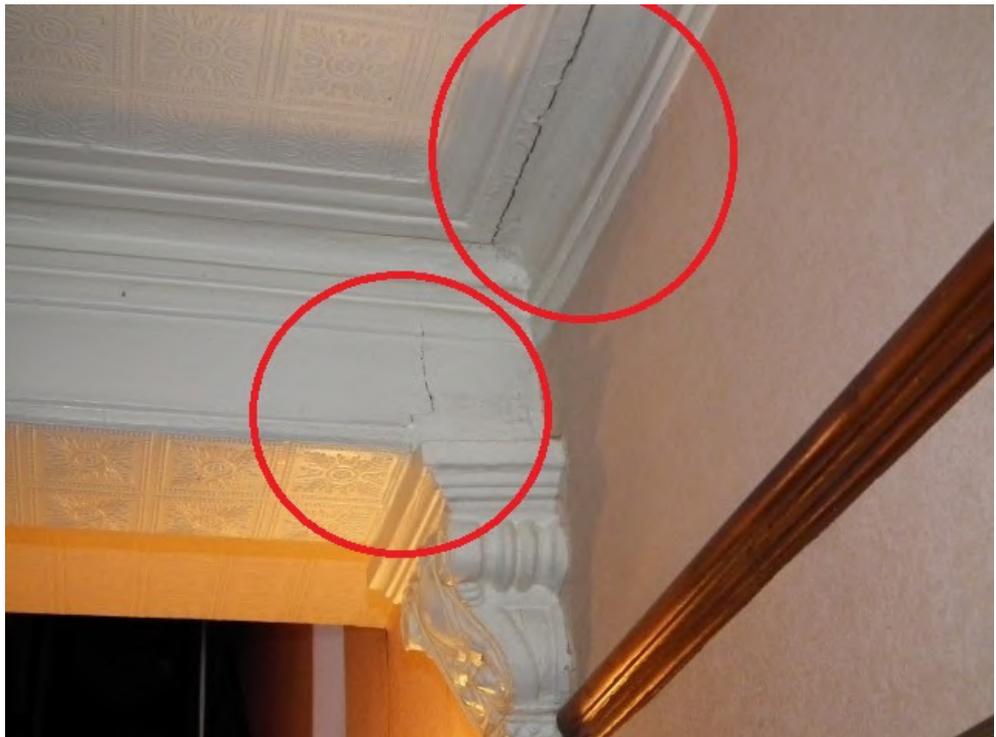
Further cracks in side elevation in hallway

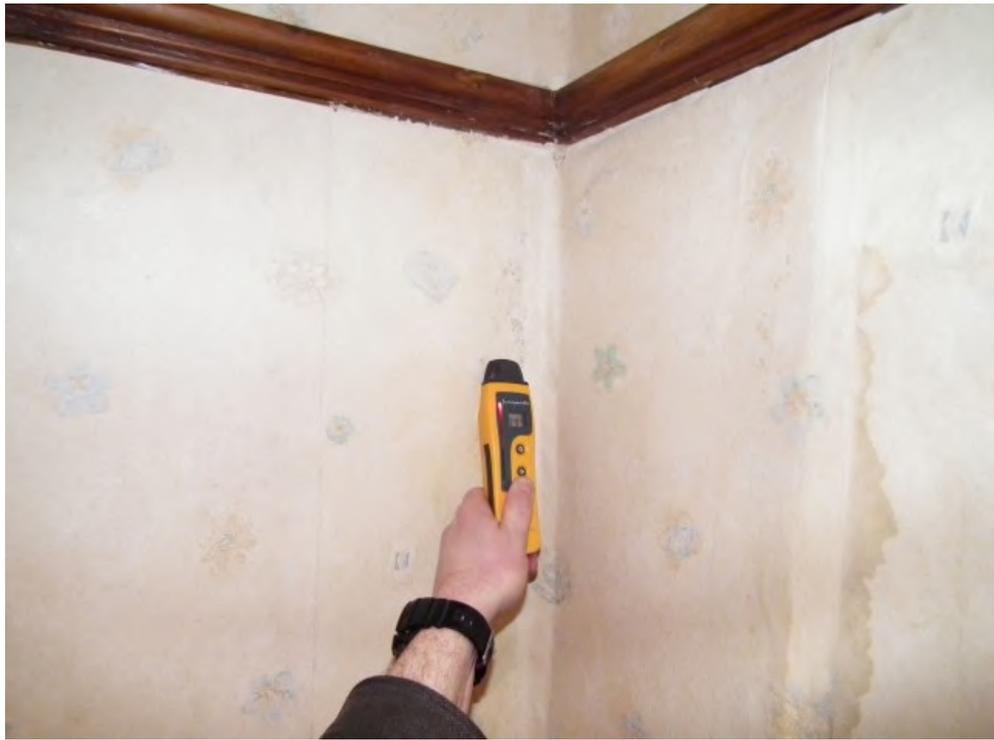
There are visible damp patches on walls in ground floor front room

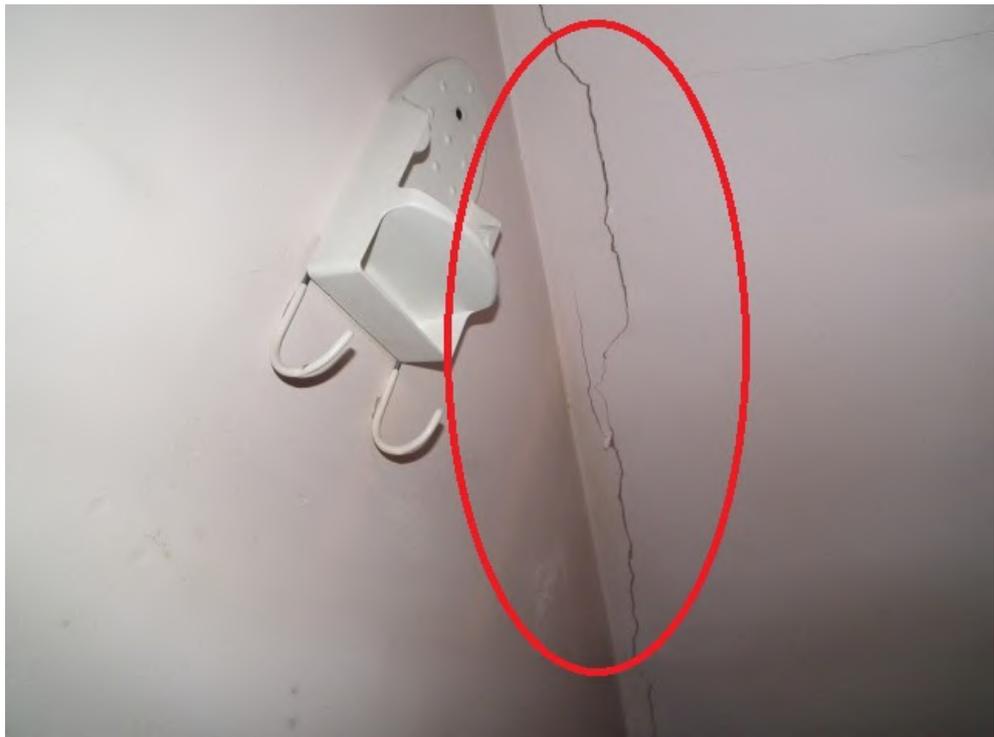
Crack in plaster inside under stairs cupboard also on side elevation

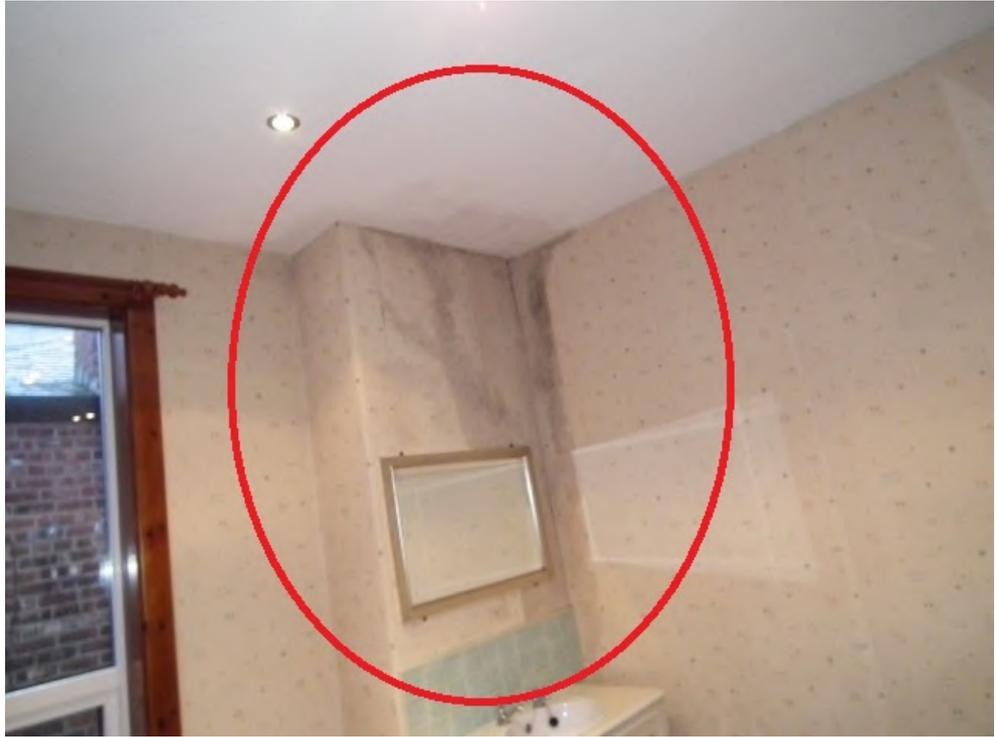
Visible damp patches on chimney breast

<b>Action Required</b>	<p>Capping of the pots is required to prevent water penetration to the flues and any crumbling or cracked pointing should be renewed. Refer to 4.1</p> <p>If the flues are to be used, they should be checked by a reputable heating engineer specialising in flues and chimneys, prior to use. Flues should also be swept clean at this time.</p> <p>If the flues are not to be used, it is important to maintain an adequate airflow, by means of ventilation, through unused chimney flues to prevent the build-up of condensation within the chimney. Ventilation grilles should be fitted to all blocked breasts.</p>

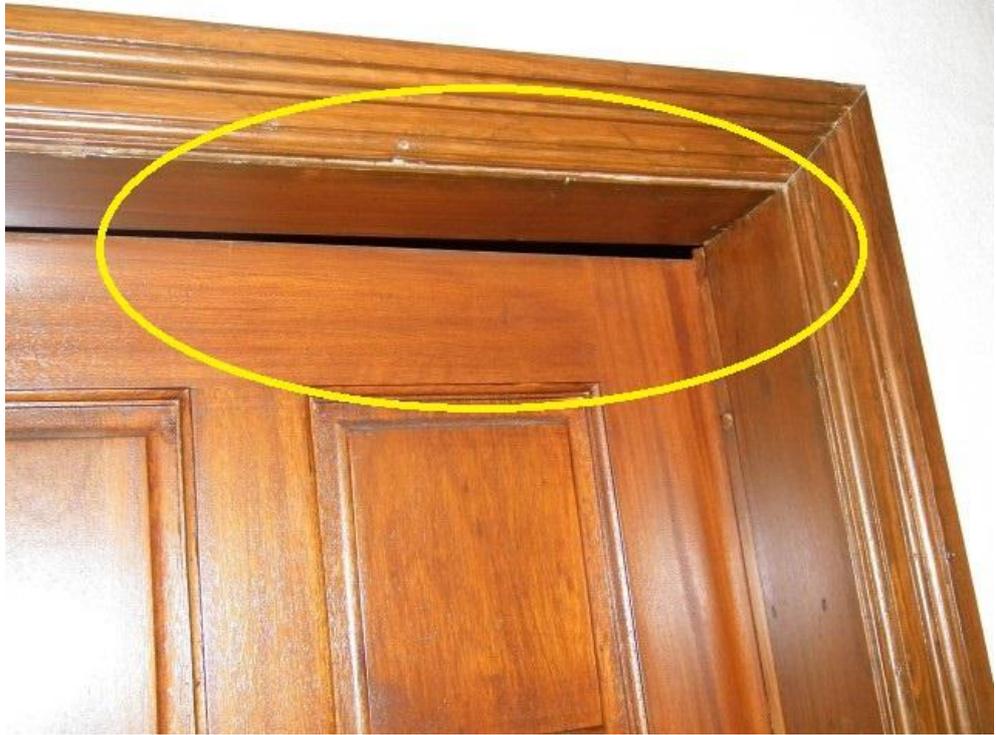
Several doors will not close

<b>Action Required</b>	<p>The doors that will not close will need to be removed, altered to suit the frames and refitted. The incorrect latch mechanism should be replaced.</p> <p>Door hinges and locks should be regularly lubricated. Internal timbers should be inspected regularly for evidence of bowing or distortion, woodworm and other defects.</p> <p>Carry out normal maintenance as required.</p>

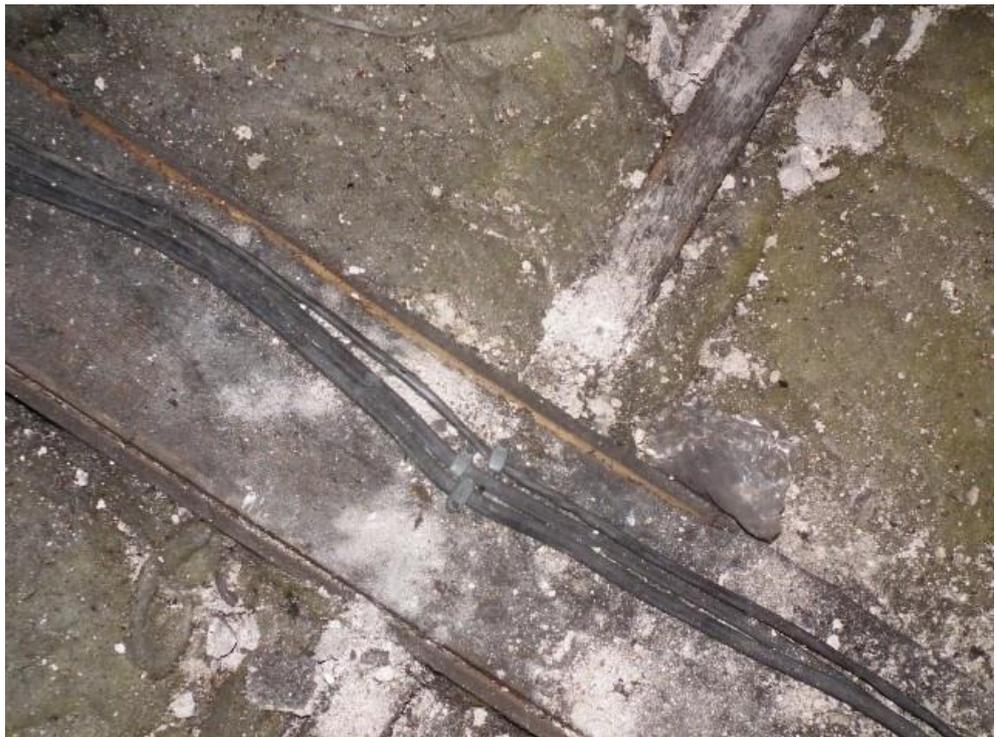
Electrical cables could be damaged by storage or by foot fall

<p><b>Action Required</b></p>	<p>Ideally the cables in the loft should not run along the top of the timbers to prevent damage. If it is not feasible to move the cabling care must be taking to avoid them when storing items in the loft.</p> <p>Some services will be obscured by furniture and other objects at the time of the survey. Upon occupation it is strongly advisable to visually check all socket outlets and switch points for any broken housings or loose fascias. Any damage seen should be repaired accordingly, including the loose fitting on the porch canopy.</p> <p>The NICEIC recommends that electrical installations are subjected to an Electrical Installation Condition Report (EICR) by a suitably qualified engineer at least every 10 years.</p>

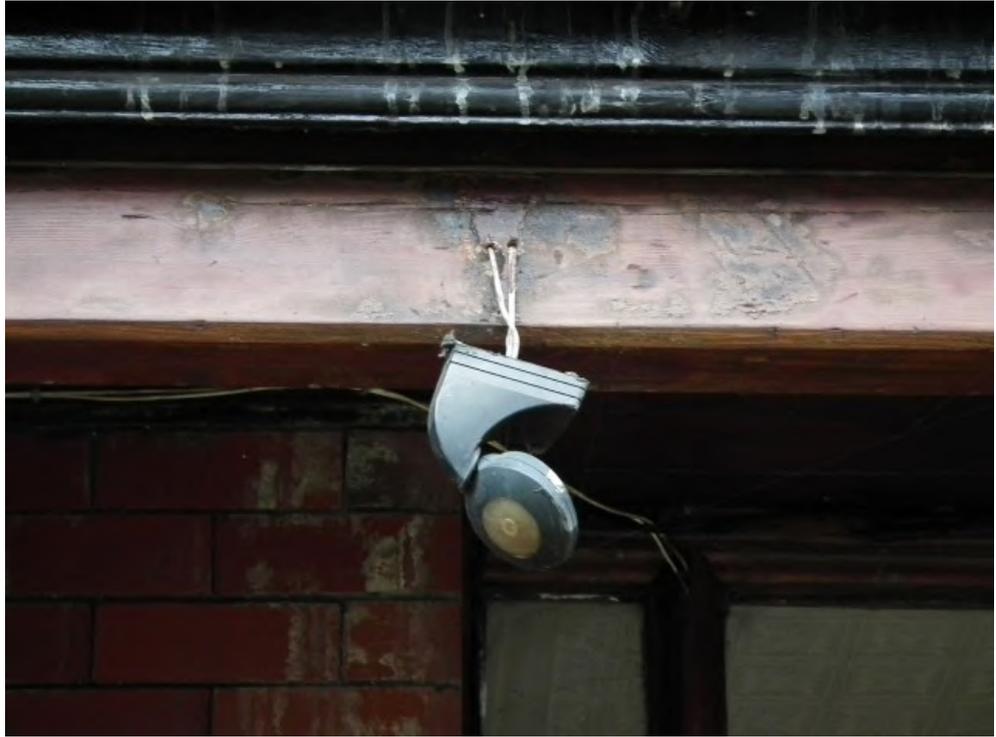
Broken fitting on porch canopy

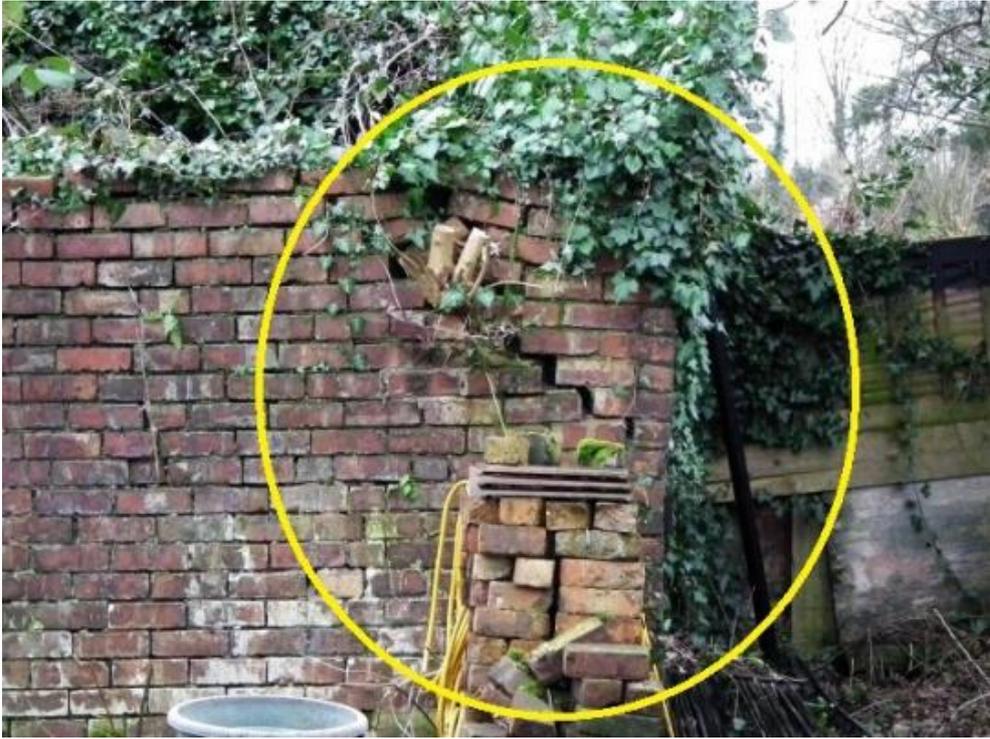
<b>Construction &amp; Type</b>	There is a brick built outhouse in the rear garden. It is unused and has no roof.
<b>Nature of inspection and Limitations</b>	The outhouse was assessed for general condition and was examined externally to identify areas of rot, damage, leaks and other defects.
<b>Condition</b>	The building is completely overgrown by vegetation and the walls have major cracks and displaced brickwork
<b>Action Required</b>	It is recommended to demolish and remove the structure, as the walls are in a dangerous condition. However it could be rebuilt if required. It would require all the vegetation cutting back and a new roof installing plus a new door.

<p>Major cracks in outbuilding</p>

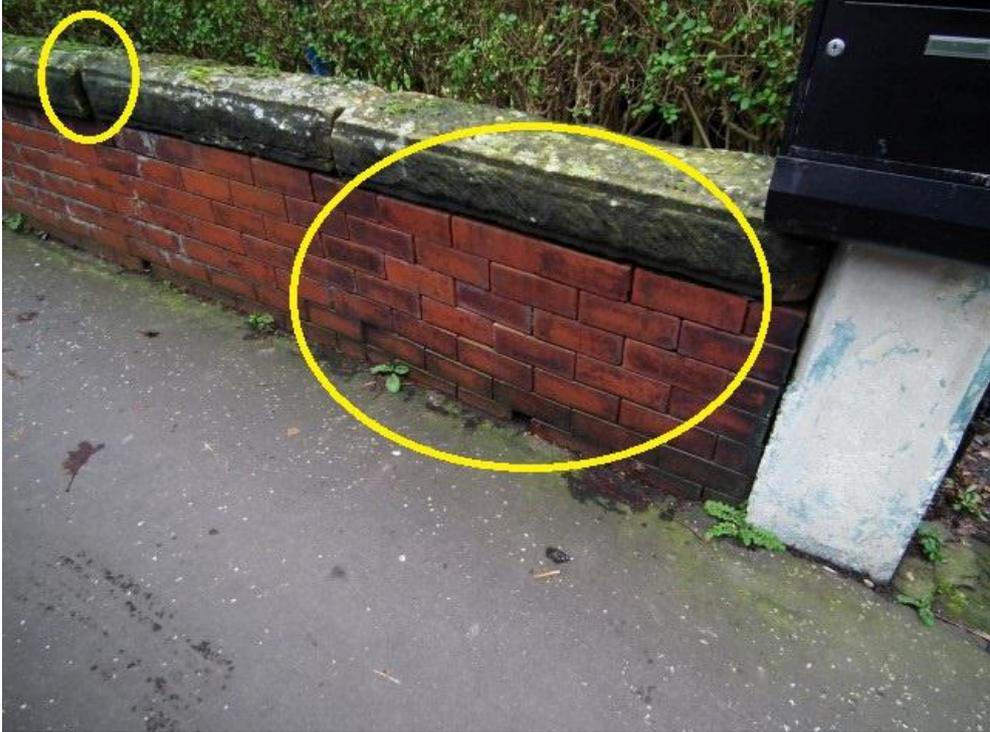
<p>Missing pointing on garden wall</p>

<p><b>Action Required</b></p>	<p>General maintenance is required to several areas around the grounds including new fencing, re-pointing the garden walls, re-laying the patio concrete slabs and repairing the cracked concrete to the front.</p> <p>It is recommended to either remove/renew the broken stone gate post or explore the possibilities of having it properly repaired.</p> <p>Trees and large bushes should be maintained and pruned on a regular basis.</p>

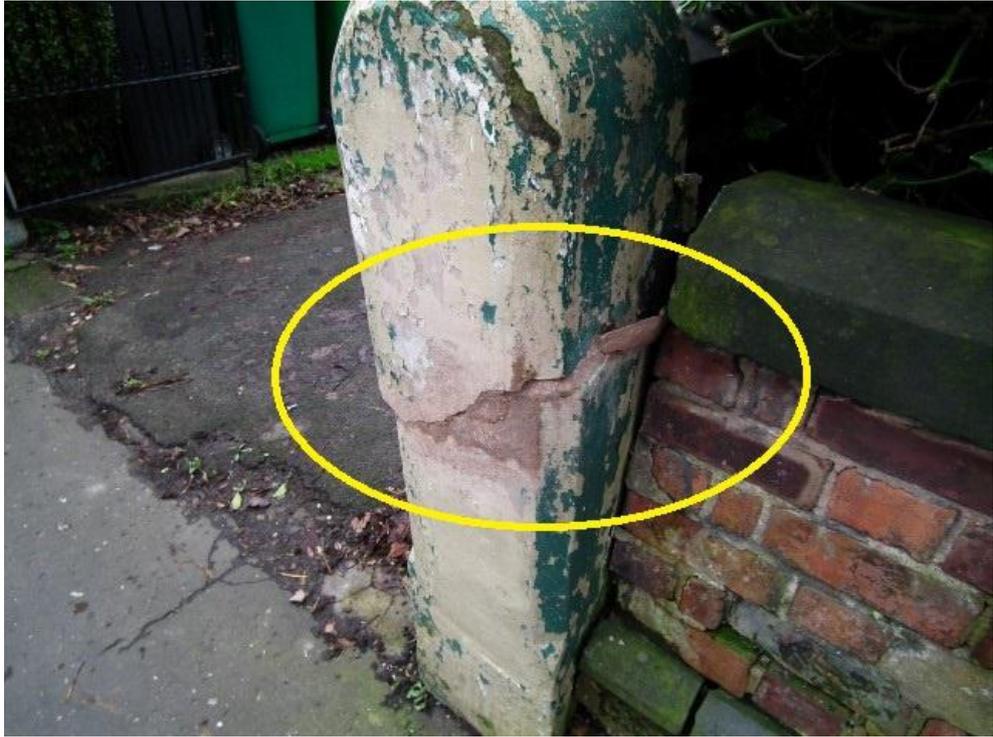
Crack in stone gate post which may be dangerous

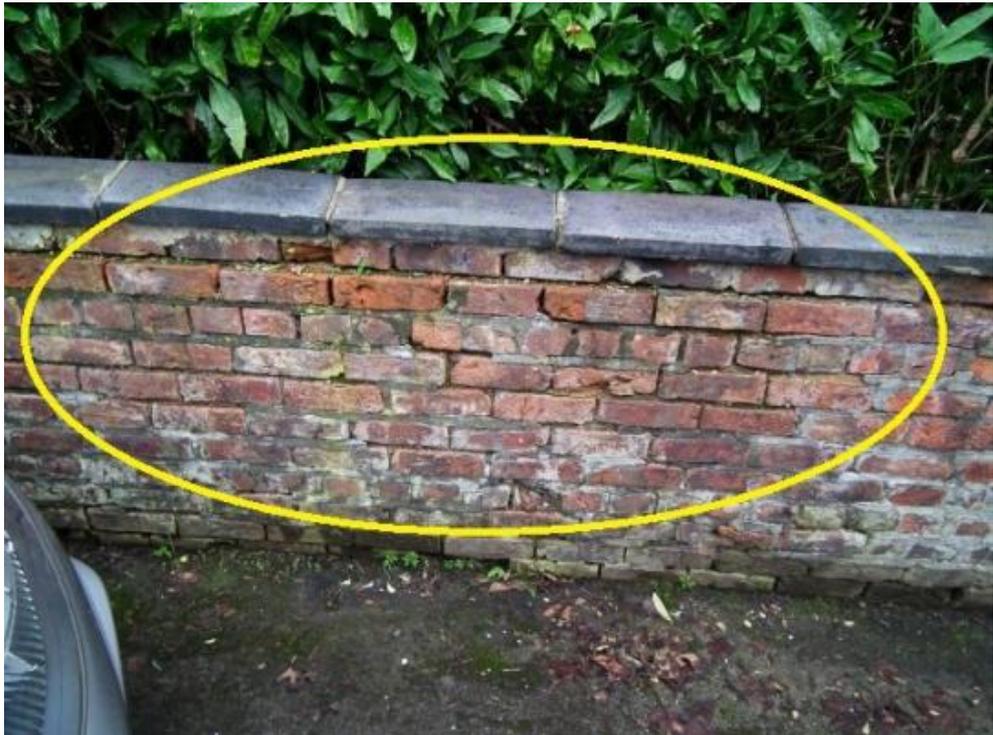
Garden wall in poor condition

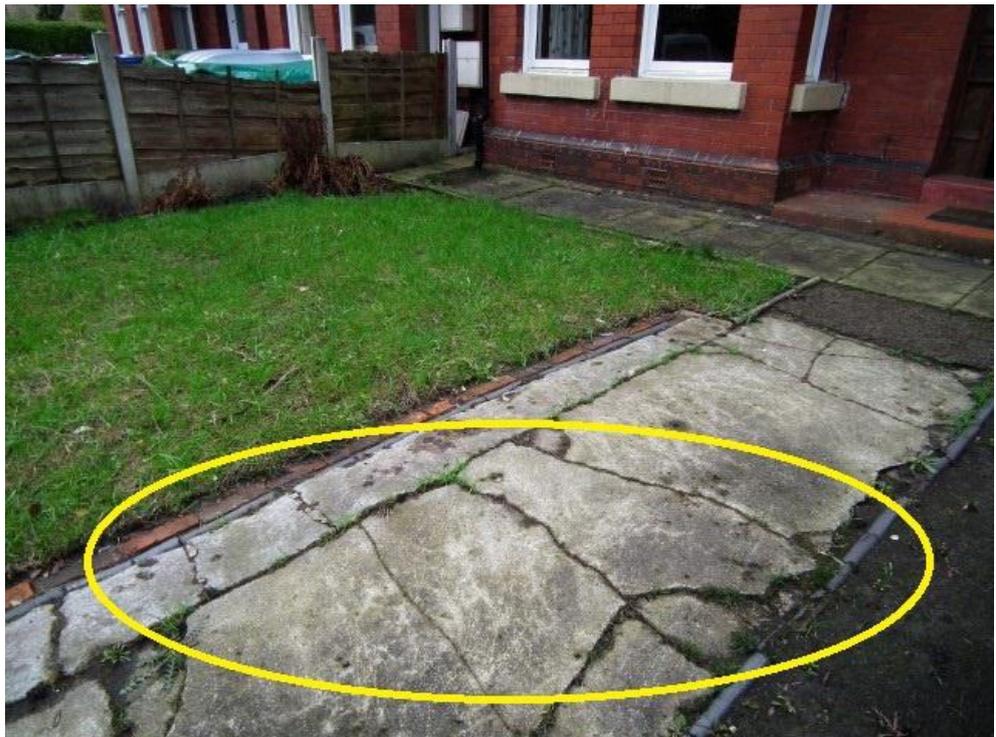
Cracked concrete

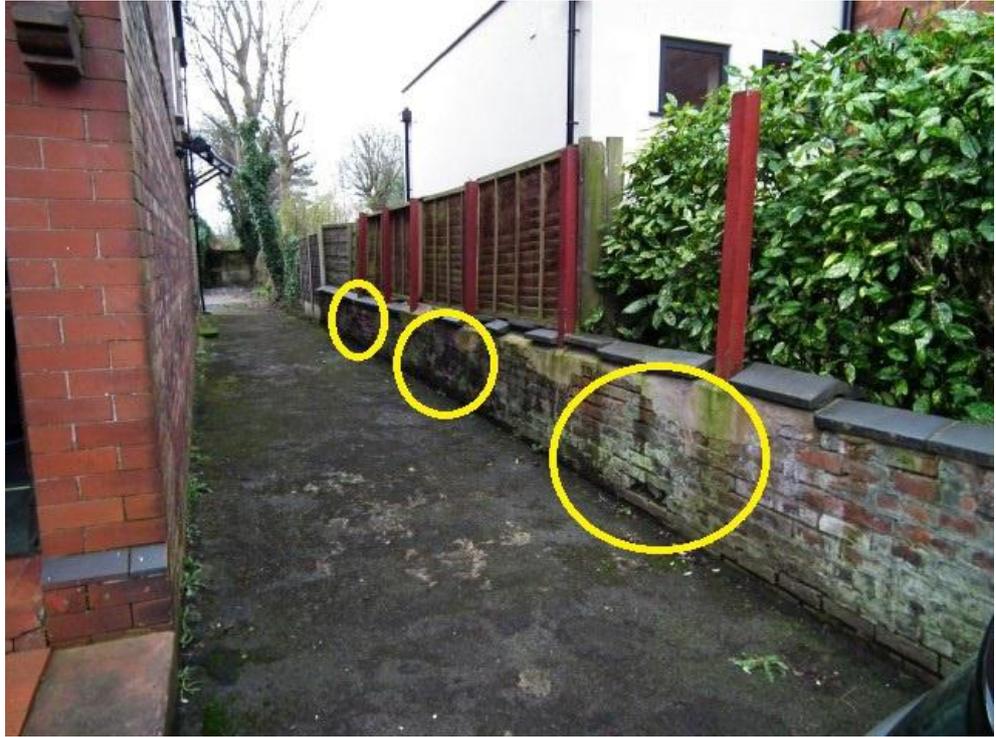
Garden wall in poor condition

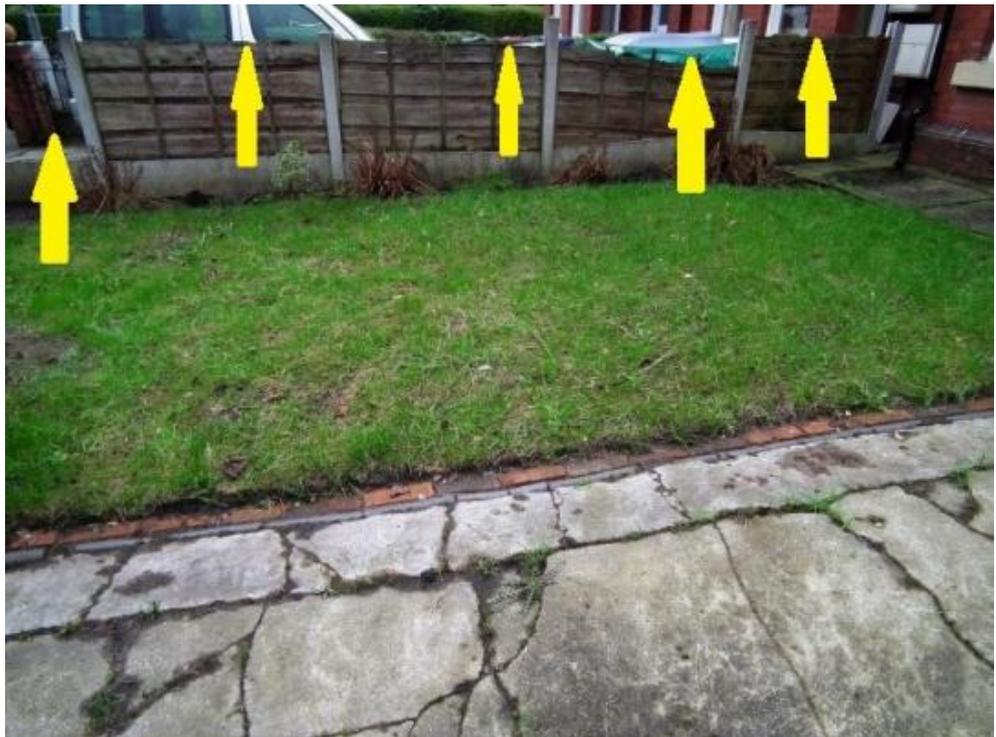
Fence in poor condition

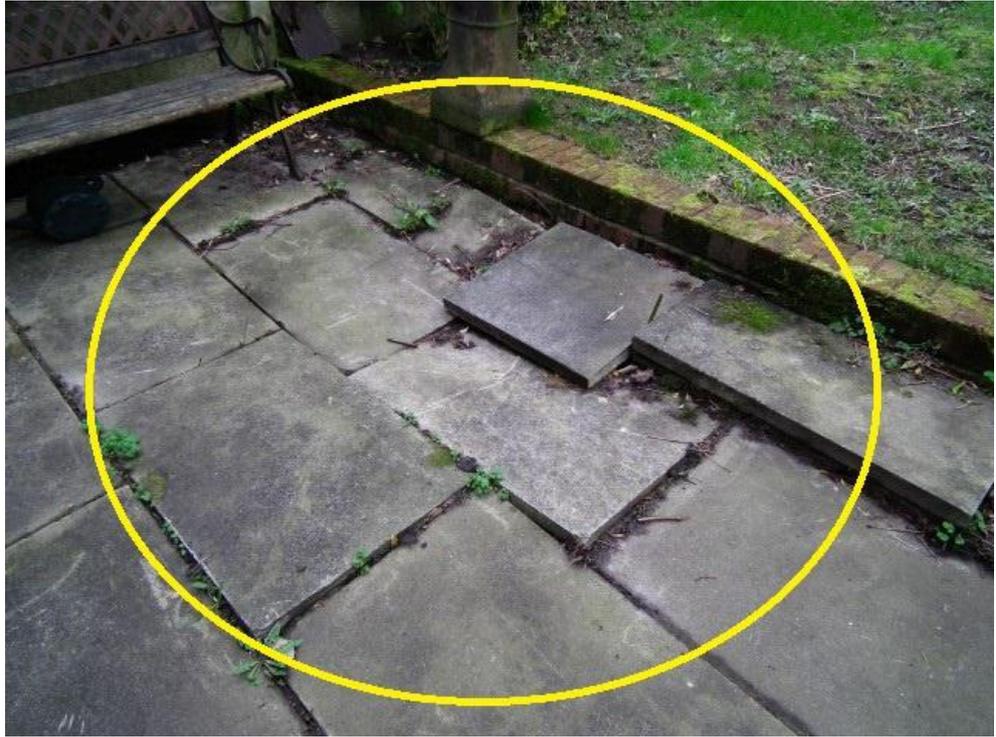
Uneven patio
