Mi HOME BUYER SURVEY

# HOME BUYER SURVEY REPORT

The format of this Mi HOME BUYER SURVEY REPORT is consistent with the guidance note requirements for a Survey Level 2 as defined by RICS Surveys of Residential Property 3rd edition May 2016

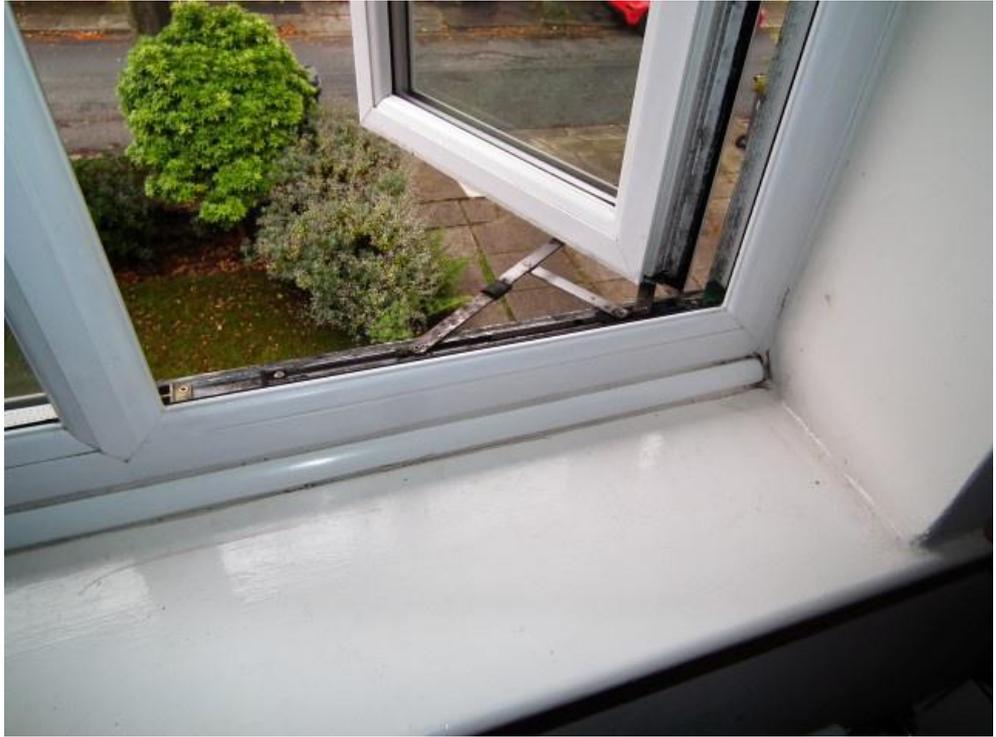
Some windows open fully and can be classed as fire escape windows

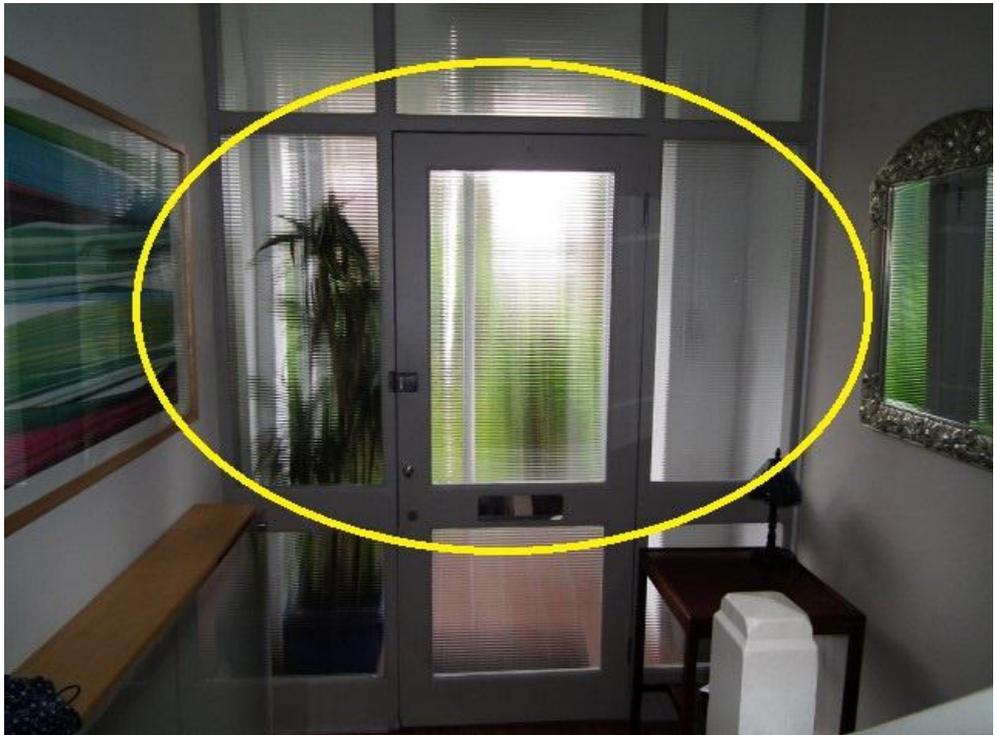
The glass in the internal porch door may not be Safety Glass.

May not be safety glass

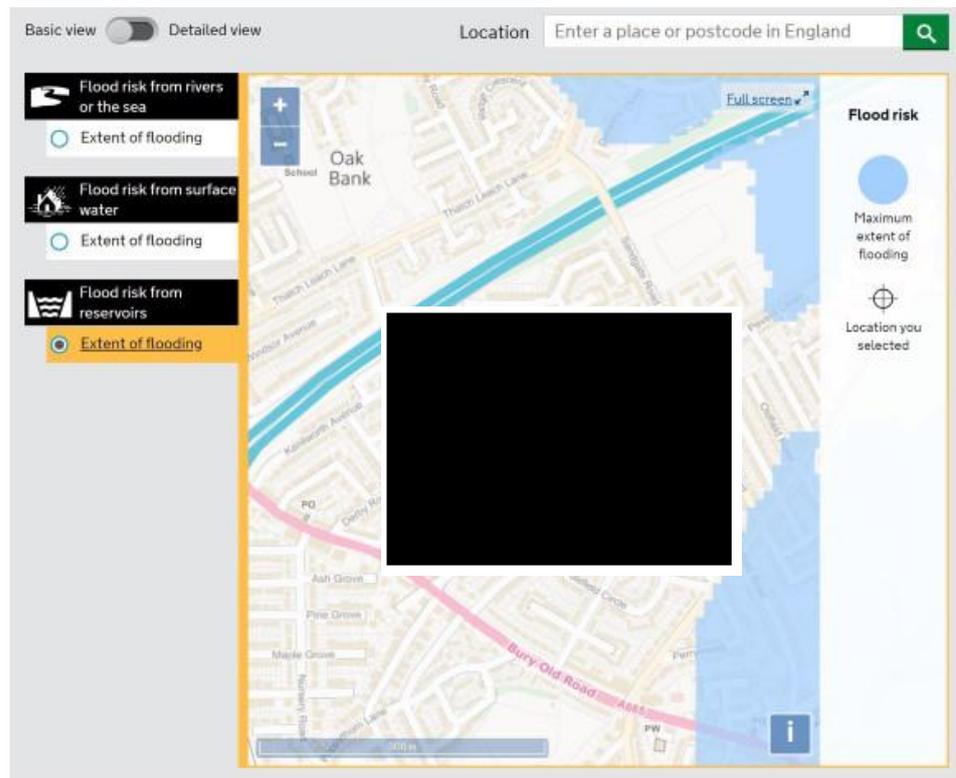
No flood risk

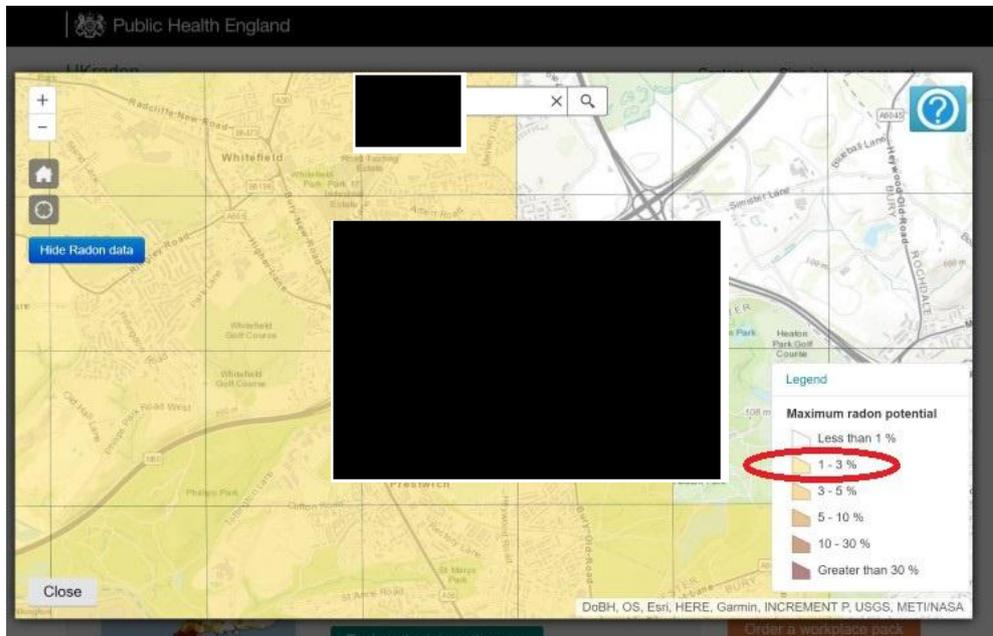
Radon

As the property is in an orange area, it means that there is a 1 - 3% risk and further action needs to be taken. In these cases, UKradon recommends an on-line 'UKradon search'. This is easily arranged and only costs a few pounds.

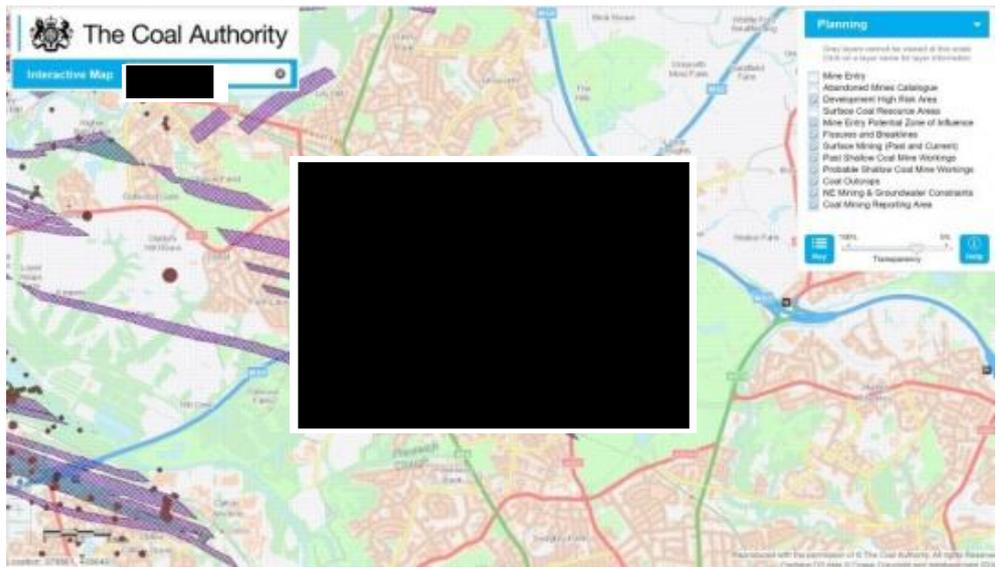
<p><b>Mining</b></p>	<p>The property is in a coal mining reporting area and according to the Coal Authority website, it is in a Development High Risk Area.</p> <p>It is highly recommended to have a Coal Authority search carried out for the property because any previous reports are not transferable.</p> <p>Their reports offer expert advice based on their unique database of coal mining information as well as their vast archive of historical maps and plans. The reports should also be covered by an indemnity insurance policy.</p> <p><a href="https://www.groundstability.com/public/web/home.xhtml">https://www.groundstability.com/public/web/home.xhtml</a></p>

Property is in a Coal Mining reporting area

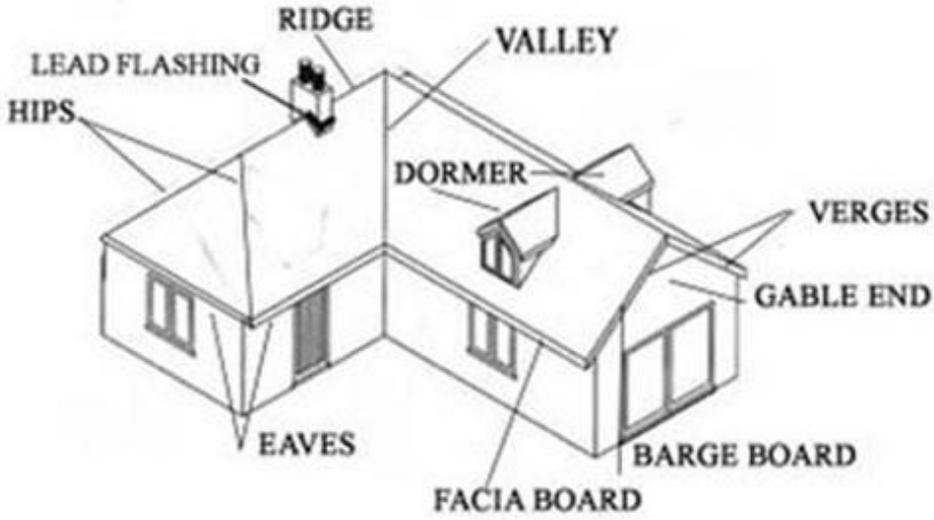
<p style="text-align: center;">Roof Elements</p>

<p><b>Condition</b></p>	<p><b>Pitched Sections</b></p> <p>The top line of ridge tiles is even with no evidence of any undue levels of flexing or bowing. The roof slopes look flat and even with no obvious signs of sagging.</p> <p>The pointing to the roof verge is cracked in places.</p> <p>There are a small number of slipped, chipped and cracked tiles visible on the main roof pitches. The number of damaged tiles is within a normal range for a roof of this type and age and would not significantly affect the performance of the roof at this stage. The tiles noted would benefit though from being replaced</p> <p>There is a large amount of moss growth on the rear slope and the extension roof. Moss retains water which adds weight the to the roof and can also lead to leaks in extreme circumstances</p>

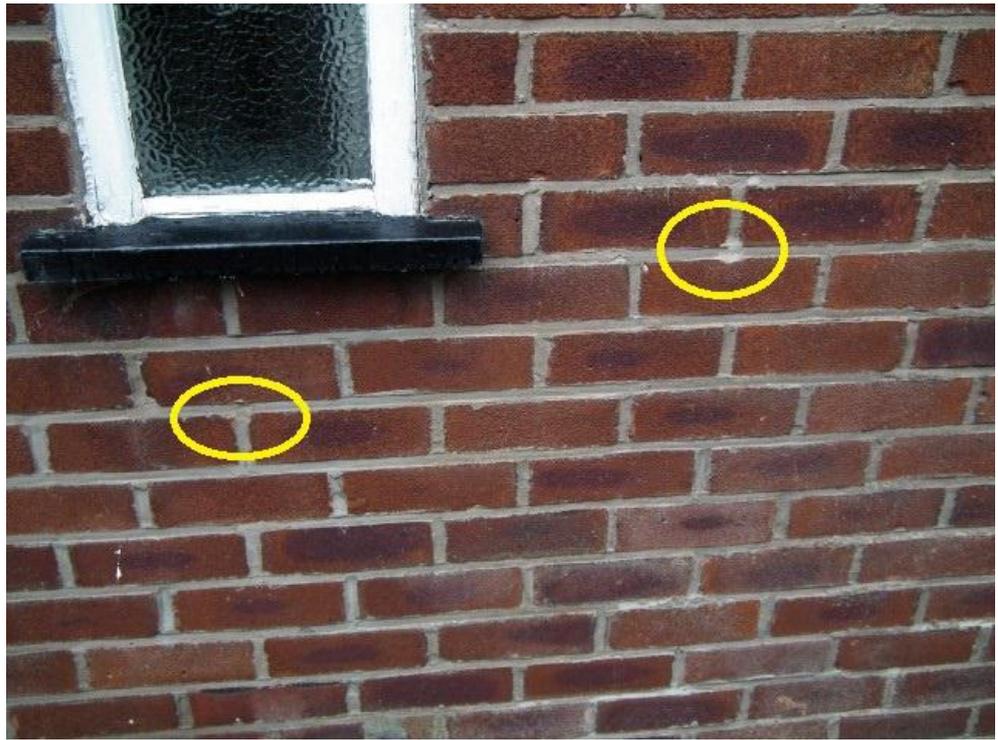
Evidence of cavity wall insulation

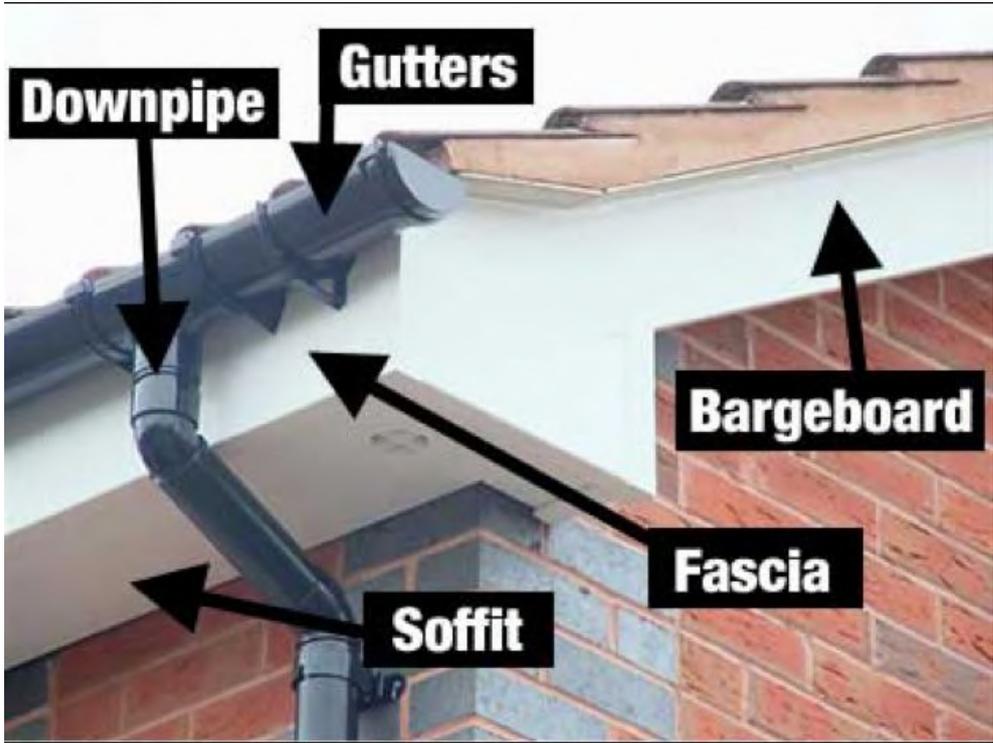
<p style="text-align: center;">Eaves detail</p>

The soffits [panels that link the gutter boards to the walls] do not have ventilation grilles installed to supply cross ventilation to the roof space. (Refer to Section 5.1).

<p><b>Additional Information</b></p>	<p>Advice: The soffits boards [horizontal boards at roof edge] may contain asbestos. Asbestos should not be drilled, sanded or removed without protective equipment and/or specialist advice. See section 3.2.</p>

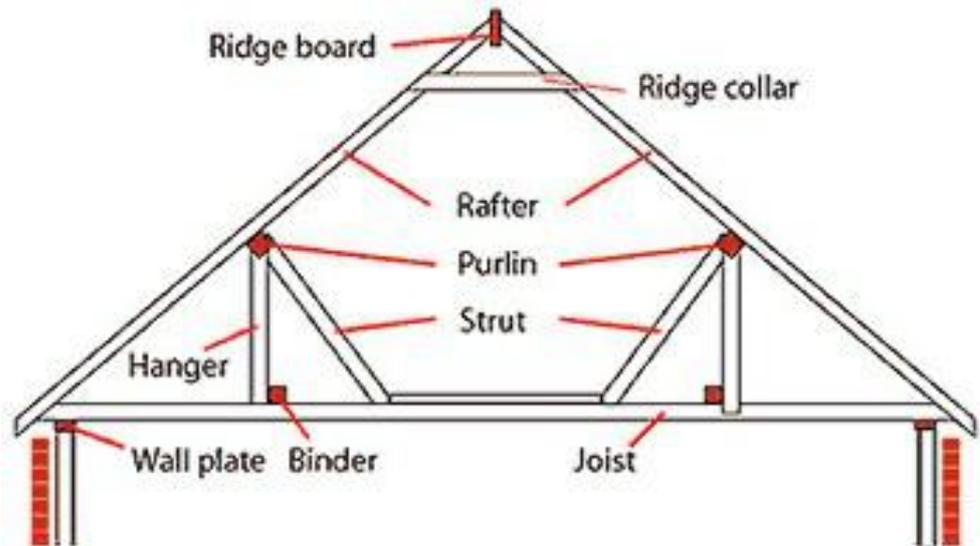
The loft insulation has been pushed into the eaves in places which will restrict the ventilation further in those areas.

There are holes in the Party wall (refer to 3.2)

Traditional roof construction

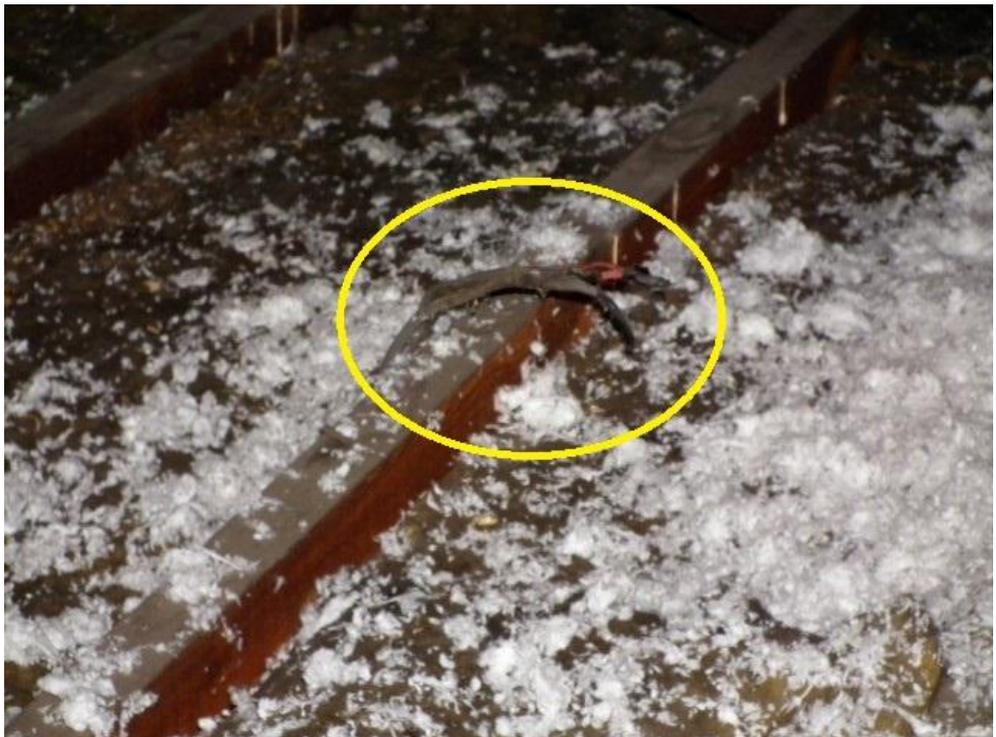
Possible live wiring in loft

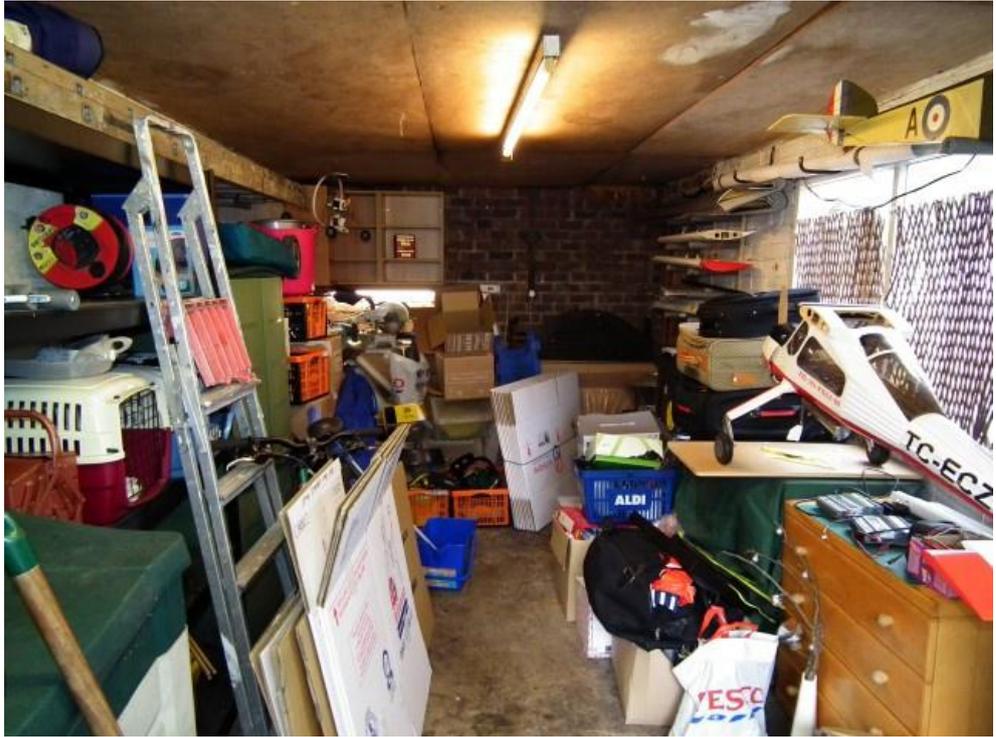
The panelling on the double doors are bowing outwards, the timber window frame is showing signs of decay and there are some minor cracks in the pointing of the brickwork in places.

Garage is full of storage
