# BUILDING SURVEY REPORT

CLIENT  
PROPERTY

The format of this MiBuilding Survey Report is consistent with the guidance note requirements for a Survey Level 3 as defined by RICS Surveys of Residential Property 3rd edition May 2016

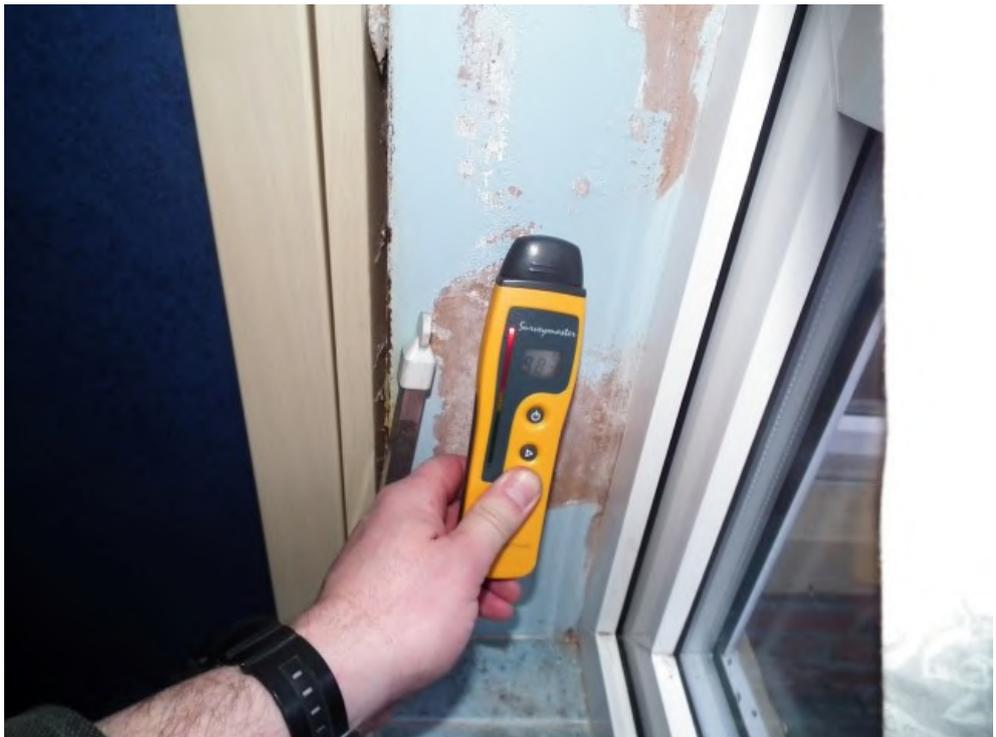
High damp readings on internal walls of first floor bathroom

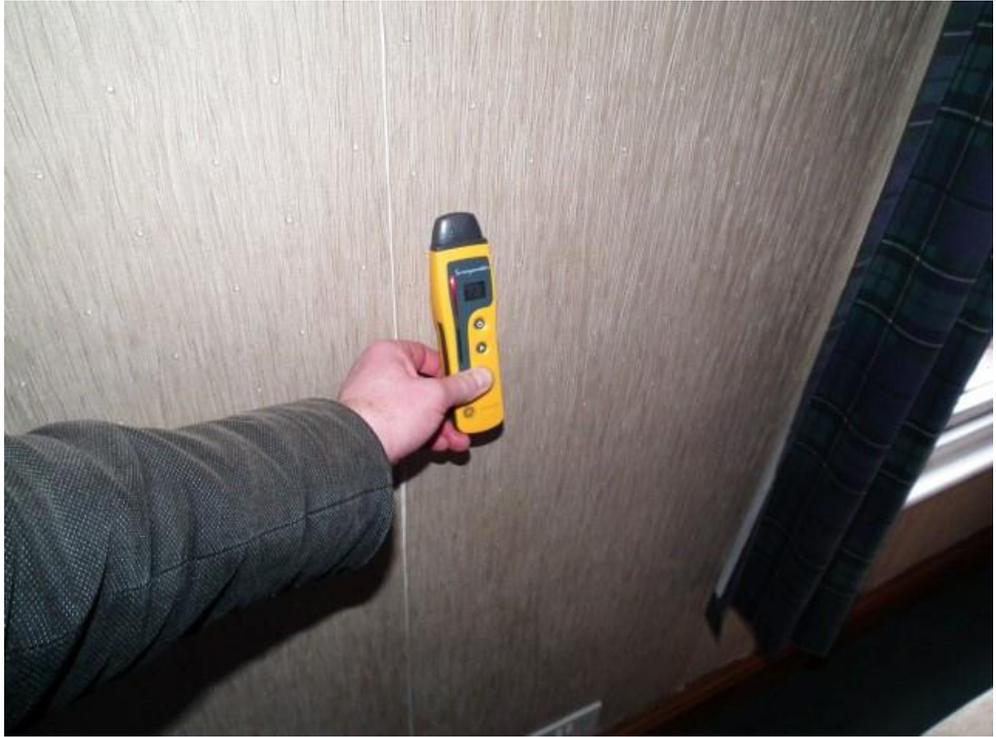
High damp readings on side elevation

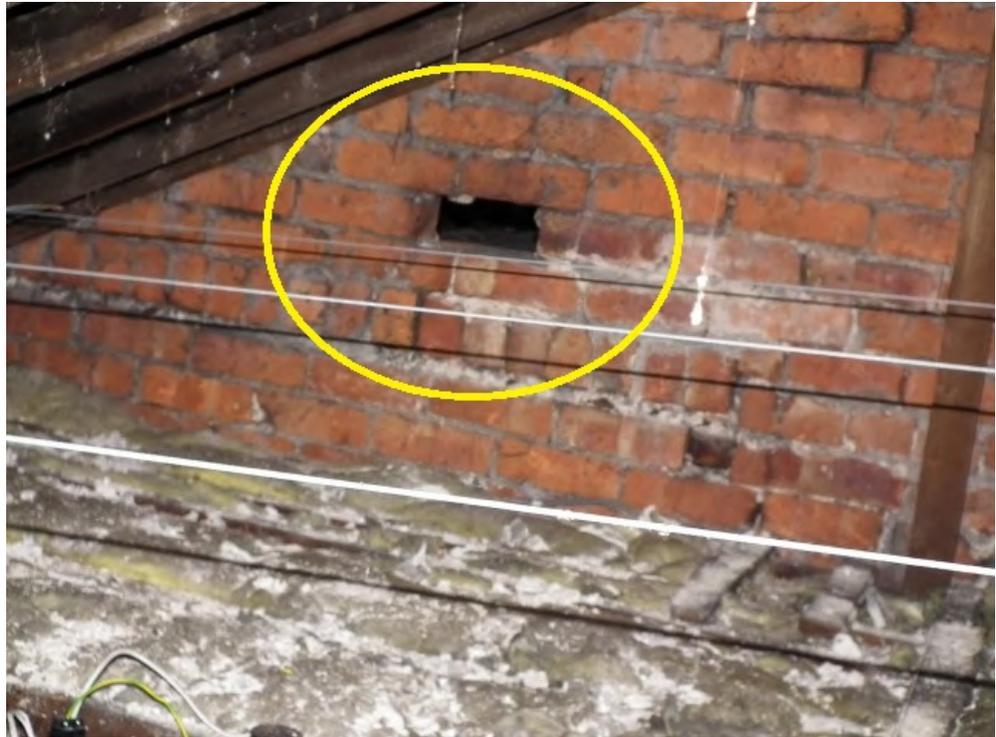
There are gaps in the Party Wall in the loft space that could increase the risk of fire spread should one occur

Gaps in Party Wall

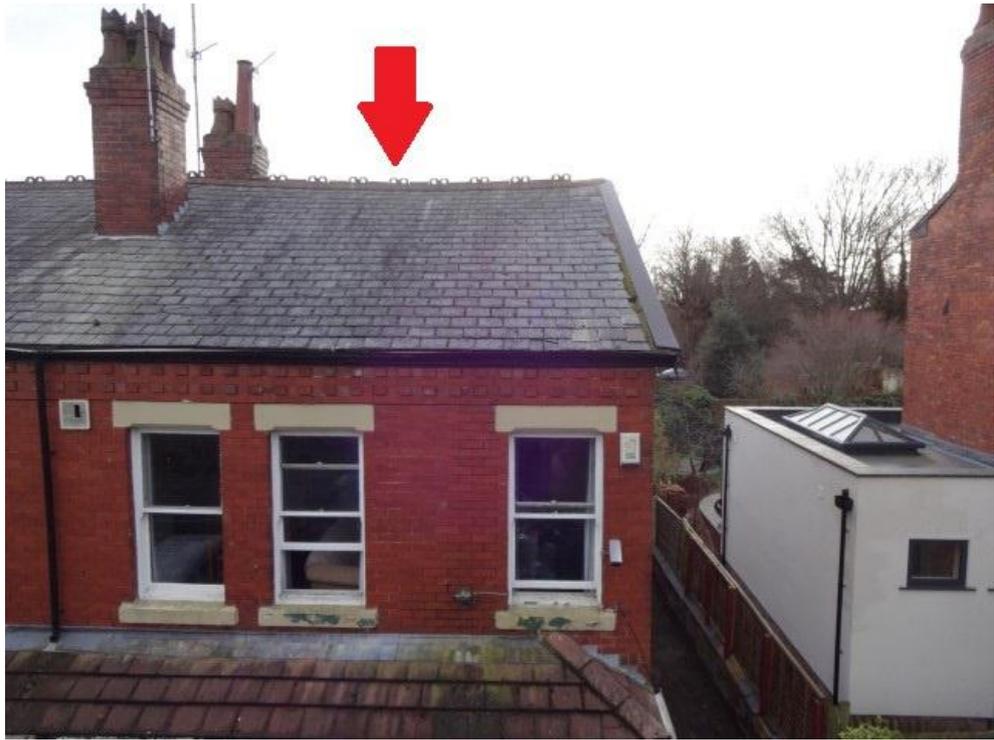
<b>Construction &amp; Type</b>	The main roof slopes are pitched and covered with natural slate. Ridge tiles are clay, the valley gutters are lined with lead.
<b>Nature of inspection and Limitations</b>	The roof pitches were examined from ground level with the aid of a high zoom camera and using a pole camera, where necessary for possible defects including sagging, collapse, broken/missing/damaged tiles, holes, and other evidence of failure.
<b>Condition</b>	<p><b>Pitched Sections</b> The ridge of the front section of roof is sagging.</p> <p>The majority of the pointing to the ridge tiles is missing. There are a several slipped, broken or missing slates on all slopes and holes are visible. The condition of the roof covering is causing high moisture levels in many of the roof timber and this could also be contributing to the sagging ridge.</p> <p>The porch canopy roof has some cracked tiles.</p>

Ridge of main roof is sagging

<b>Action Required</b>	<p>It is recommended to have the roof completely recovered, with the same type of natural slate in use at the moment. Concrete tiles are a lot cheaper to buy but are also a lot heavier. Concrete tiles could triple the weight of the roof, which could cause serious damage to the roof structure. Also it may be necessary to replace some of the timbers.</p> <p>You should carry out a thorough visual inspection at least once a year, ideally in the Spring to identify and repair any damage that could have been caused by winter weather. Any missing mortar at the verges and beneath any hip or ridge tiles should be replaced. Any moss or other accumulated plant matter should be cleared</p>

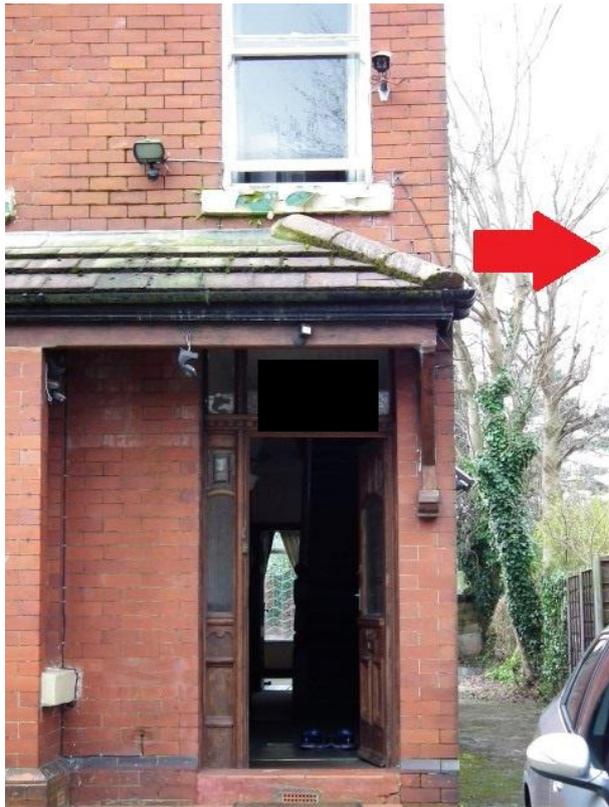
<p><b>Structural</b></p>	<p>There is evidence to suggest that the side elevation has subsided slightly and most of the wall is bowing outwards at first floor level. Refer to 4.4</p>
<p><b>Health &amp; Safety related matters</b></p>	<p>There is no evidence of recent inspection of the electrical or heating systems, but certification may be available. See also 6.1 and 6.2.</p>

Side elevation is bowing outwards at first floor level

<p><b>Action Required</b></p>	<p>It is suspected that the subsidence is historic and therefore not ongoing. However the lack of lateral restraint on the side elevation may allow the wall to continue bowing if it is not rectified. Additional lateral restraint is required along the side elevation to prevent further movement. This involves drilling into the walls to tie the the floor joists to the wall in several places, or alternatively it can be carried out internally by lifting the floorboards and installing tie bars to the joist/wall junction point. There are companies available that specialise in these kind of repairs.</p> <p>The areas of missing and cracked pointing need to be racked out to a depth of 25mm and re-pointed with lime mortar.</p> <p>Walls should be examined regularly to inspect for changes in the nature of any cracking or other defects that may become apparent.</p>

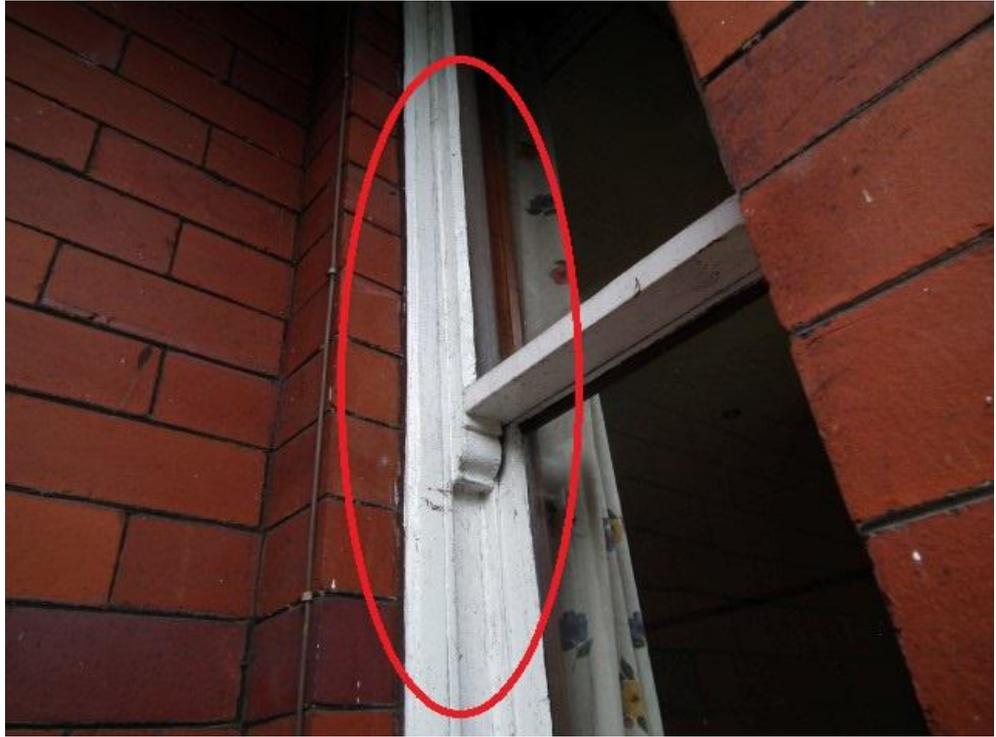
Sash windows are unlikely to open because of paint

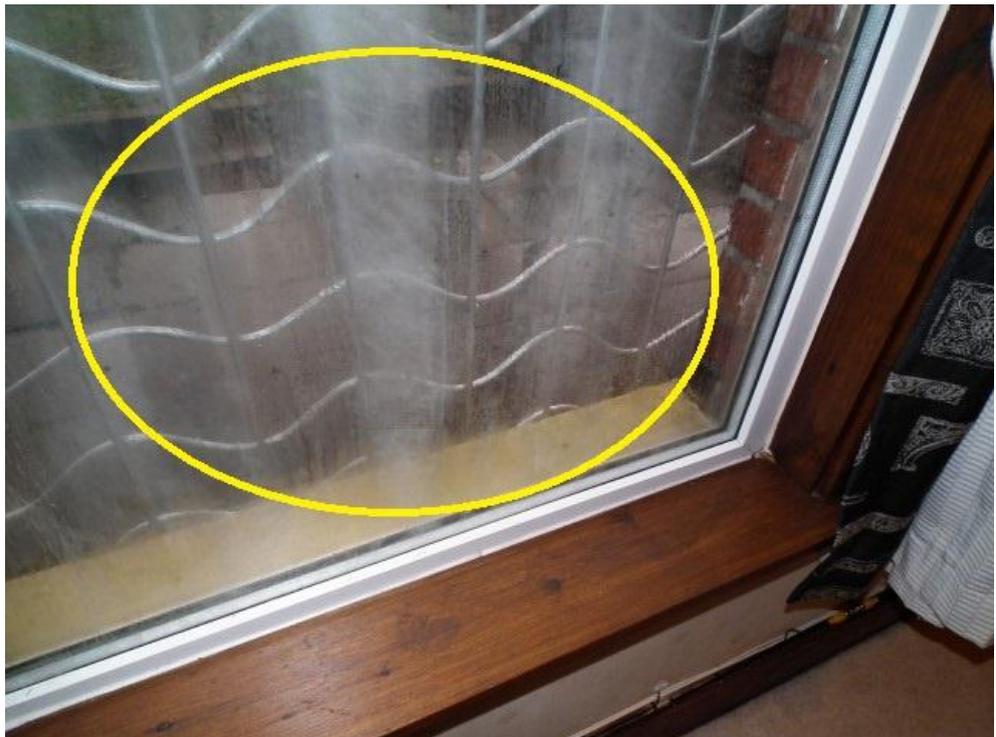
Condensation inside double glazing

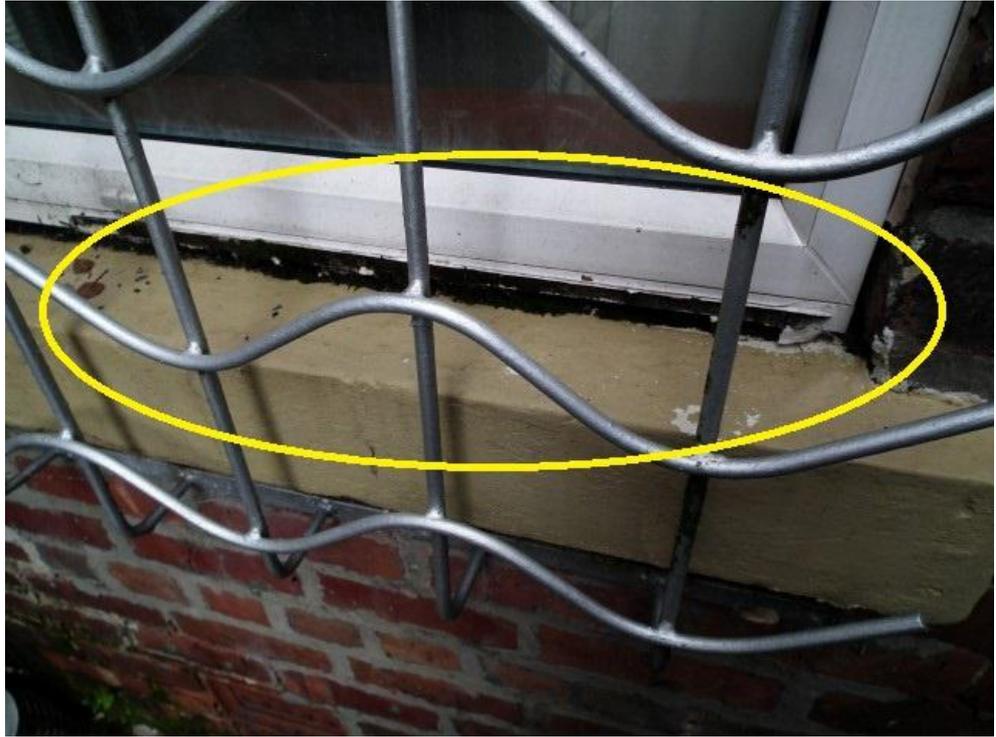
plastic sill has been removed from a rear window

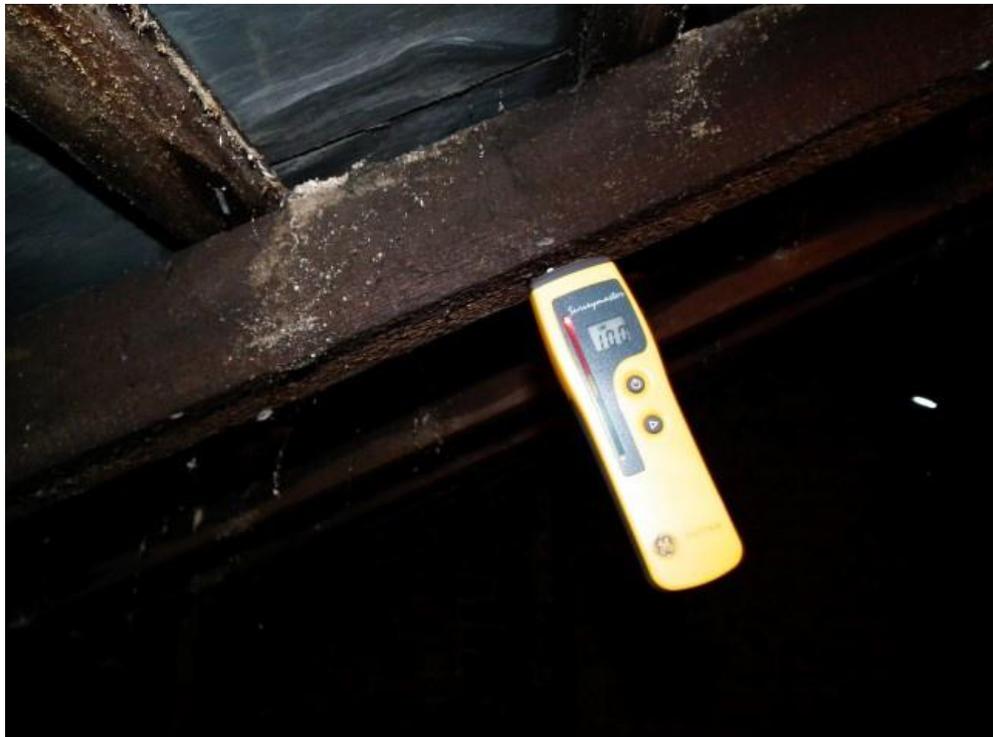
Extremely high damp readings in some rafters

<p><b>Action Required</b></p>	<p>Ventilation must be installed to allow the moisture to evaporate and prevent rot in the timbers. Vents can be installed in the gable walls, the roof slopes or at the roof ridge, but it is recommended to provide a selection of all three to maximise the cross ventilation in the roof space. The areas where white mold is forming will need treating with an appropriate fungicide and the support for the additional brick column should be checked to ensure it is resting on a load bearing wall.</p> <p>It is recommended to have the gaps in the Party Wall filled to reduce the chance of fire spread should one occur. This can be done with cement mortar or fire retardant expanding foam. (Normal expanding foam is not suitable for this purpose, it must be fire retardant)</p> <p>Regularly monitor timbers for evidence of wood boring insects and other such infestations.</p> <p>Care should be taken when moving around, or storing heavy objects, in the roof space. The spaces between the floor joists will not support a persons weight, or that of large boxes etc. Where heavy items are to be stored it is important to distribute the weight evenly using fixed boards. Additional structural support may be required if you plan to store large quantities of heavy items in the roof space.</p>

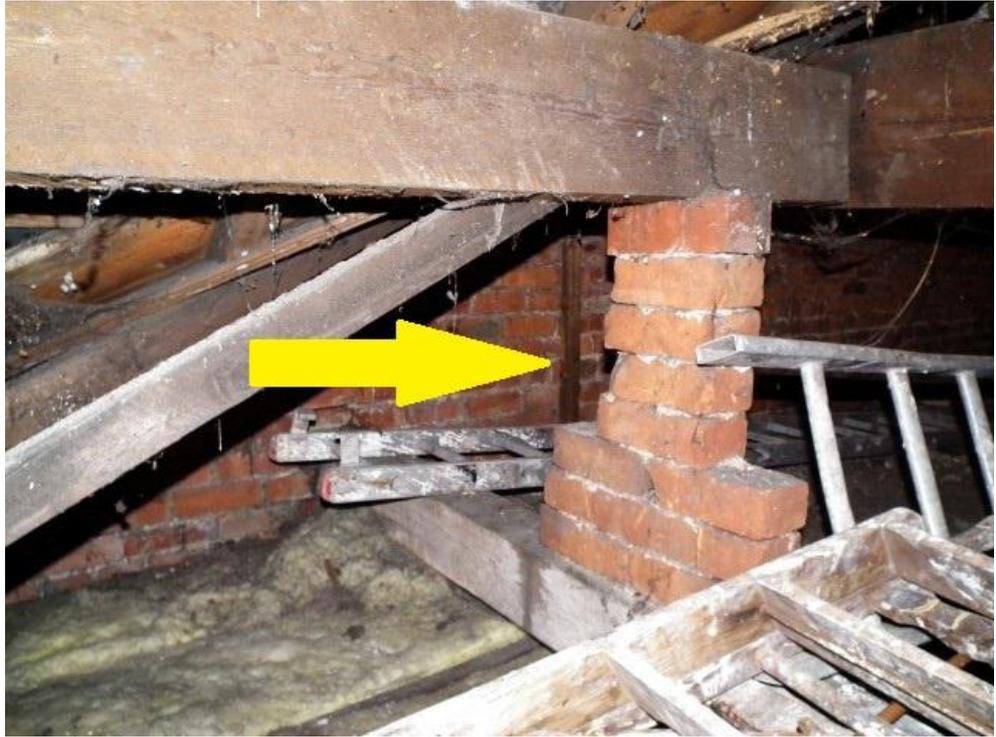
Brickwork added to support roof timbers

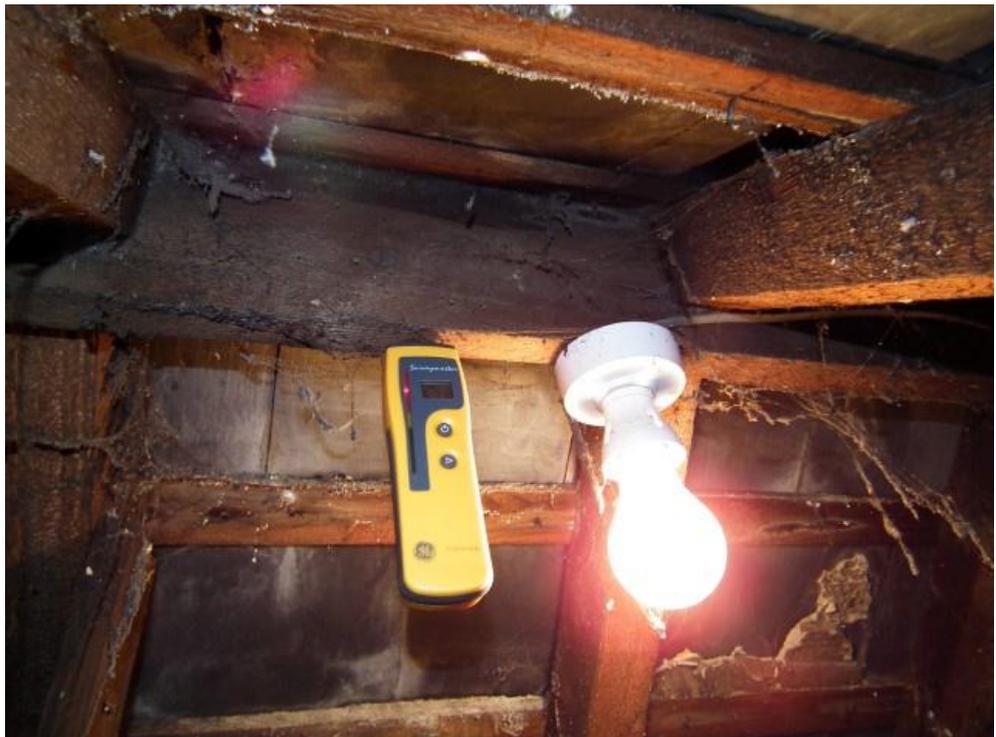
High damp readings in roof timbers

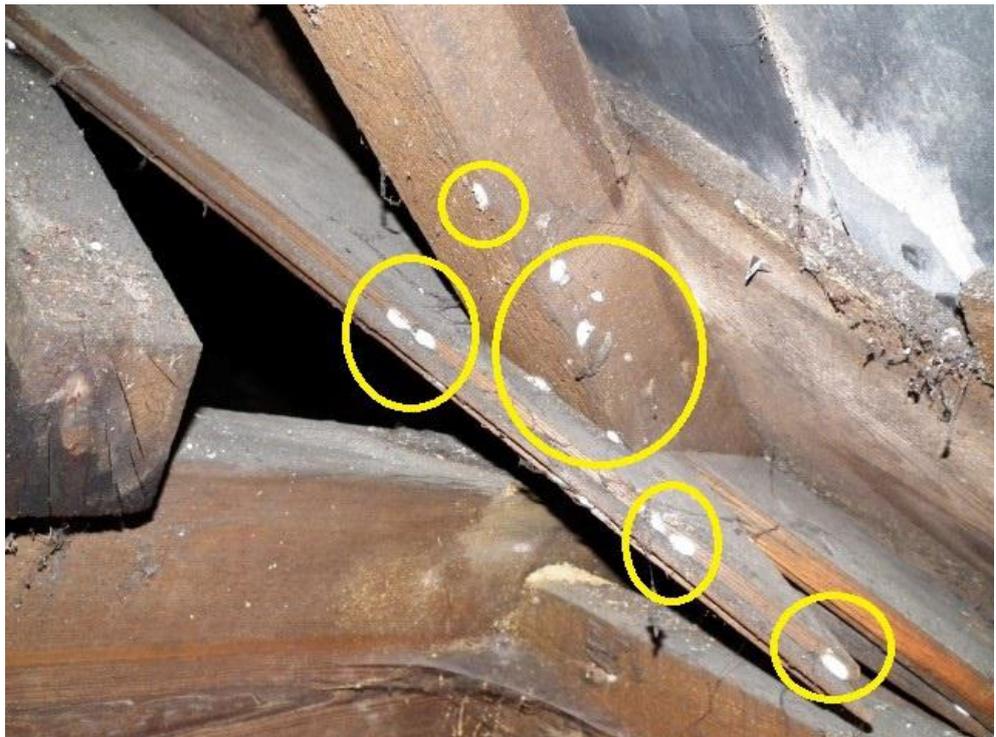
<p><b>Condition</b></p>	<p>There is inadequate ventilation in the roof space. This can be seen on several timbers where white mold is beginning to form. The loft insulation has been pushed into the eaves in several places which will restrict ventilation further. There is evidence of water penetration where the chimney meets the roof slopes and in several other areas, where there are excessively high damp readings in many of the roof timbers and some are visibly wet. There are several holes visible in the roof covering that will be contributing to the high moisture content in the roof (refer to sections 4.1 and 4.2). There are holes in Party wall (refer to section 3.2)</p> <p>The piece of timber that is supporting the brick column (which is supporting the purlin) should span from external wall to the load bearing wall of the hallway beneath, but this could not be checked at the time of the inspection due to the storage in that area.</p> <p>Spot lights have been installed in the ceilings of the rooms below and can be seen in the loft. This type of light fitting should have fire retardant covers installed to protect the insulation from the hot fittings.</p> <p>The roof space is laid with about 100mm of wool type insulation at joist level. Increasing the thickness to the current recommendation of 270mm is advised for maximum energy efficiency</p>

Evidence of white mold beginning to form in roof

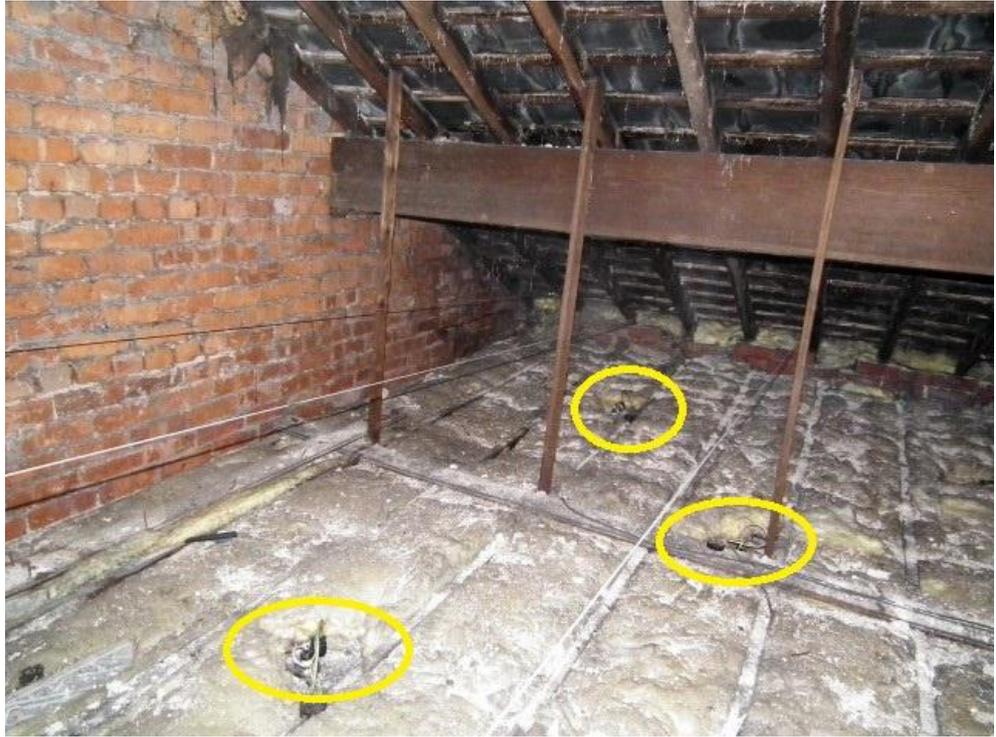
Light fittings should be covered with fire retardant covers

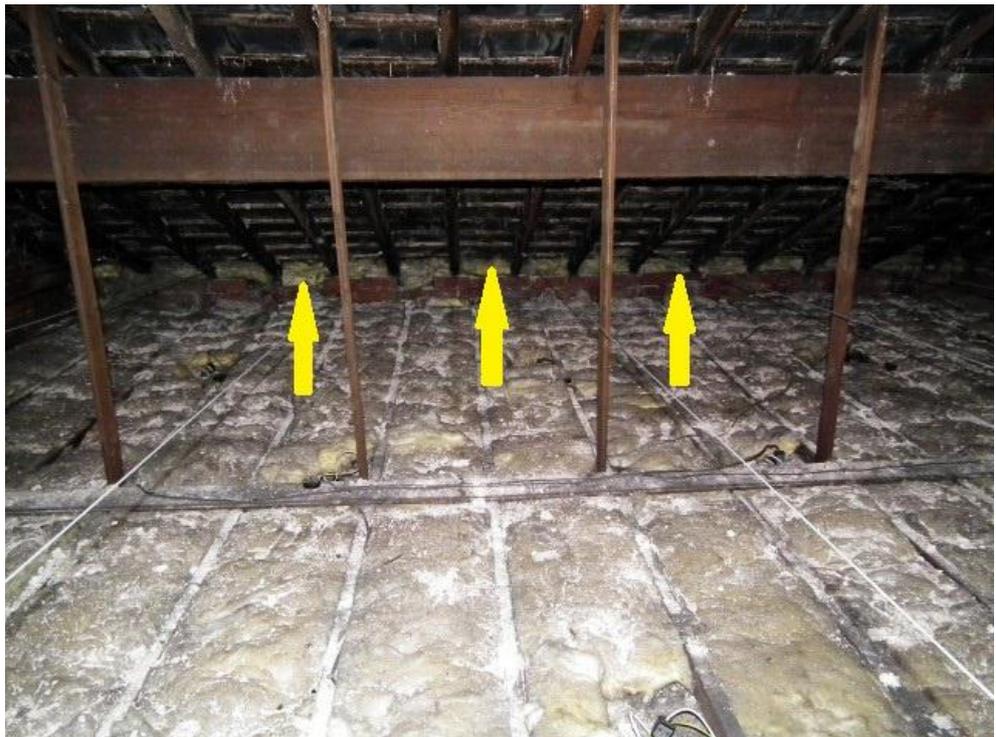
Insulation pushed into eaves

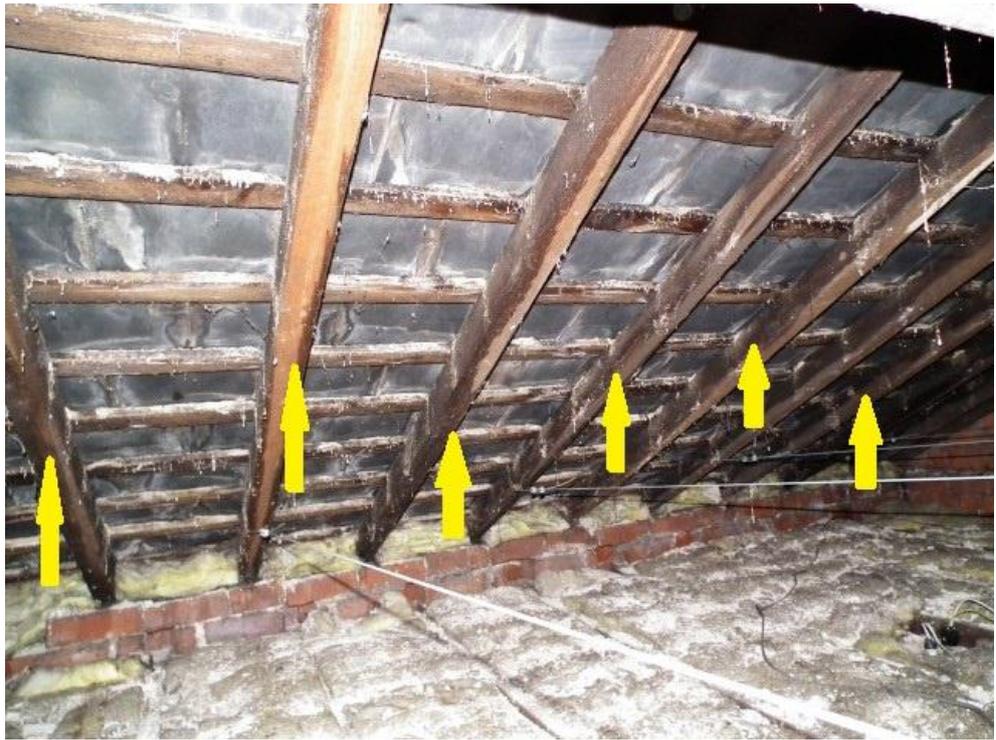
Roof timbers are visibly wet

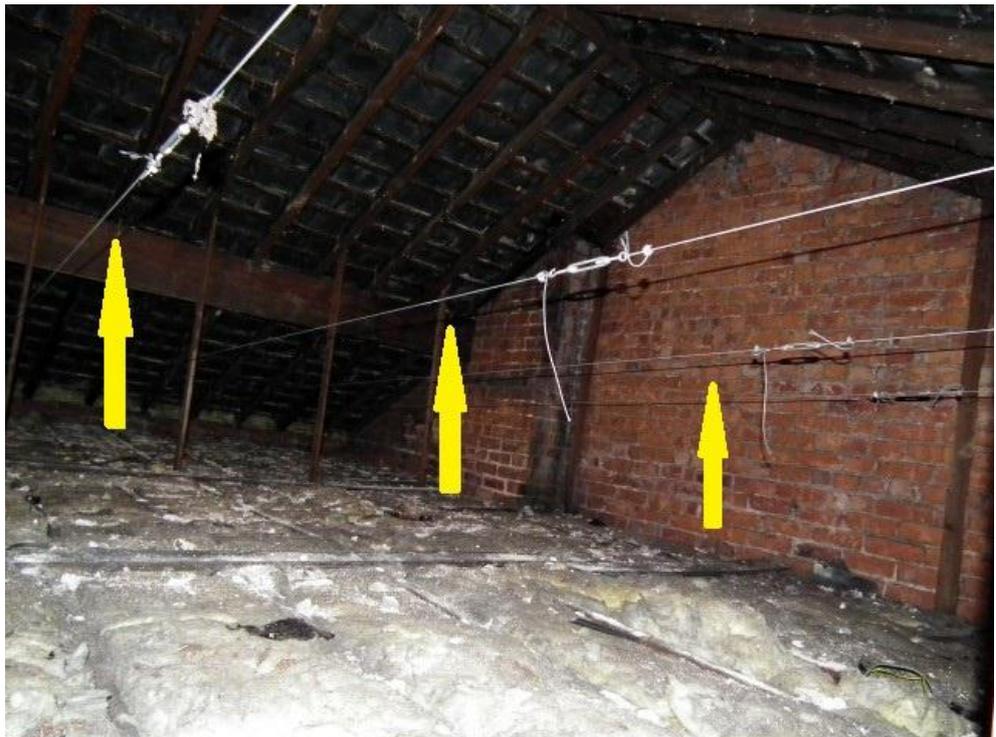
Cables added to prevent roof spread

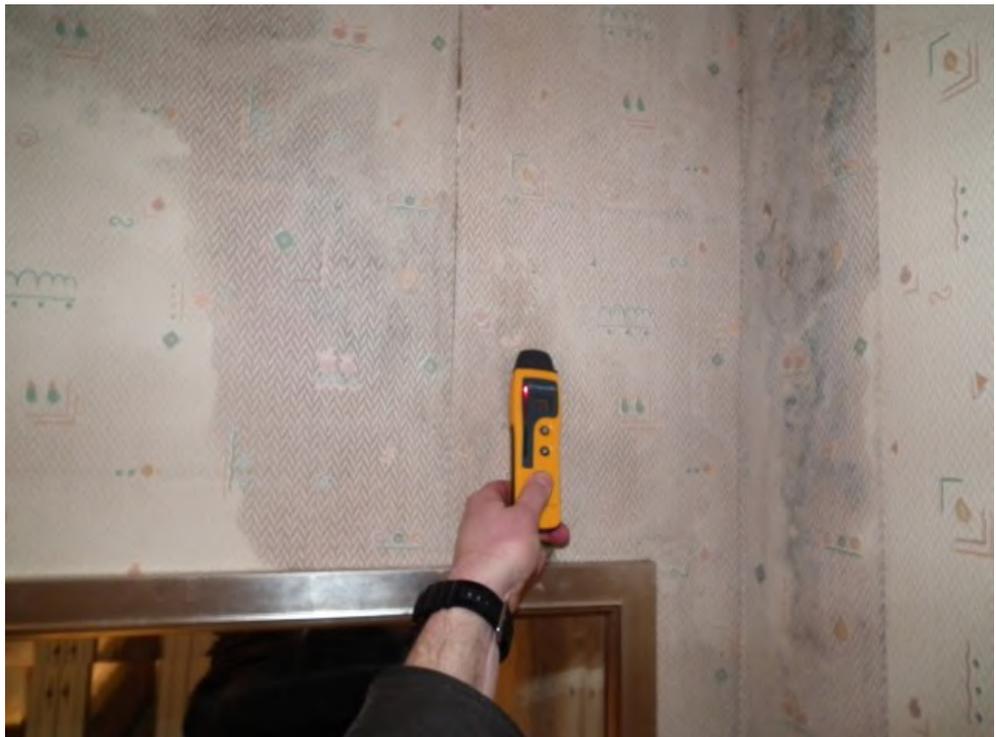
High damp readings

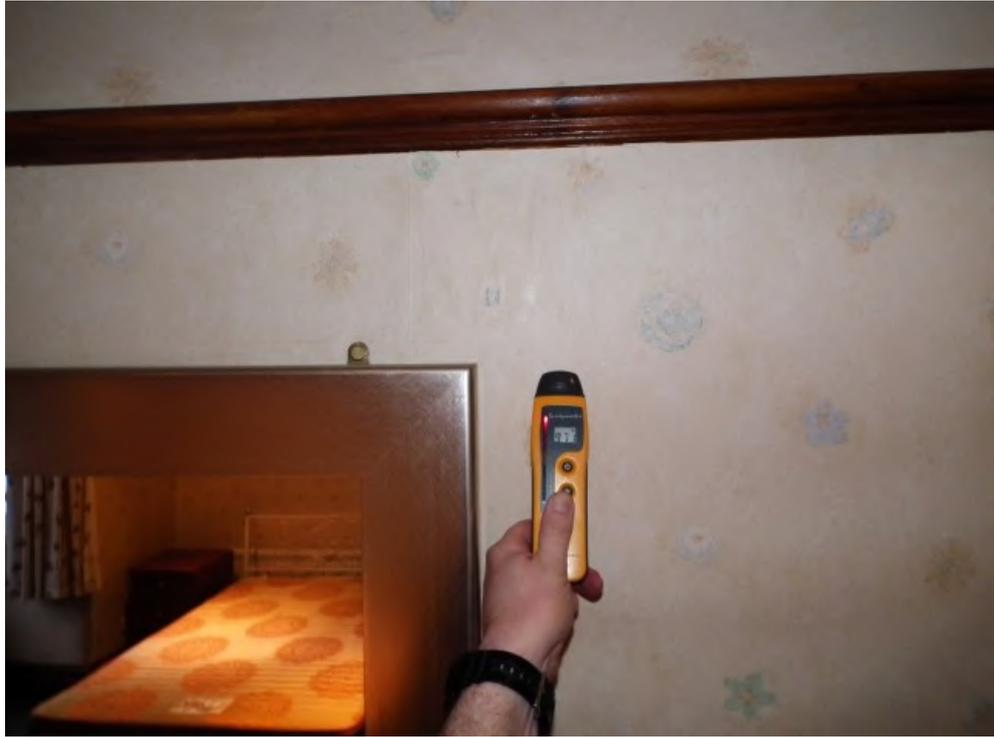
High damp readings of ground floor front room

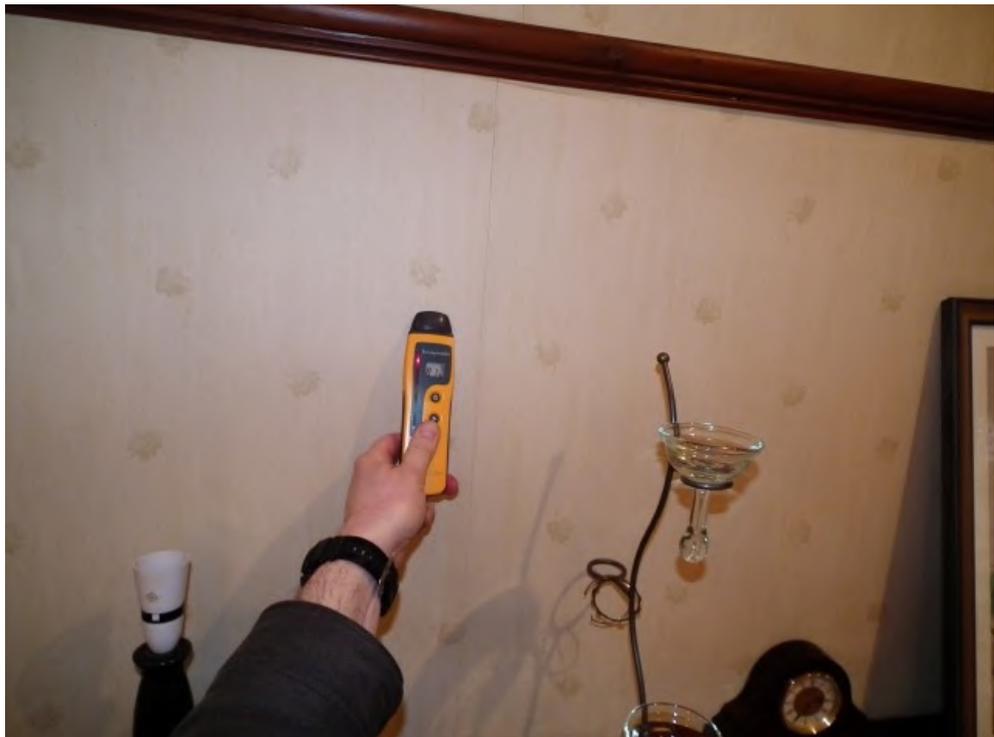
High damp readings in chimney breast in kitchen diner

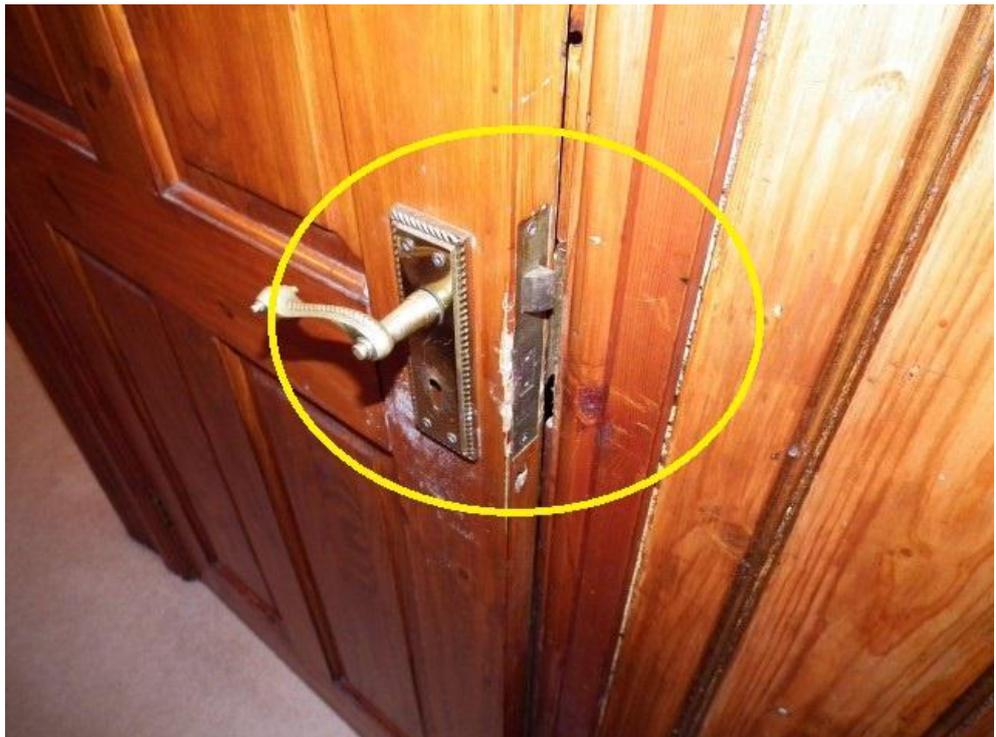
Door for under stairs cupboard will not close and latch is incorrectly fitted

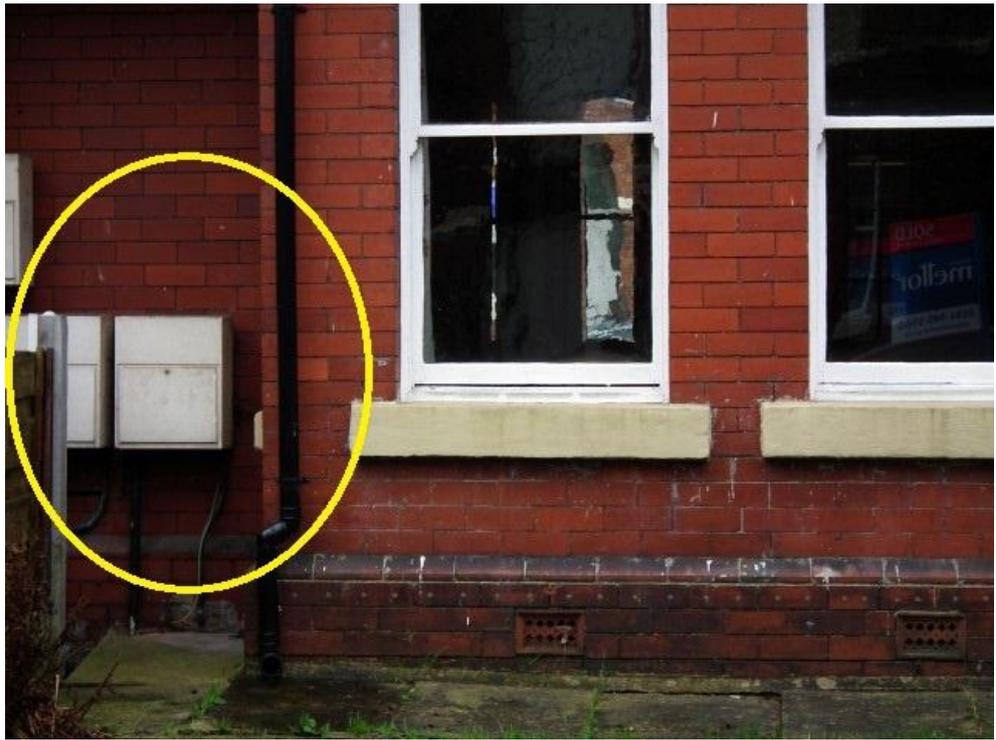
Location of gas meter

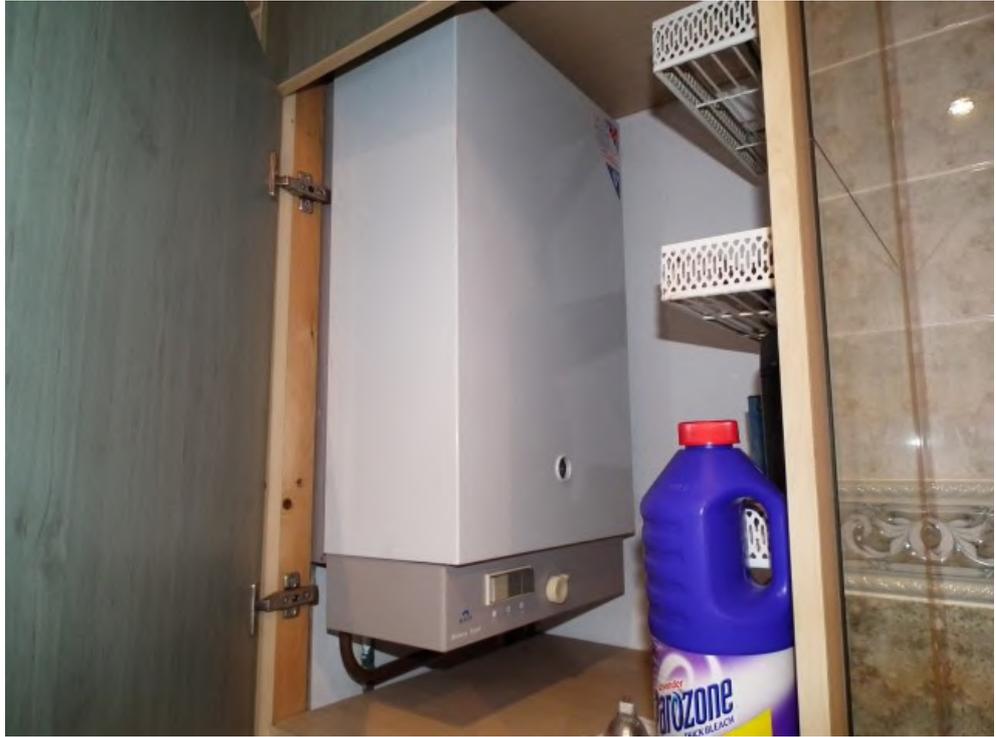
Location of domestic hot water boiler

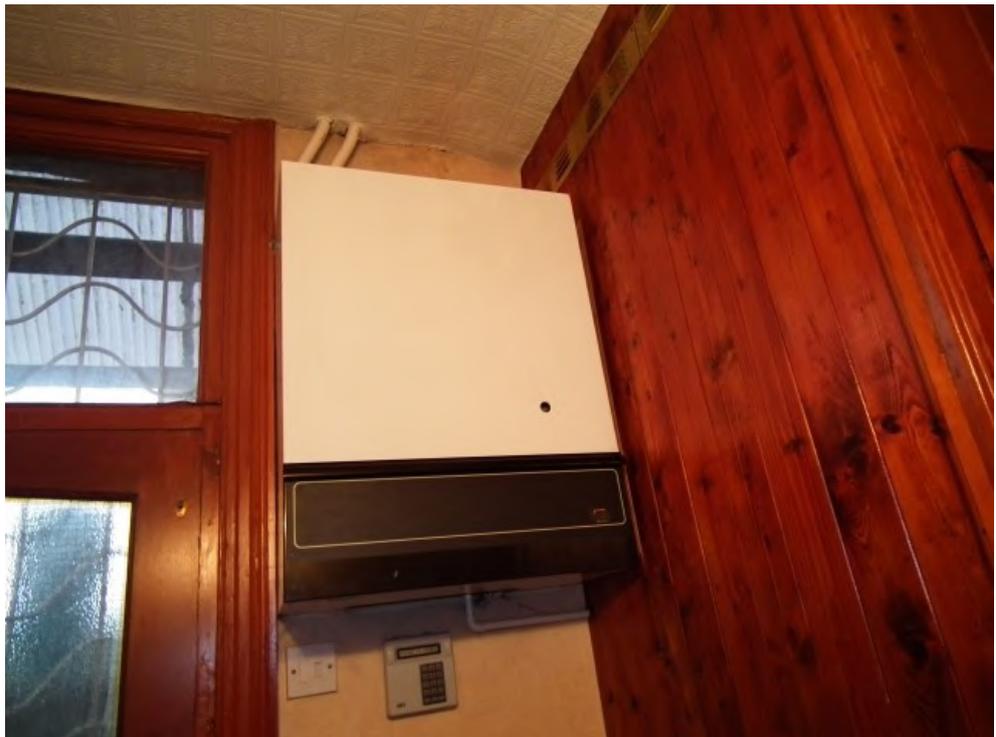
Location of central heating boiler

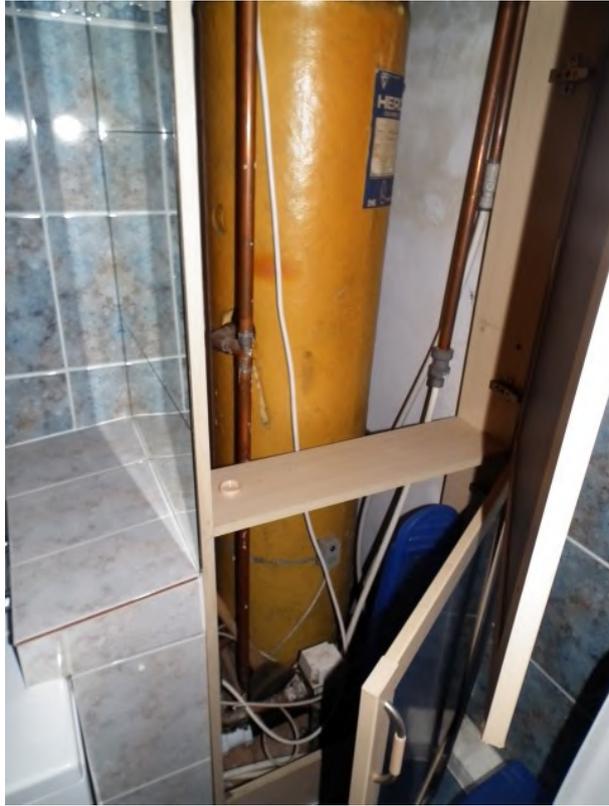
location of the hot water cylinder in first floor bathroom

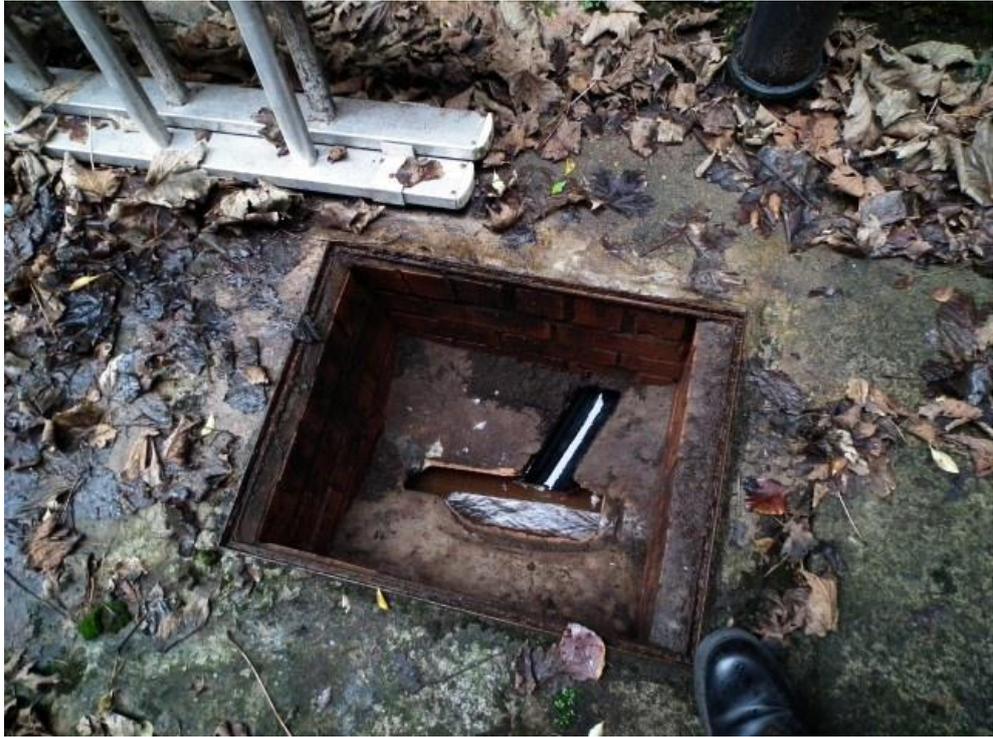
Drains are clear and free flowing

<b>Action Required</b>	<p>Drains should be regularly inspected to ensure they remain free from blockages, tree root damage or other obstructions.</p>

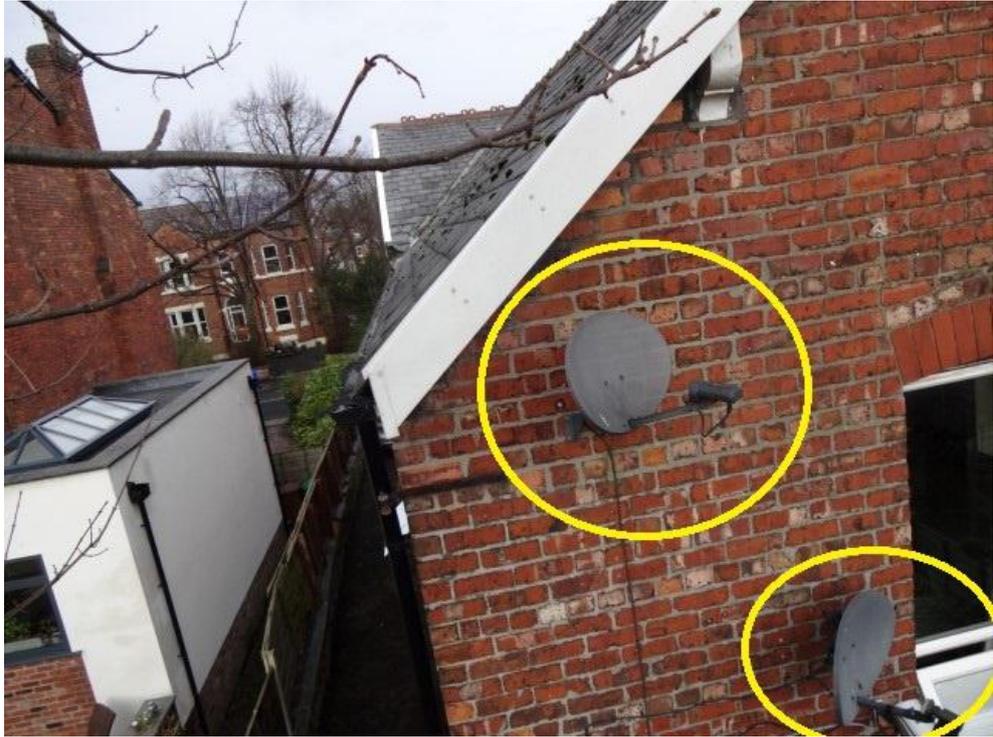
Satellite dishes located on the rear of the property

<b>Action Required</b>	<p>Examine all fittings regularly to ensure that they are secure.</p>

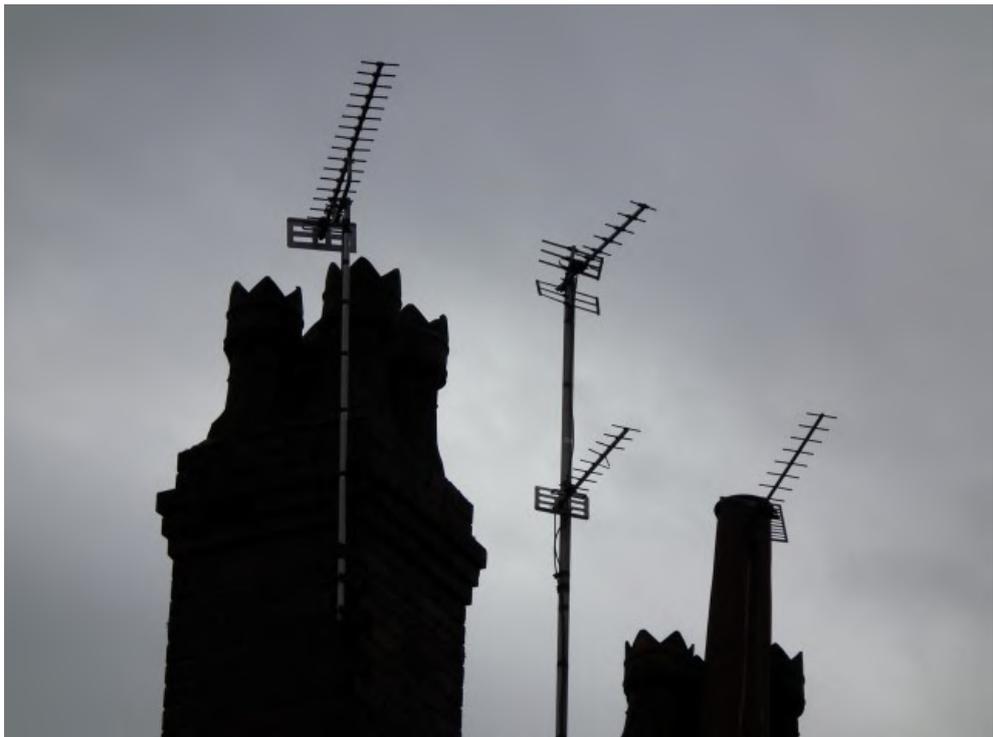
TV aerial attached to chimneys

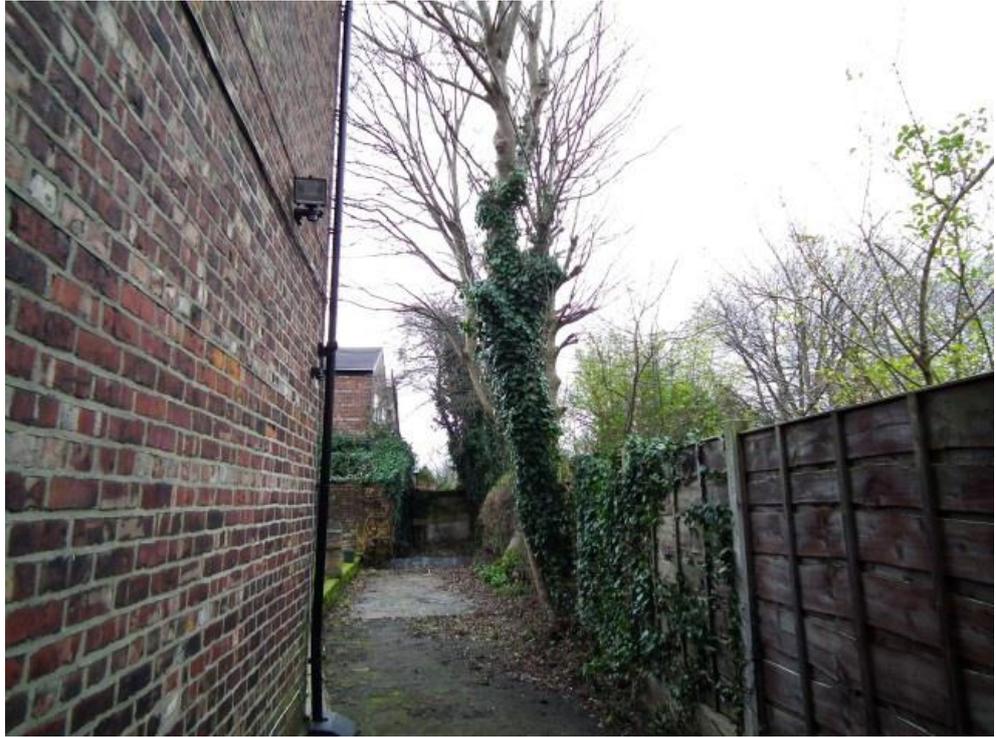
Trees close to property

<p><b>Action Required</b></p>	<p>General maintenance is required to several areas around the grounds including new fencing, re-pointing the garden walls, re-laying the patio concrete slabs and repairing the cracked concrete to the front.</p> <p>It is recommended to either remove/renew the broken stone gate post or explore the possibilities of having it properly repaired.</p> <p>Trees and large bushes should be maintained and pruned on a regular basis.</p>
